# ***APPENDIX I***

## ***Restoration activities for each area***

*Report on the Conservation and Restoration work of  
LION and NAGA Balustrades at the Causeway and Outer  
Gallery of BAYON  
Angkor, UNESCO World Heritage Site.*

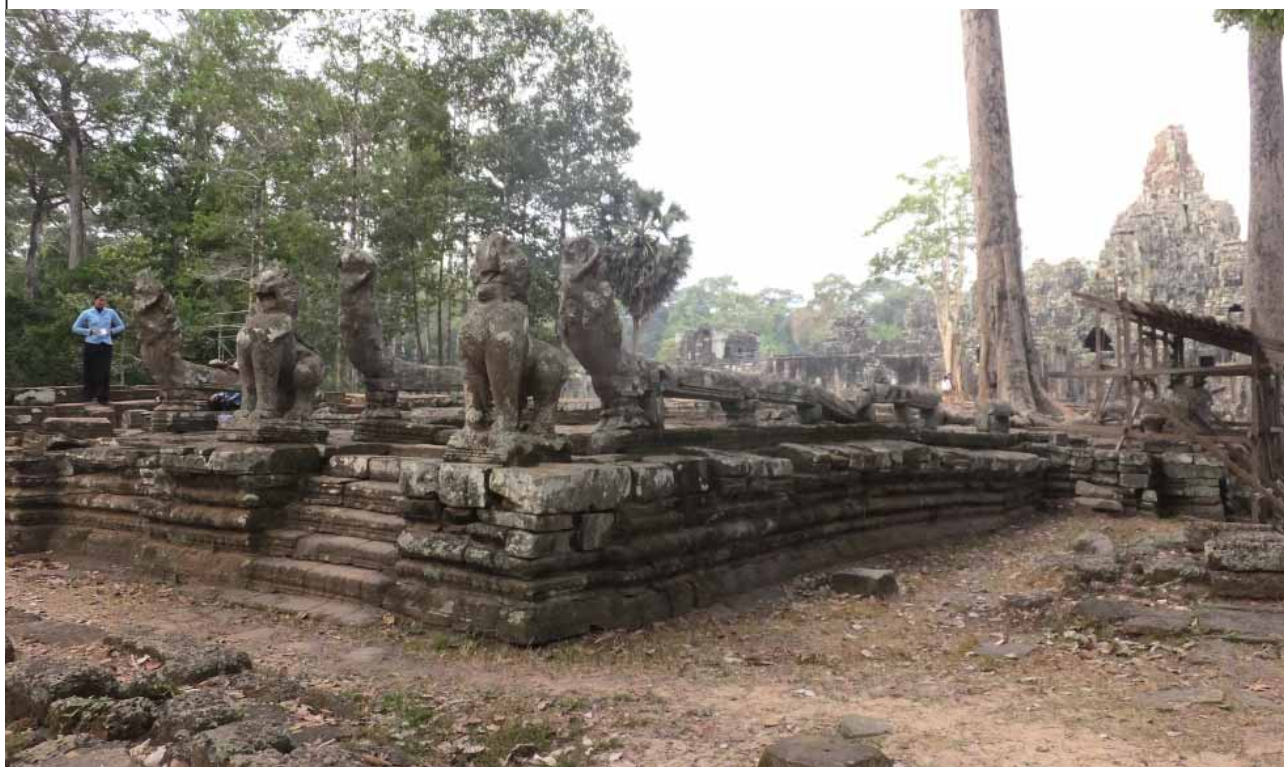
Area : T71.1-1/NorthEast Operated Term : 5 month

In this area, platform was heavily distorted and some elements were fell down under the platform. After surveying and recording, we confirmed that some scattered elements of the balustrade around the platform could use and back as a handrail.

After dismantle the balustrade and started repairing of each elements, in parallel, maintenance platforms was started. It was obvious that one of the causes of inclination of balustrade was uneven subsidence of platform structure. The problems of such subsidence mainly be ascribed to the loss of the soil compacted inside the platform. However, in our project, we only reconstruct surface layer of the platform. Thus, it was difficult to make align the horizontal level and make stable condition to install balustrade. For such gap between platform and basement that could not keep stable condition, we insert new sandstone plate for support, and also filling gap with soil 4.

For this Naga Head71.1.1.8.1.23, two different parts are connected as one Naga statue in the previous restoration. We decided not to connect this two part again, and made new Naga body part for Naga head so that Naga statue can install in stable condition. The length of the Naga body were referred to the trace of post on the basement.

Although the basements was not repositioned, the base was heavily distorted on the north face and had to be levelled and stabilized by inserting sandstone plates between the floor and the basement. The handrails were mostly repositioned except for the Naga heads. As many members had collapsed onto the platform or were placed in other positions, these had to be identified their original positions and repositioned. A number of substitute posts were used, and the positions of these were also changed to appropriate positions for levelling and stabilization.

In this area, 1 Lion statue was restored (L-2: 71.1.1.9.1.2, 71.1.1.9.1.3, L-3:71.1.1.9.1.4).For 71.1.1.9.1.4, the ankle portion was lost due to breakage, and although it had been mortared and joined in the previous restoration, there was a risk that it would break again due to deterioration of this material. Therefore, new sandstone material was processed according to the required size, filled in, and joined.

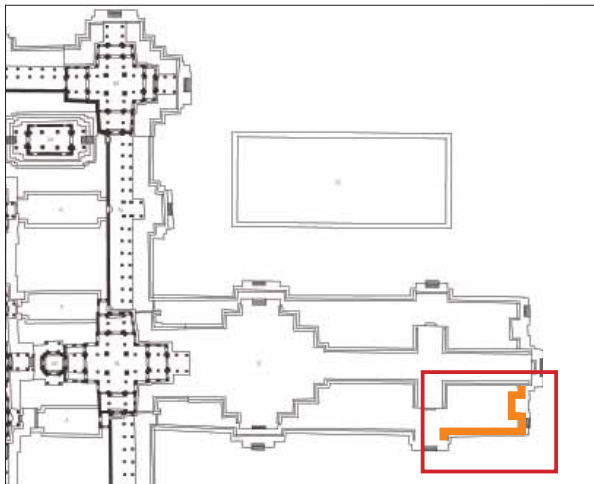
## Area : C71.2-1 / SouthEast part Operated Term : 5 month

From previous survey at the southern balustrade, we found that most basements are original and situated in original position. Although, some of the posts and handrails were fell down on the platform caused from distortion of platform. Also, most posts were substitute elements replaced in previous restoration, we decided to reuse these elements by result of trial assembling.

Uneven subsidence of platform structure was most remarkable at west edge of the balustrade, southeast stair of causeway, as we could see more than 60cm subsidence around here. This cause very unstable situation of balustrade including Naga statue and needed large scale adjustment in order to keep every balustrade at same level. In the maintaining work of the platform, we filled vertical and horizontal gap of platform with laterite blocks or soil 4 as necessary. Although, it was not enough to make Naga statue at same level as other handrails, we insert 4 sandstone blocks under basement.

In our work, we installed these fallen handrails and posts. Also, mortar which inserted in the previous restoration between posts and handrails were replaced by new sandstone. For this area, the range of uneven subsidence of platform structure was more wide than other area to inner of causeway, and difficult to implement maintenance of platform only directly under the balustrade. Thus maintenance were performed 2m inside the balustrade.

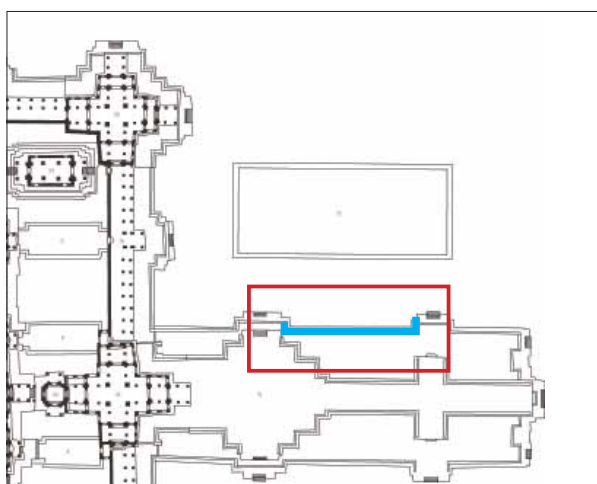
## Area : T71.1-1/West part Operated Term : 8 month

In Area 71.1-1, many balustrade elements had collapsed onto the platform, and investigation confirmed that many balustrade elements installed in this area during restoration in the 1930s were not in situ, but had been replaced during previous restorations and moved from other locations. Close examination of these members revealed considerable deterioration, including cracks, peeling, damage, and breaks in many of them. In addition, there were many scattered stones piled up around this area and at the edge of the reservoir on the north side of the approach, and it was confirmed that some of these elements were related to the balustrade.

Several handrails and posts were found by arrangement of a scattering stone around north side of the area 71.1-1. These elements seem to have been installed in this place in the past restoration by inspection from an old picture taken just after past restoration by EFEO. When we considering the location of these scattering stone and elements fell the platform at reconstruction work, as far as it was possible, the original position was specified. And when the original position was unclear, the most stabilized location was considered. □Finally, we decide to put back 3 handrails and 2 posts from scatted elements found from north pond. Though these elements also need supplementation by new sandstone in order to set back on the platform.

In this area, 1 Lion statue was restored. This lion statue which lay down on the platform we decided to produce a new support pedestal for this statue and make a statue rise, for we judged that it would cause further degradation of a statue if we left the statue in the state.

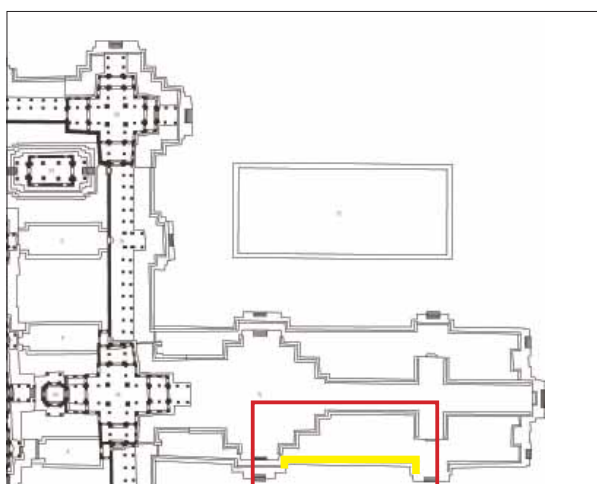
## Area : C71.2-1 / West part Operated Term : 3 month

As for the state of Naga balustrade before restoration, many handrail and post elements were already missing at middle part, and also remaining basement elements were also scattering on the platform. For the western corner, some handrails were remaining and substitute elements of the post were inserted by past treatment but it could never be said that it was stable situation. Opposite eastern side, uneven subsidence of platform structure causing distortion of platform especially under the most eastern Naga head was inclined and in danger of falling.

After finished repairing all the elements, direction of the reconstructing was decided through trial assembling work. At west corner, we confirmed that to some of the substitute post would be difficult to reuse, we decided to make new substitute posts by new sandstone for supporting handrails. Also, new sandstone was supplied to some basements which were partially missing. At east corner, in order to stably install heavy Naga head, we judged the minimum platform improvement would be necessary to correct the distortion of the floor. Thus, in the range of 1.5 meter across the balustrade were dismantled. Also, some new sandstone support inserted under this Naga head for support.

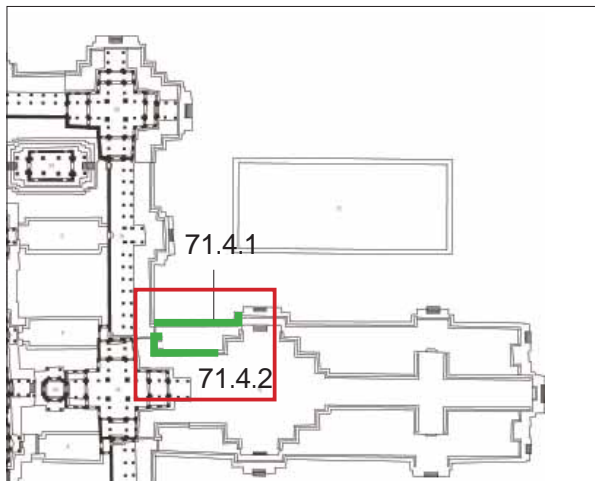
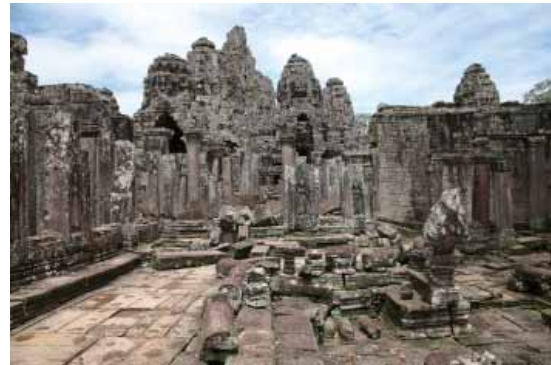
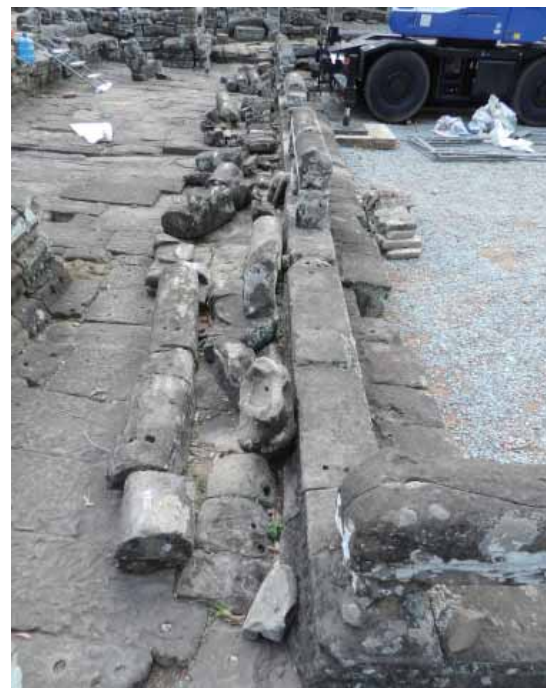
## Area : C71.4 / Operated Term : 6 month

Area 71.4.1 is the place where we could see vivid influence of damage by fallen tree in some decades ago. Many elements of balustrade and Naga statues were broken and fell down on the platform. Platform was distorted by the changes over years, in particular, the most outer line of the surface layer were moved to the outside and causing the big gap with inner line that balustrade should be set on. Also, certain inclination could be seen that was too unstable to reconstruct without any treatment.

71.4.2 is a section that collapsed again after restoration in the early 20th century due to the collapse of a large tree. Many collapsed balustrade elements were scattered in situ and the elements were also damaged into small pieces. Preliminary investigation confirmed that all the original bundles were in place. Careful identification of the small piece combinations allowed us to restore them to their original appearance.

After basements finished put back, we start to back handrails. 3 of the posts need replacement by new sandstones because it was too unstable to use former substitute elements. Also one post out of 7 original posts need to fill with new sandstone to the missing part. Some of Naga body we put back as same place before dismantling, but some we changed the place according to the situation of the area. Such as; stone from scatter stones that we just found and connect, need to find the places to back it all.

In another part, the new sandstone processing work for supplement missing part by the new sandstone where went on to 3 elements (1 post and 2 handrails). These were found from scattered stone around this area .

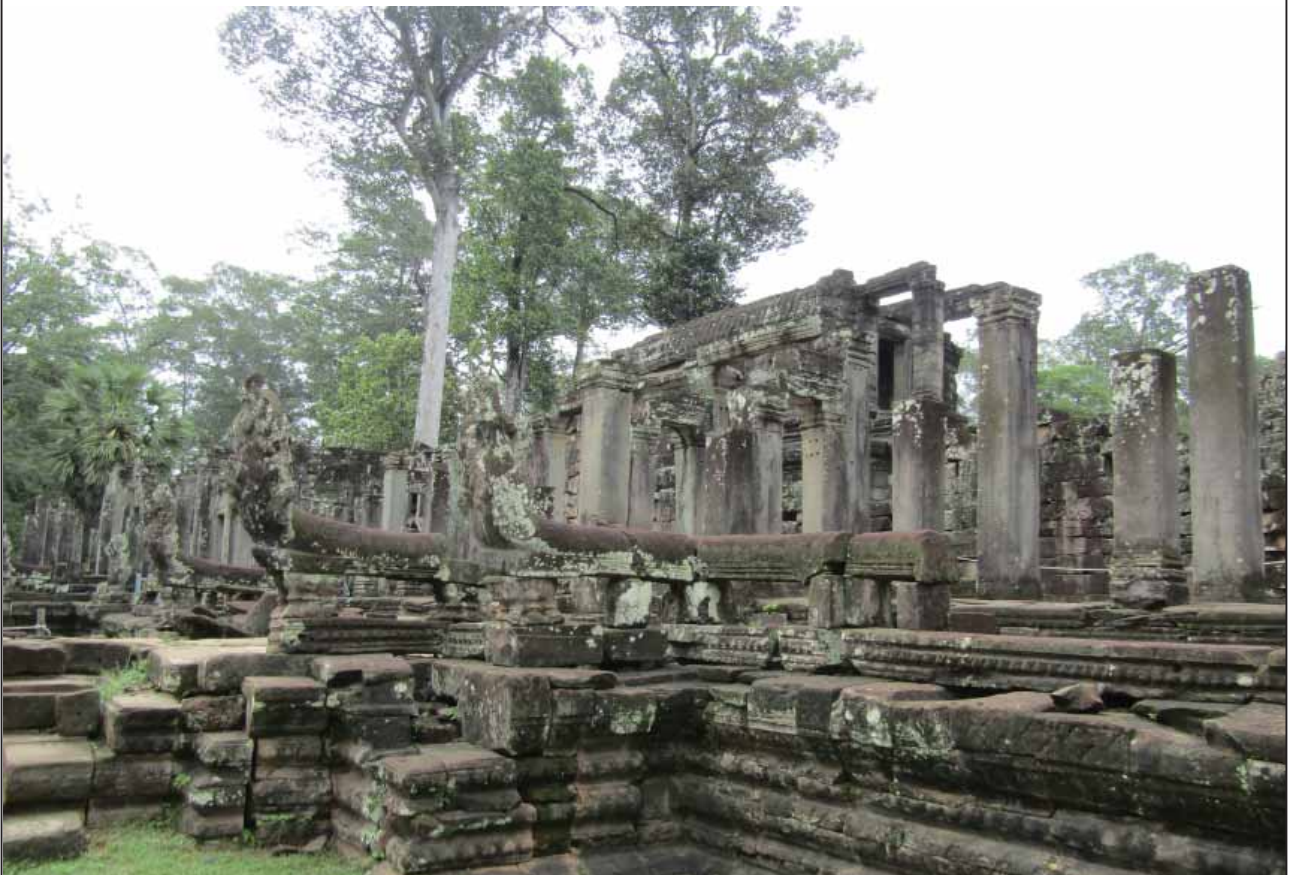
Area : T68.1 work period : 8 weeks

Except around porch, most handrails and posts were missing in this area. There are two Naga statues at this area. Whereas eastern Naga statue was in stable condition, western Naga (68.1.8.1.4) statue was broken in two pieces and in unstable situation. Thus we decided only dismantle western Naga statue. Previous treatment of this NAGA was already deteriorated and again broken. Also the basements under this statue were in unstable condition caused from horizontal direction gap between the floor of platform. One basement (67.1.8.3.2) were broken in 2 pieces, thus we decide to dismantle this basement and related posts and handrails.

In this area, we set mini crane at northwest of this area. Dismantled elements were moved to JASA restoration hat and had repairing. At reconstruction work after connection of Naga statue and basements, Some sandstone plates were inserted between basement and platform floor, as platform around porch caused serious uneven subsidence. Also, small piece of sandstone support was inserted under a handrail.

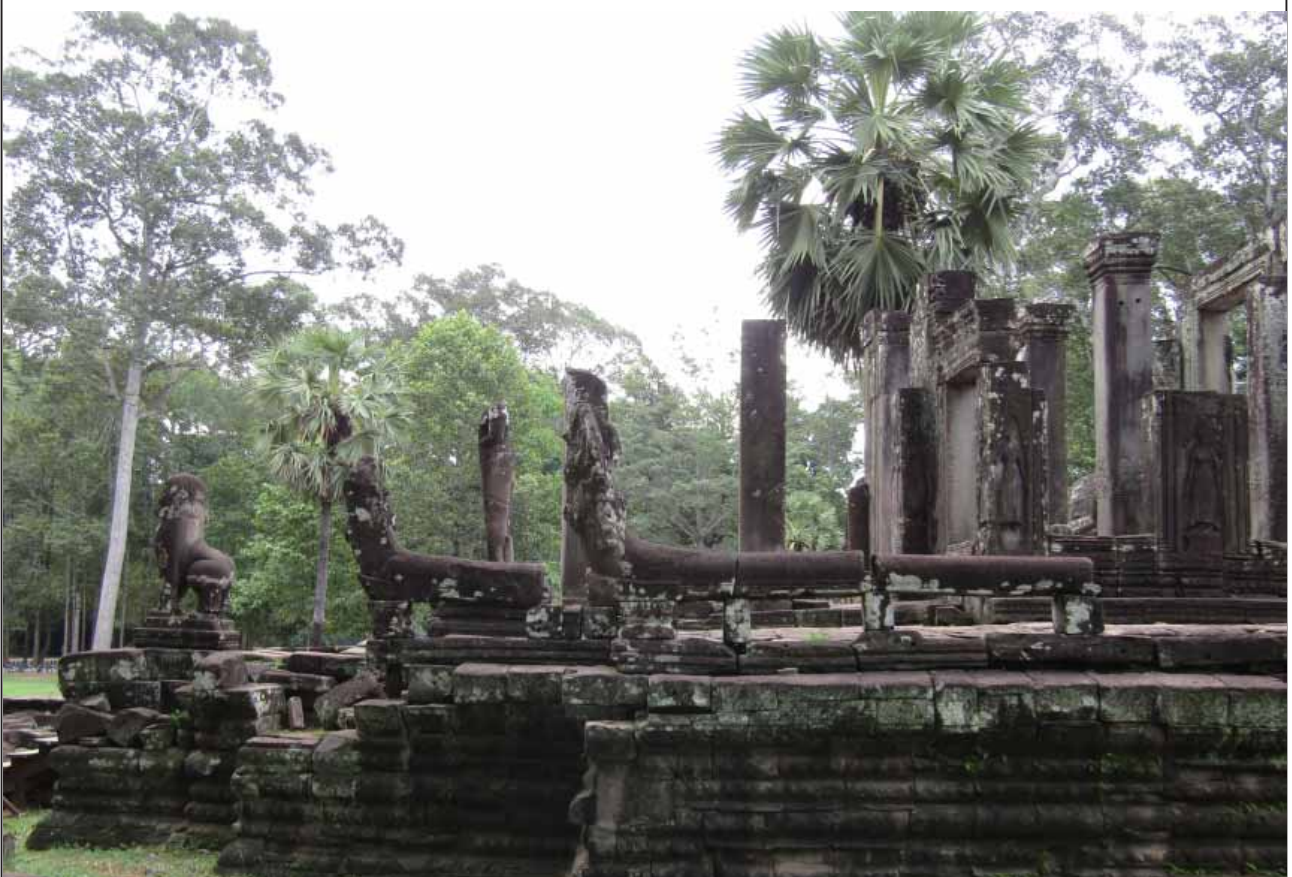
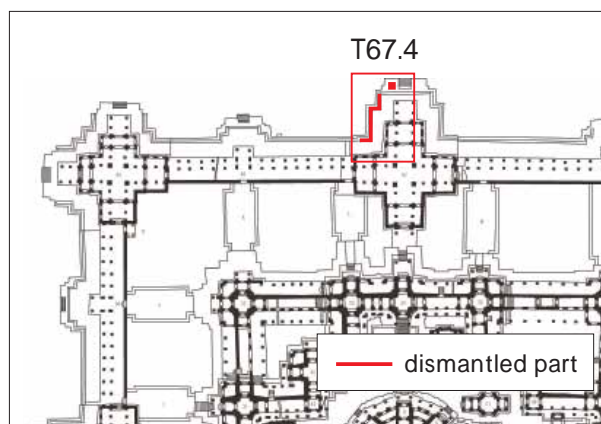
Area : T67.4 work period : 16 weeks

There are 2 Naga statues in this area. For the eastern Naga statue(67.4.8.1.1), two elements of the platform directly under the Naga statue's basement were missing and concrete support was inserted under the basement of Naga statue. However this concrete support was deteriorate and needed replacement with new sandstone supports. Also, the trunk of the other western Naga statue (67.4.8.1.4) was broken and had no previous repairing, just supported by substitute post. Thus we decided to connect this broken Naga statue and so that we could remove substitute support.

Also, one lion statue in this area was broken into two pieces(front legs and pedestal was separated ) and also very unstable situation caused from uneven subsidence around the statue.

There were scattering stones around this are, thus first of all, we had to secure the space for set mini crane. We took photo records before moving these scattering stones and move to other place. Also many tourist walk pass T67 for gate, we set temporary enclosure around restoration area in consideration of safety and noise. After that, we carefully dismantle lion statue and other balustrade. After repairing of each elements, we confirmed how much and where sandstone plates and lead plates should be inserted. From discussion with JASA experts, we decided to insert two new sandstone support under Naga statue 67.4.8.1.1. For this new supports, we mark rough texture for surface finishing. Naga statue 67.4.8.1.4 was connected and install without substitute post when reconstructing.

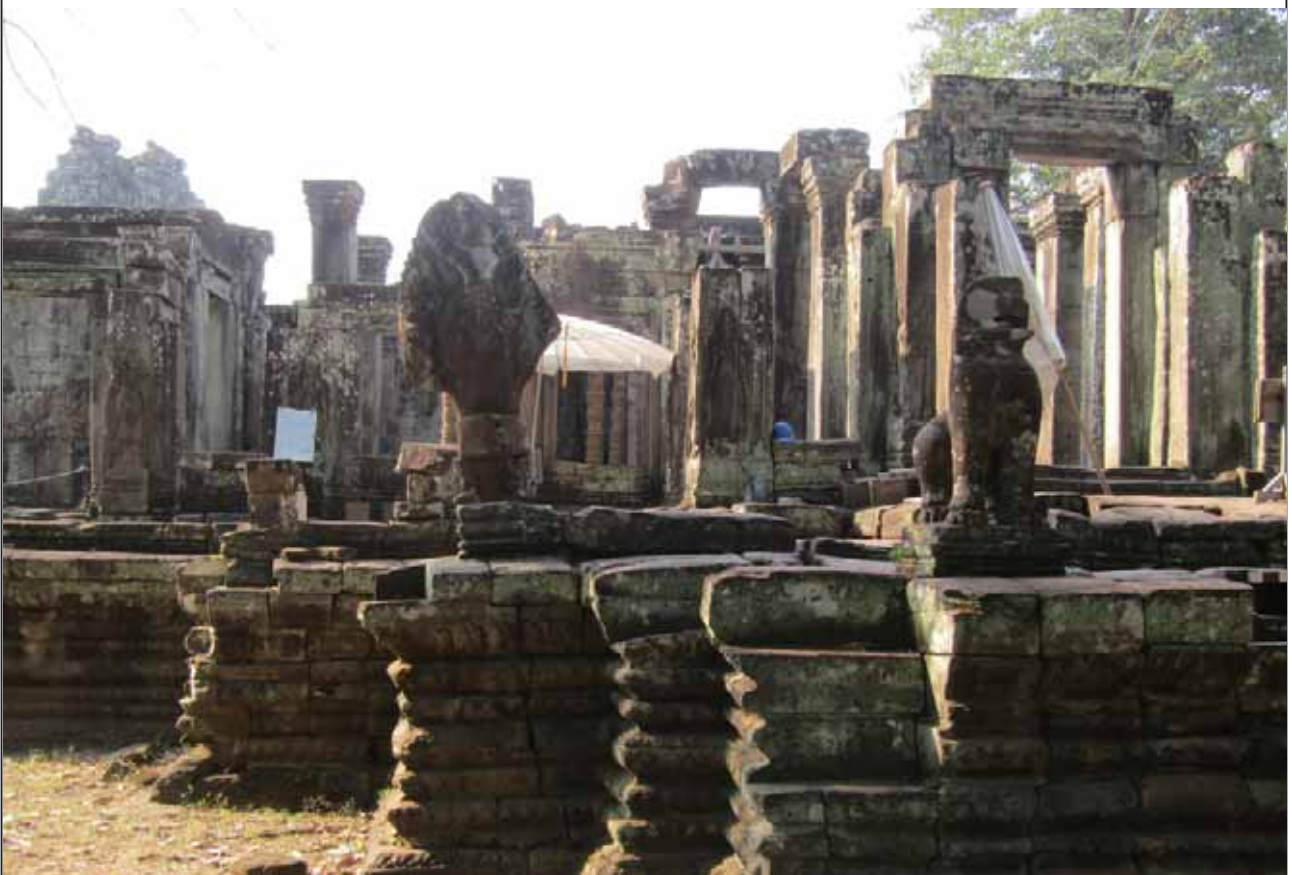
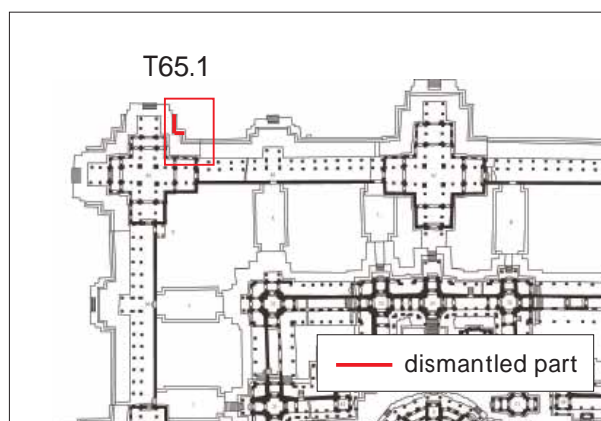
Area : T65.1 work period : 6 weeks

The Naga statue of this area (65.1.8.1.1) was inclining to the outside due to broken of the basement. For the other part, is seems comparatively stable.

In this area, we decided to dismantle only Naga statue and handrail beside this statue, and posts and basement under these handrails. As a result of dismantle, as there some were uneven settlement of the platform, there were no gaps at floor, thus we decided to re-install the elements without touching platform. For the Naga statue 65.1.8.1.1, part of Naga head was broken and connected in the previous restoration, though deterioration of the connection was concerned, we reconnect this part. Also, we also connected broken basement which caused inclination of Naga statue. When reconstructing, some leadplate were inserted between basement and post and Naga statue to eliminate the inclination of the Naga statue.

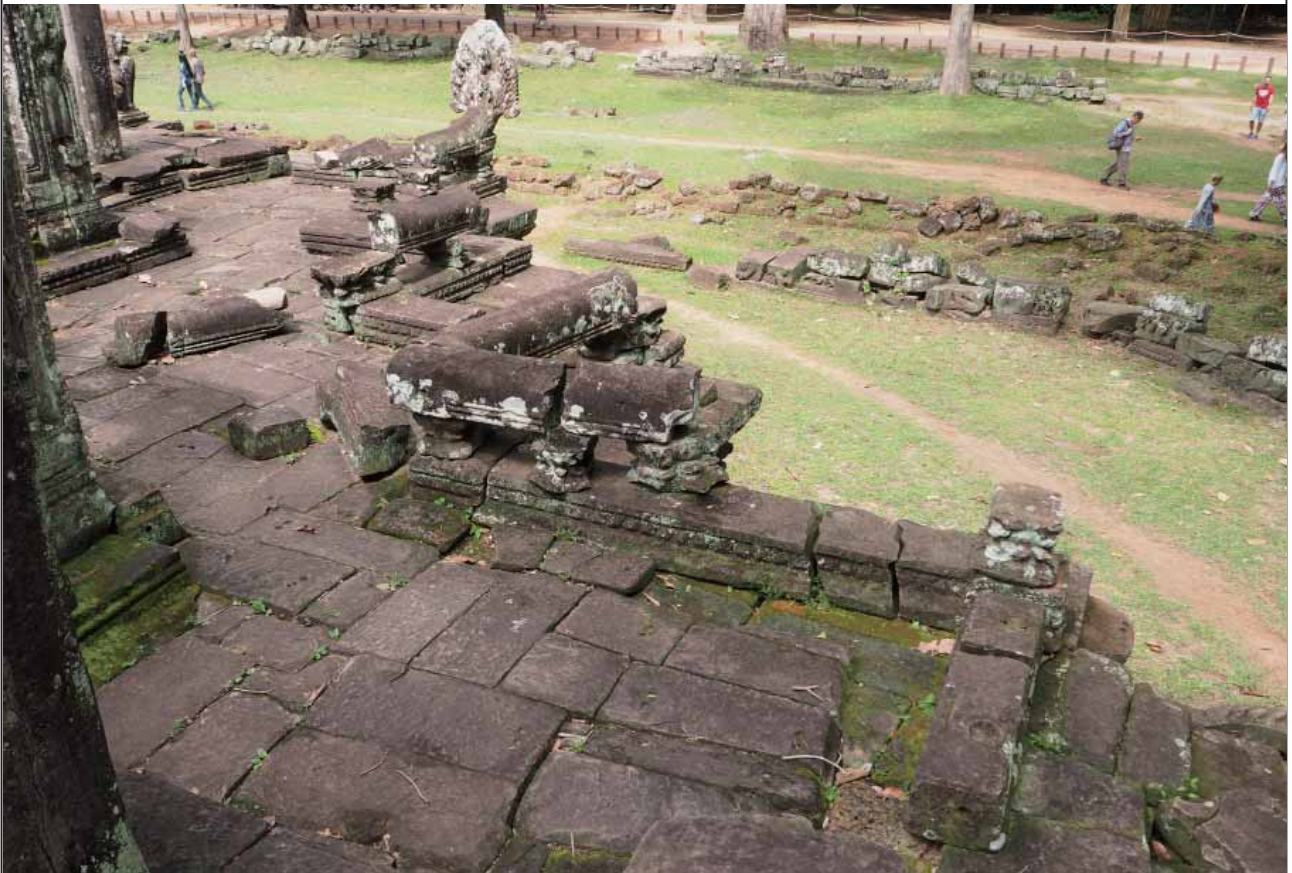
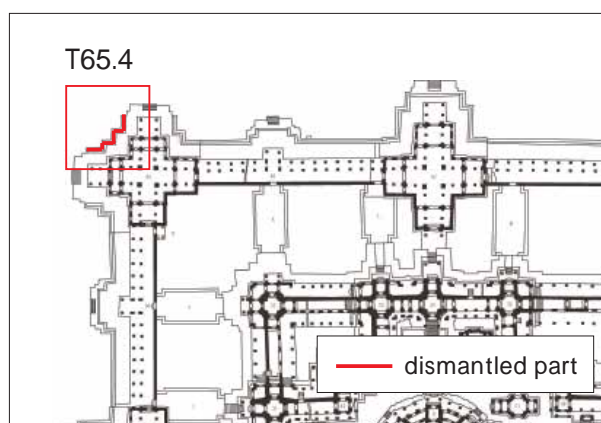
Area : T65.4 work period : 20 weeks

Uneven settlements of the platform forming big gaps and breakage of the basement, and caused many falling of handrails and posts. Also, it was clearly visible that rest unfallen NAGA statue was installed at unoriginal position by previous restoration. Furthermore, in the rain season, ground around this area was covered with rain water, these fallen elements was also submerged in water and causing further deterioration.

First of all, we begun from setting site around this area after records of the scattering stone. Specific work was which find the combination of fragments that could be joined and identification work of the original position was carried out carefully. One of the largest progress in this work is we found that one Naga statues installed at T64.2 and piece of handrail could be joined and originally positioned at western edge of balustrade in this area. Finally all scattering stones on the ground and platform could installed in this area. Also simple platform improvement was done before reconstructing work.

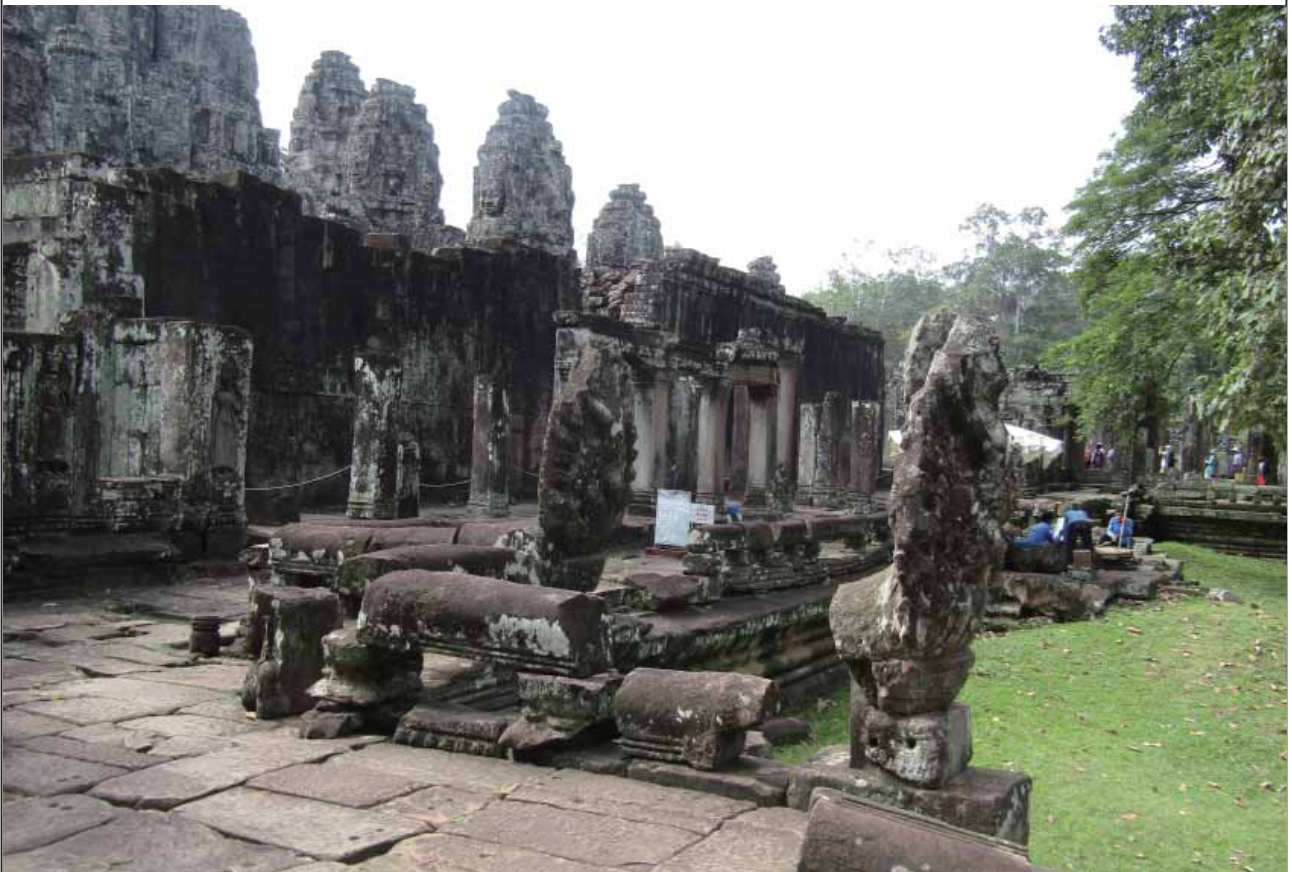
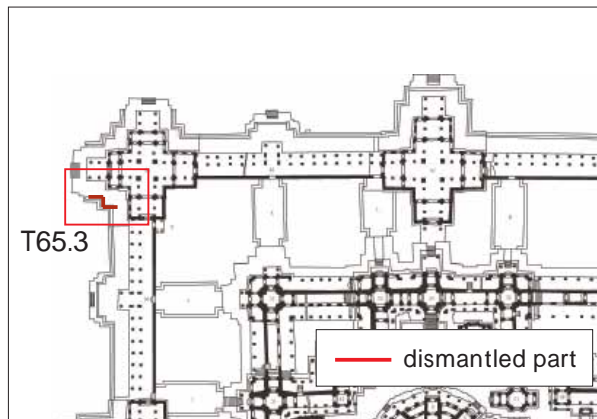
Area : T65.3 work period : 10 weeks

There are 2 Naga statues in this area. Western Naga statue (65.3.8.1.1) was missing whole trunk and fixed with iron clamps and pin to the substitute post and basement. The other Naga statue (65.3.8.1.5) was broken into two pieces. Also, some of the basements has delamination and broken into fragments.

For one lion statue stood in this area, some cracks and other deterioration are recognized. Thus we decided to dismantle this statue and implement filling of cracks exfoliation.

For the situation as above, we decided to dismantle most of the elements of balustrade except few basements and posts at western edge. Also, these deterioration of the elements caused from uneven settlement of the platform. Thus we dismantle first upper layer of the platform in order to remove the soils which enter into the gap and eliminate the gap between platform floor.

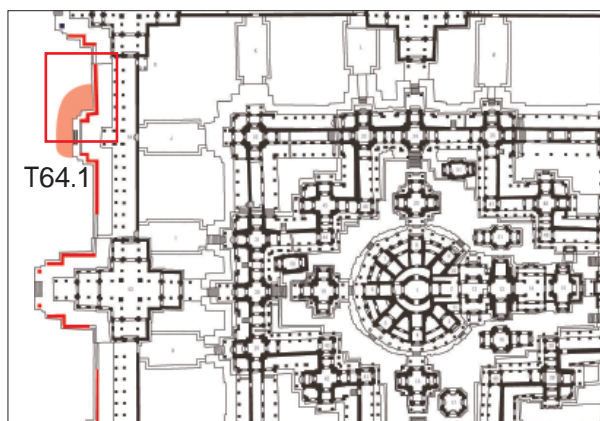
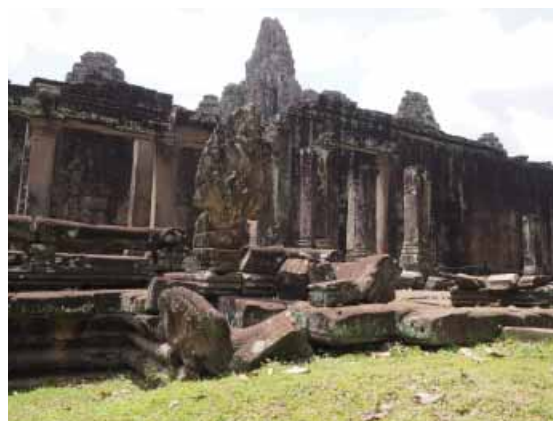
## Area : T64.1 work period : 8 weeks

Restoration work in this area began in October 2019, after the completion of the earth clearance work around the platform of Area T64. As a result of the clearance work, many balustrade elements and fragments related to the Naga statues were found, so investigations were carried out in T64.1, T64.2 and the adjacent area T63.4 to determine which elements could be combined and to identify their original locations. Finally, it was found that many elements could be returned to the previously missing parts, in particular, all the elements of the T64.1 Handrails were found in perfect order. Also, many small fragments were found that could be joined to the Naga statues that had collapsed on the platform.

- One collapsed Naga statue □ C6.1.1, can connected not only with also collapsed body, but also with small head pieced found from mound by clearance work.
- It was confirmed that C6.1.19, C6.1.12-15 were joined with 64.1.8.
- C5.2.10 + C5.1.11.1 + C5.1.11.3, C5.2.8.1 + C5.2.9.1, were also confirmed to have formed a single handrail element, so they were joined and installed.
- In order to install the newly discovered handrail in places where had been lost, a new sandstone basement (N64.1.8.3.1) was inserted.

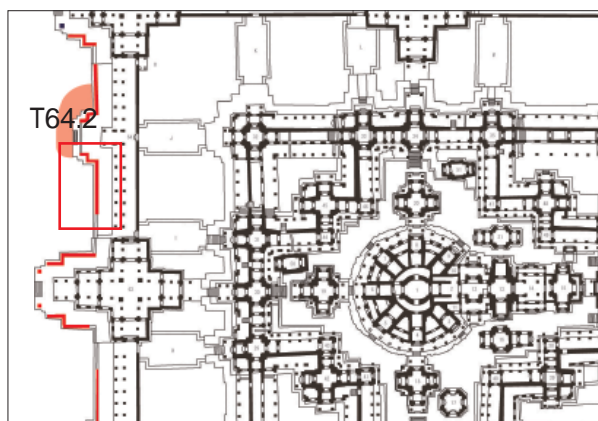
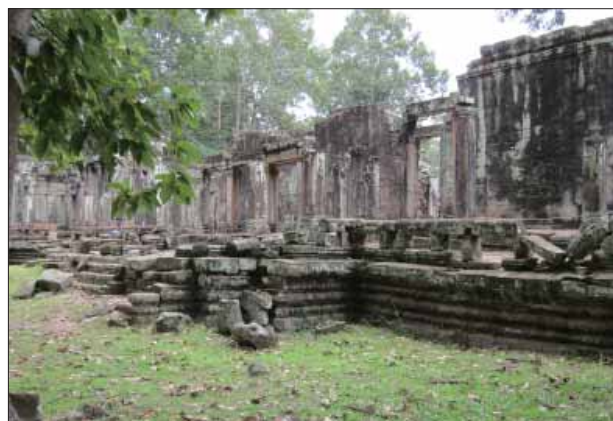
## Area : T64.2 work period : 12 weeks

Typically, the Naga head (No. C6.2.13) and body (64.2.8.1.7(2)), which had been identified prior to clearance and had fallen by the staircase, were found to be in situ at the balustrade corner directly above it, and were joined and reinstalled.

- -Since the location of the balustrade handrails was identified and the size of the missing handrails could be accurately determined, new sandstone material was inserted here to compensate for the missing handrails in two places.

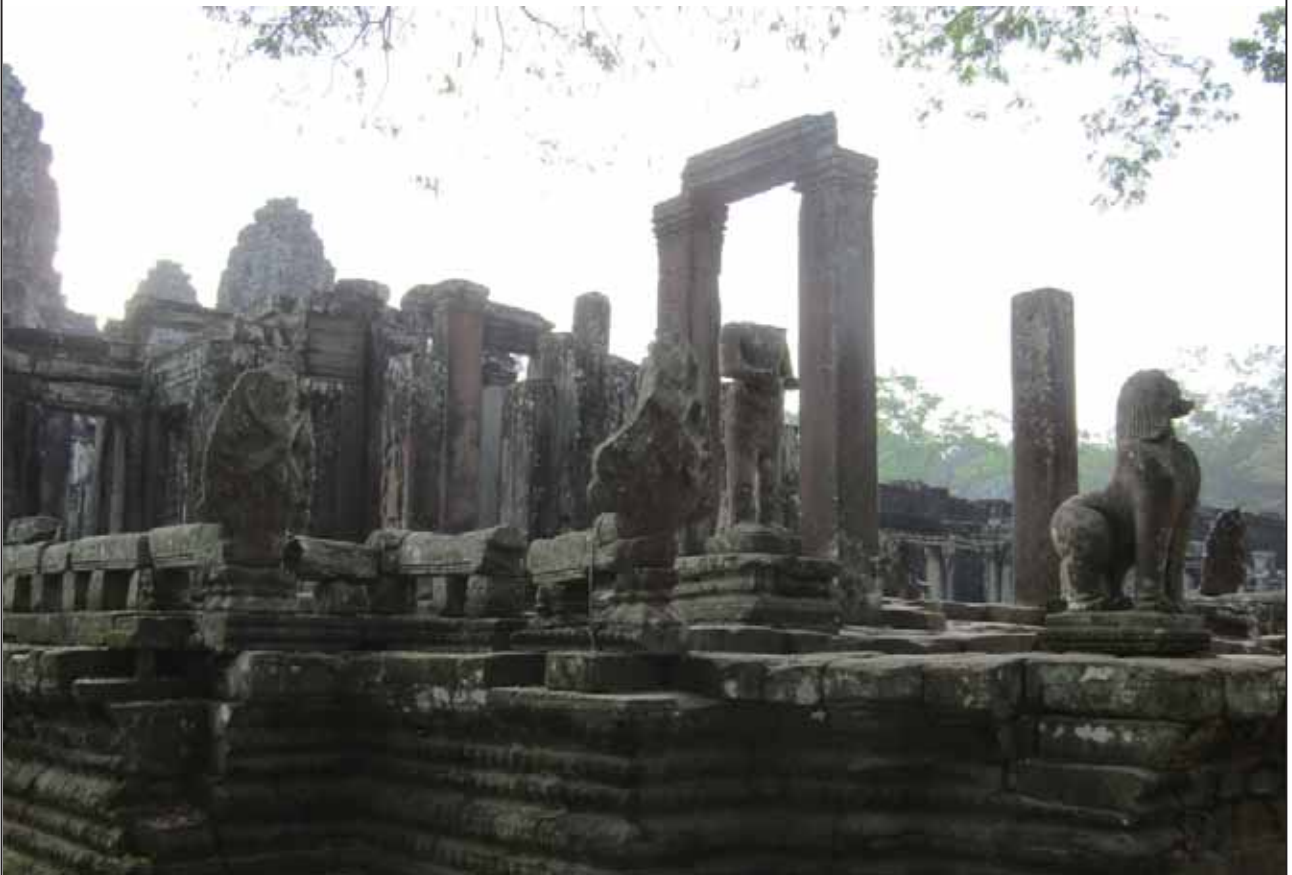
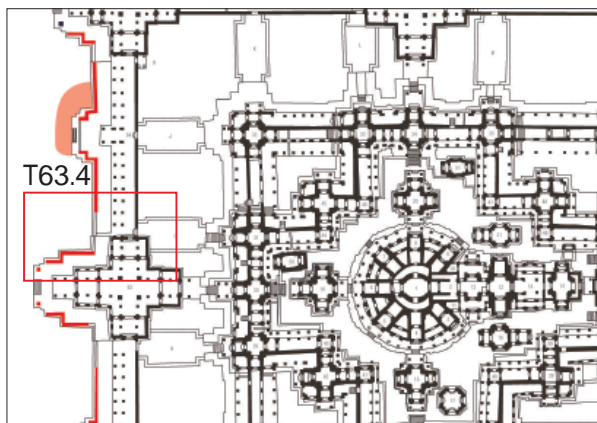
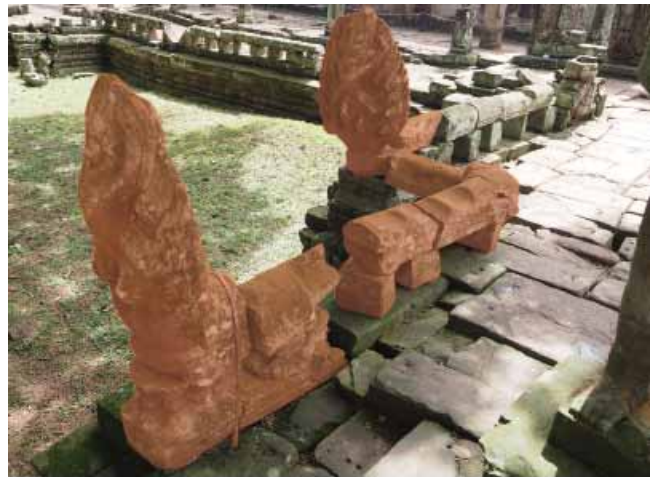
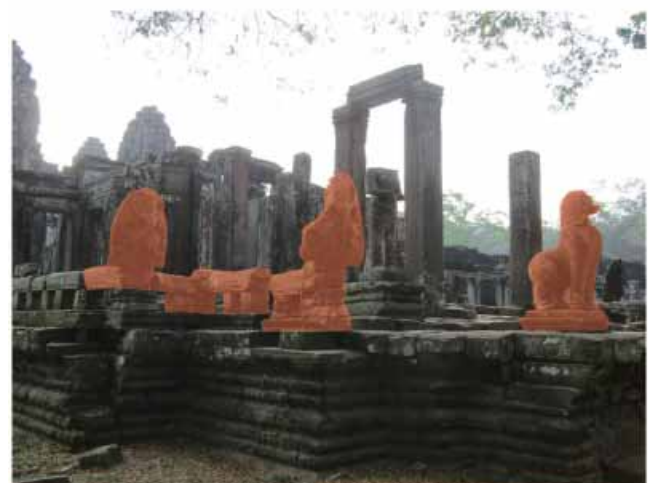
Area : T63.4 work period : 4 weeks

Restoration in this area began in March 2018. In this area, the balustrade seems to have been installed from the original in a special construction method, in which a part of the basement was directly installed as the floor stone of the platform. These platform and basement of balustrade were relatively in stable condition, firstly we decided to dismantle only one Naga and another 3 handrails and 1 Lion. This Naga statue was fixed with iron belt in the previous restoration, but this iron belt was about to come off. Also, a handrail next this Naga statue was easy to move, and recently some tourist changed the position, it was in danger of falling from platform. Furthermore when dismantle started, we found that one more Naga need some repairing, thus we also include this Naga statue for dismantling.

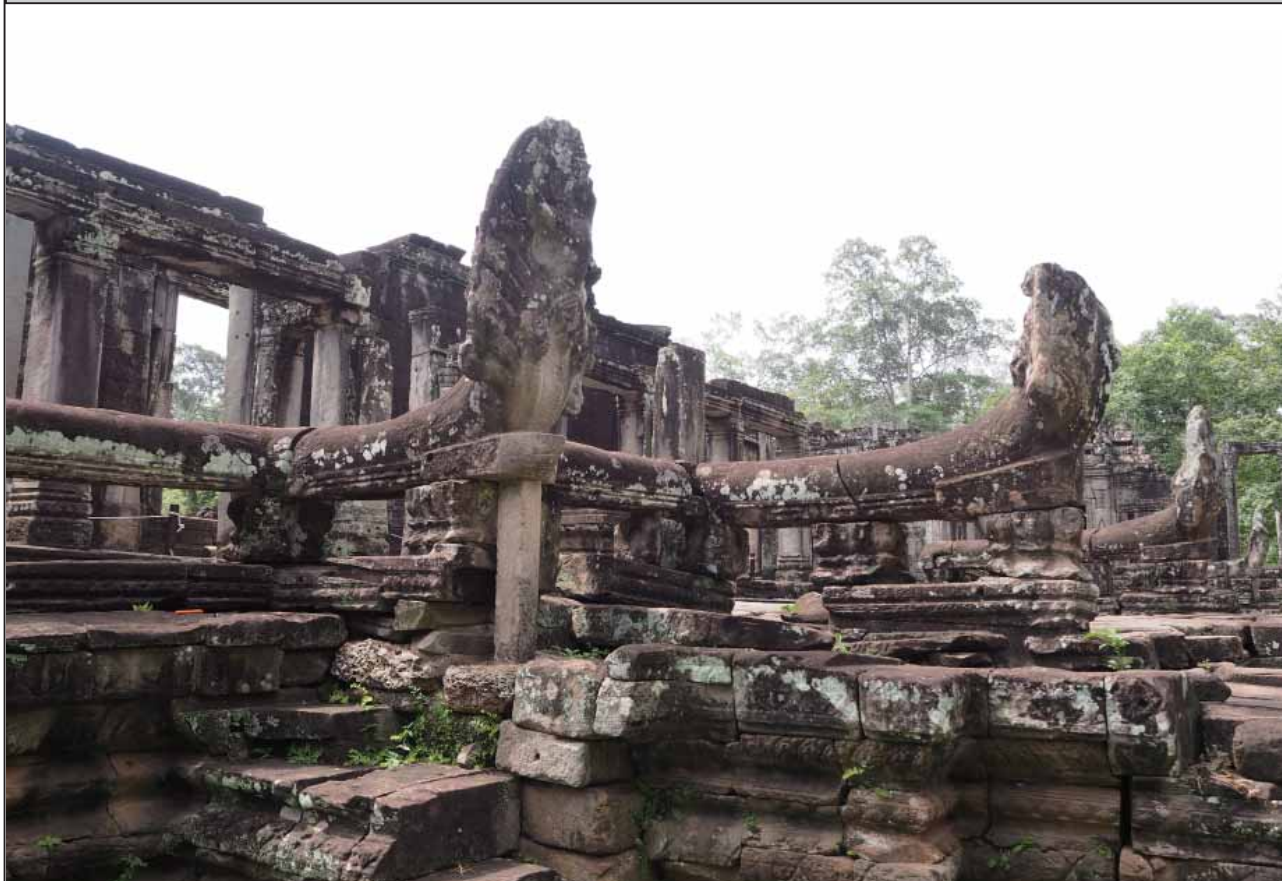
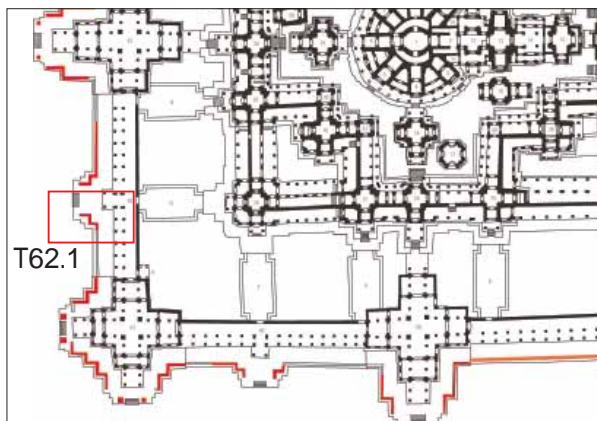
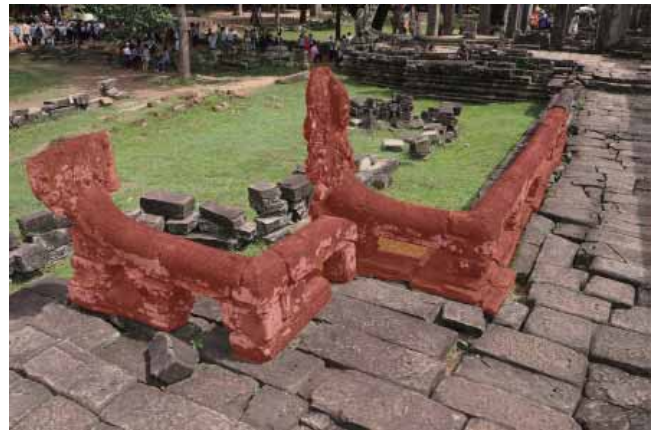
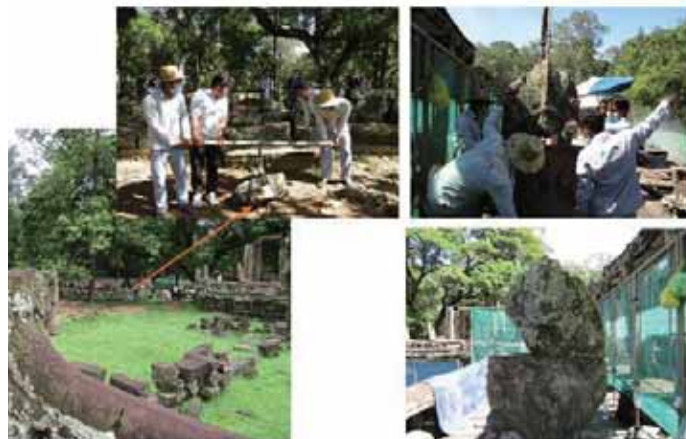
Area : T62.1 work period : 14 weeks

-The body of the Naga balustrade on the south side(C.8.4.1 and 62.1.8.1.8.2) was broken into 2 pieces. There were no connecting treatment at previous restoration, and supported by only substitute post.

-The head of the Naga statue on the north side (62.1.8.1.6) was hung over, thus it was supported by concrete support by previous restoration. From our perspective, after dismantled basement and first layer of the platform, and reconstruct removing extra

soils and gaps between the floor of the platform, upper balustrade including this southern Naga statue can be moved backward. Thus it seems that Naga statue can be set without support after restoration.

For the northern Naga statue, due to the improvement work in order to reduce large gap between floor of the platform under the northern balustrade of this Naga statue, we could bring these balustrades near to wall of the outer gallery. Thus Naga statue no more needs concrete support inserted at previous restoration. Also for the southern Naga statue, before restoration, upper half was broken and already lost. Though after survey by workers, they could found that one scatter stone lying in front of T63.2 would be connected with this Naga statue. Some of the elements of platform around these 2 Naga statue were already lost and distortion could be seen at this area, new sandstone plate were needed when reconstruct Naga statues.

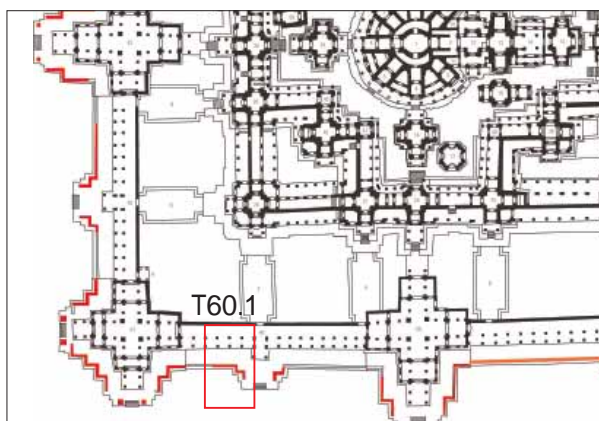
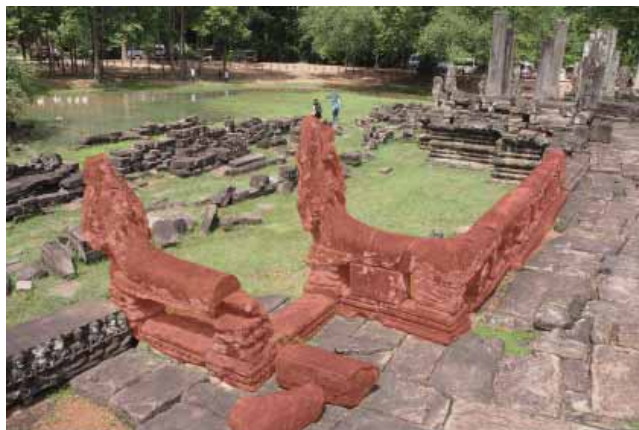
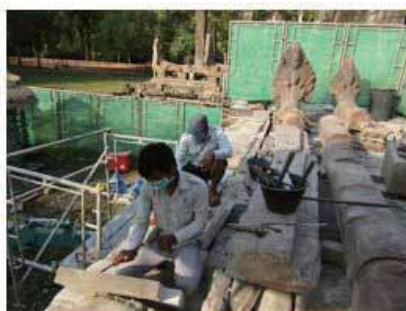
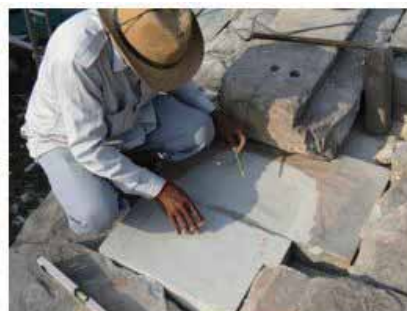
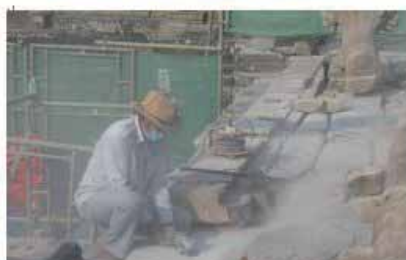
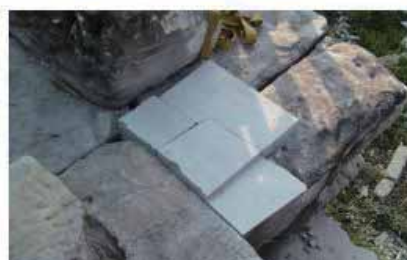
## Area : T60.1 work period : 16weeks

For T60.1, the situation before restoration was very complicated, as most of the element of balustrade were moved wrong pieces were connected or lined in not original position by previous restoration. As a result of our survey, we found many pieces that can be connect as an original element, and could identify original position so that can be back to safely. Also, due to uneven subsidence, floor of the platform directly under the balustrade was subsided, thus we had to implement platform maintenance with supplying many new sandstone plate to these subsided line. The process of the work was done with supplying new sandstone plat and lead plate. One more problem at this area was some heavy rain instead of dry season. Due to rain, sometime it was difficult to set up Mini Crane.

There was no change in the position of the naga head, but there was a significant change in the position of the other rafters. It was confirmed that 60.1.8.1.3, 60.1.8.4 and 60.1.8.1.1, which had been placed separately before restoration, were originally a single piece, so were joined together. It was also discovered that E11.1.2 and 60.1.8.1.6, which had fallen onto the platform, could be joined together. After carrying out these kinds of joins, the original positions of the handrails could be identified by the distance between the post, and the positions of the other joists were changed and installed accordingly.

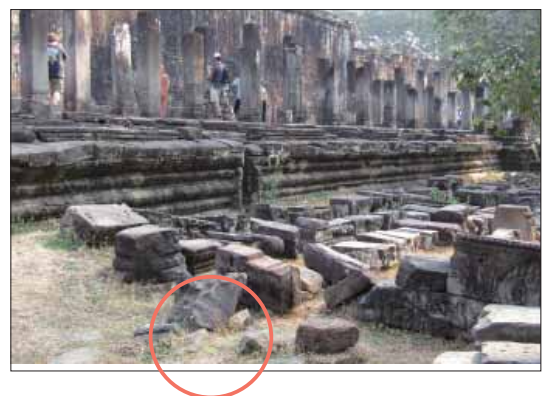
The H11.1VX fell onto the ground in the southeast of 59.2 and <P>Since it was confirmed that this element was originally connected to the handrail placed on the platform at the northern end of 59.2, and the original location of 59.2.8.1.6 was identified as the northern end, the positions of the two naga head balustrade elements were switched. As a result of these changes and repairs, some of the posts (59.2.8.2.7, 59.2.8.2.6) were moved.

In this area, 1 Lion statue was restored (59.2.8.1.1, L-2). Injection work for reinforcement was implemented. During reinstallation, sandstone plates were inserted for stabilization.

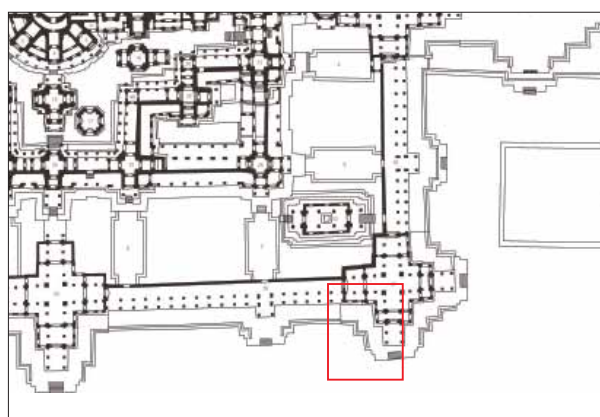
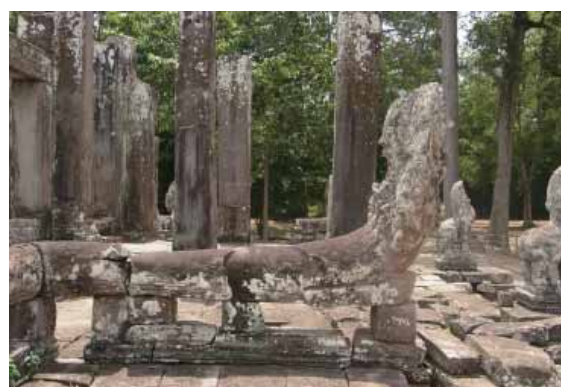
## Area : 57.3 / Southwest Operated Term : 4 month

Since this area was the first area to be restored in this project, which started in September 2012, and also the first area to be restored by JASA, the repair of the parapet components was carried out under the guidance of JASA technicians, one by one, according to the specifications of each component.

In this area, 1 Lion statue was restored (57.3.9.1.1, L-3). The ankle portion was lost due to breakage, and although it had been mortared and joined in the previous restoration, there was a risk that it would break again due to deterioration of this material. Therefore, new sandstone material was processed according to the required size, filled in, and joined. The finishing process was based on other Lion statues, but was done in a way that would make it easy possible to distinguish it from the original.
