# ***APPENDIX I***

## ***Restoration activities for each area***

*Report on the Conservation and Restoration work of  
LION and NAGA Balustrades at the Causeway and Outer  
Gallery of BAYON  
Angkor, UNESCO World Heritage Site.*

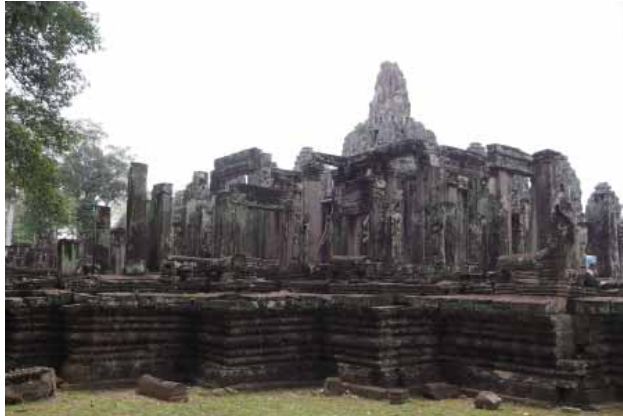
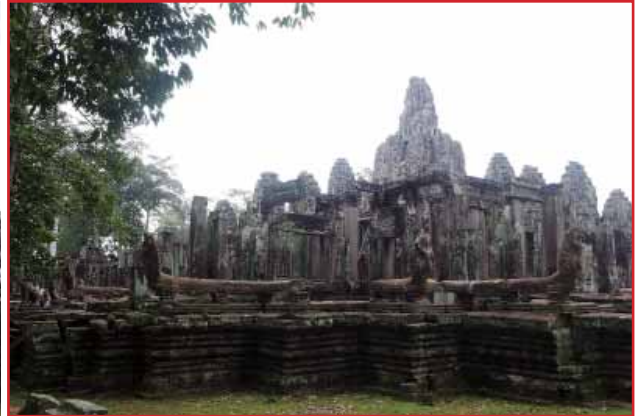
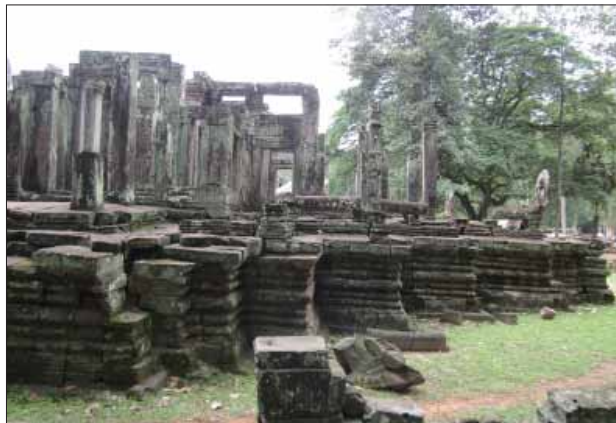
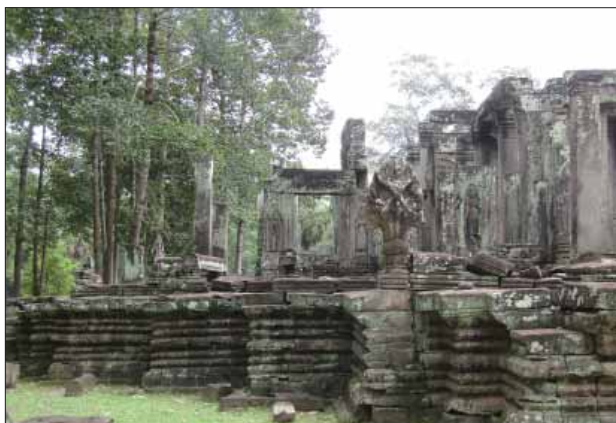
<Before and after restoration>

Uneven settlements of the platform forming big gaps and breakage of the basement, and caused many falling of handrails and posts. Also, it was clearly visible that rest unfallen NAGA statue was installed at unoriginal position by previous restoration. Furthermore, in the rain season, ground around this area was covered with rain water, these fallen elements was also submerged in water and causing further deterioration.

First of all, we begun from setting site around this area after records of the scattering stone. Specific work was which find the combination of fragments that could be joined and identification work of the original position was carried out carefully. One of the largest progress in this work is we found that one Naga statues installed at T64.2 and piece of handrail could be joined and originally positioned at western edge of balustrade in this area. Finally all scattering stones on the ground and platform could installed in this area. Also simple platform improvement was done before reconstructing work.

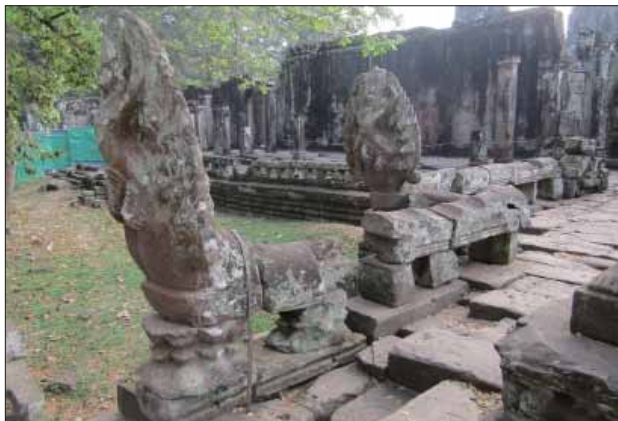
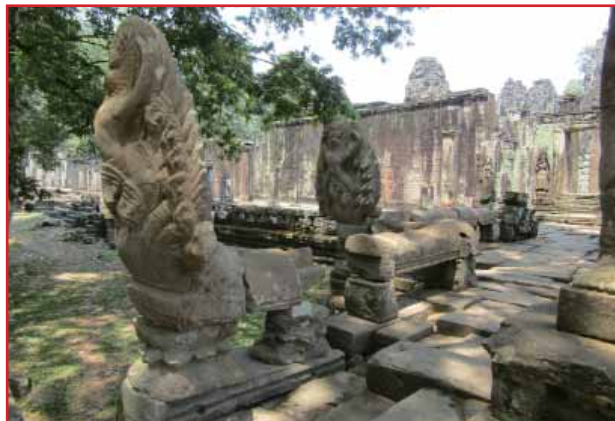
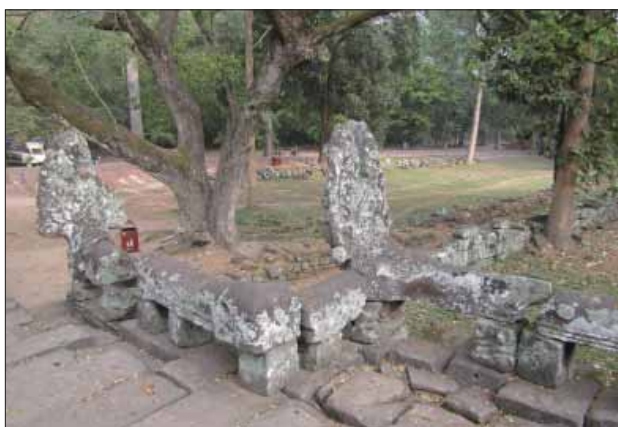
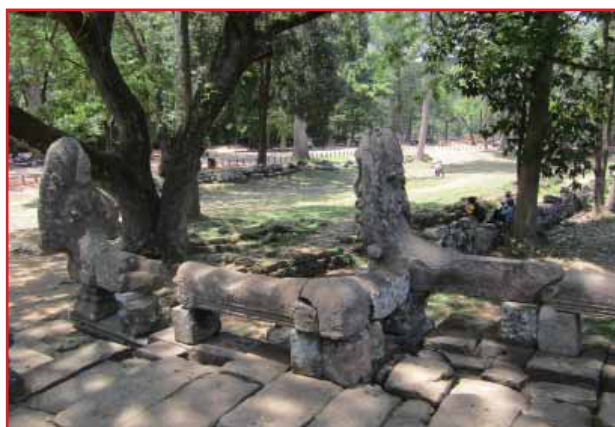
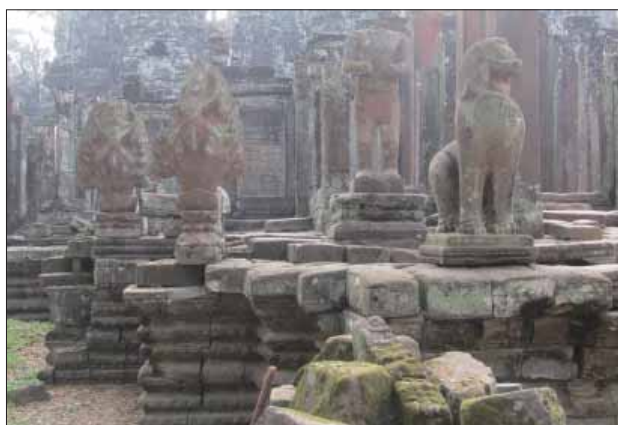
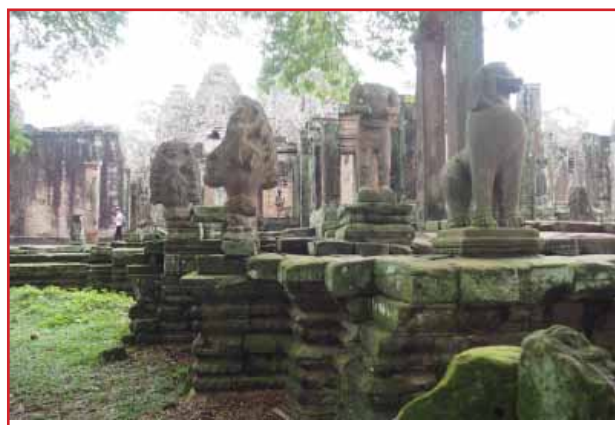
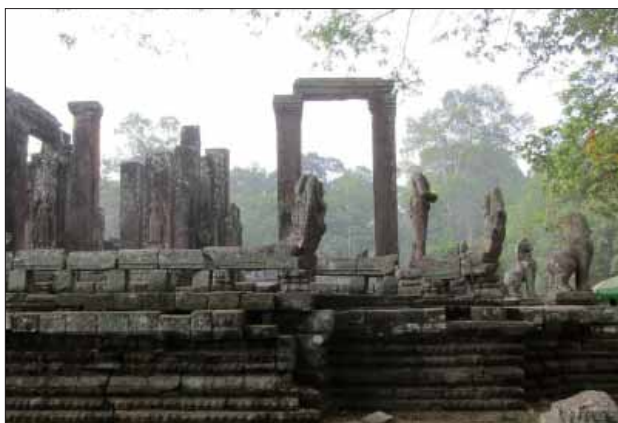
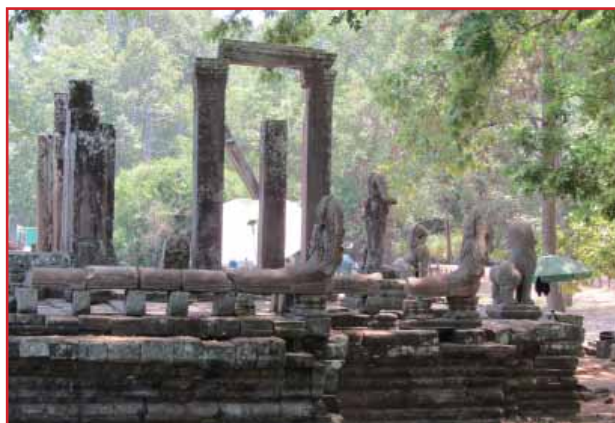
Area : T63.4 work period : 4 weeks

For T63.4, for which restoration was once completed in April 2018, there had been several elements that had not been found in their original location and had been re-installed in positions in accordance with the previous restoration, but as a result of the sediment clearance around T64 (see 5.3) and identification work, these were instead found in their original location. As a result, this area was also able to be fully aligned with the trestle following T64.1.

- Of the two Naga statues at T63.4, the southern Naga statue 63.4.8.1.3 was known not to be from T63.4, but as the Naga statue (C6.2.14 and associated elements) excavated during clearance was found to be from 63.4, it was decided to install this at T63.4. Accordingly, Naga 63.4.8.1.3.2, which had been installed at T63.4, was to be moved to T64.2.
- The handrail 65.4.8.1\* from T65.4 was joined with C6.2.13 excavated from near T64 and its original location was found to be the Naga head C6.2.14 matching element mentioned above, so this element was also moved from 65.4.
- It was observed that 6.2.8.1.4, installed at T64.2, joined 63.4.8.1.4 and 63.2.8.1.10 to form a single handrail element.
- It was confirmed that girders 62.8.1.9 and 62.8.1.11, also located at T64.2, were joined to elements at 63.4 to form a single handrail element.
