# ***APPENDIX I***

## ***Restoration activities for each area***

*Report on the Conservation and Restoration work of  
LION and NAGA Balustrades at the Causeway and Outer  
Gallery of BAYON  
Angkor, UNESCO World Heritage Site.*

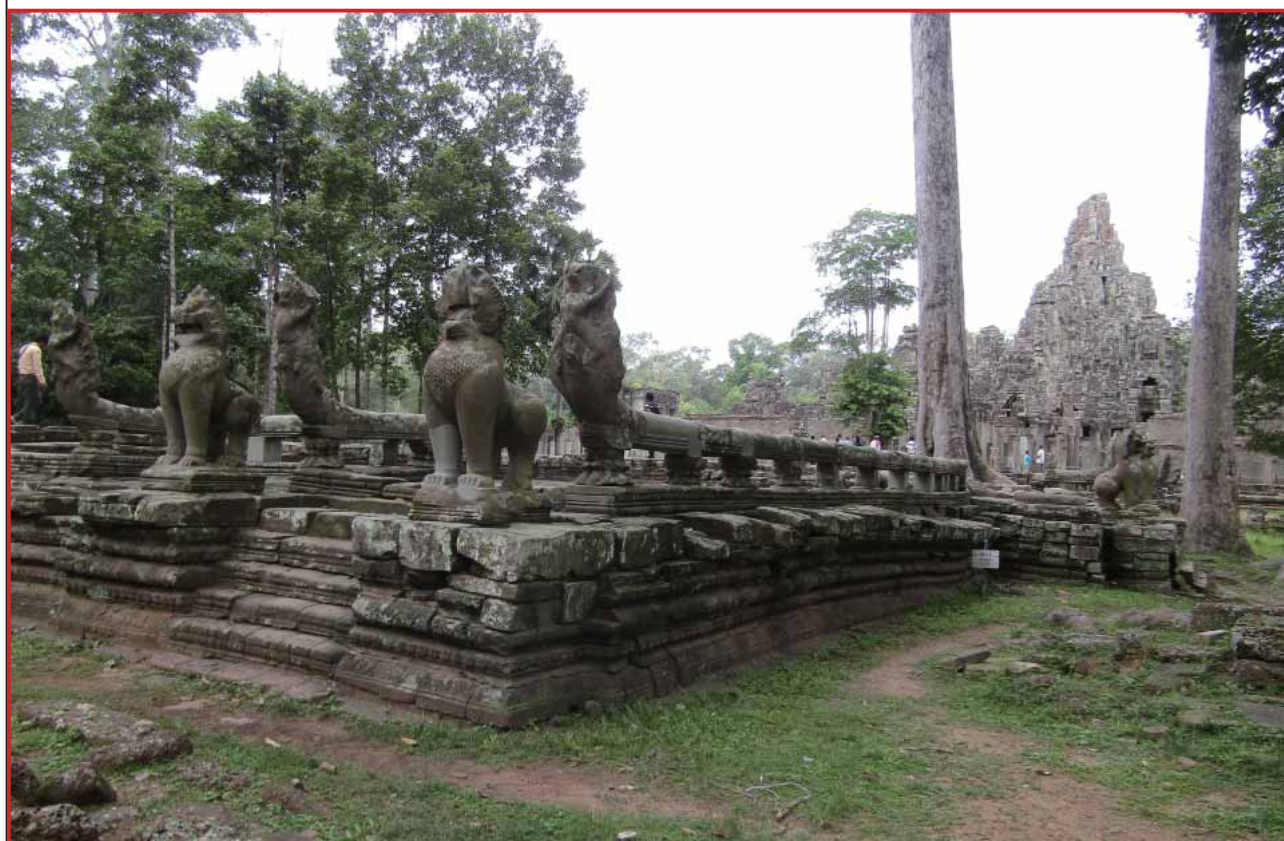
After Restoration

In this area, platform was heavily distorted and some elements were fell down under the platform. After surveying and recording, we confirmed that some scattered elements of the balustrade around the platform could use and back as a handrail.

After dismantle the balustrade and started repairing of each elements, in parallel, maintenance platforms was started. It was obvious that one of the causes of inclination of balustrade was uneven subsidence of platform structure. The problems of such subsidence mainly be ascribed to the loss of the soil compacted inside the platform. However, in our project, we only reconstruct surface layer of the platform. Thus, it was difficult to make align the horizontal level and make stable condition to install balustrade. For such gap between platform and basement that could not keep stable condition, we insert new sandstone plate for support, and also filling gap with soil 4.

After finished maintenance of platforms, trail assembling work had started. We try to find the original location of each elements. If it was impossible to find the original location, we have to search the most appropriate order of the elements. After decide all the position of the elements and decide place to supply new sandstone, finally we move to reconstructing work.

For this Naga Head71.1.1.8.1.23, two different parts are connected as one Naga statue in the previous restoration. We decided not to connect this two part again, and made new Naga body part for Naga head so that Naga statue can install in stable condition. The length of the Naga body were referred to the trace of post on the basement.

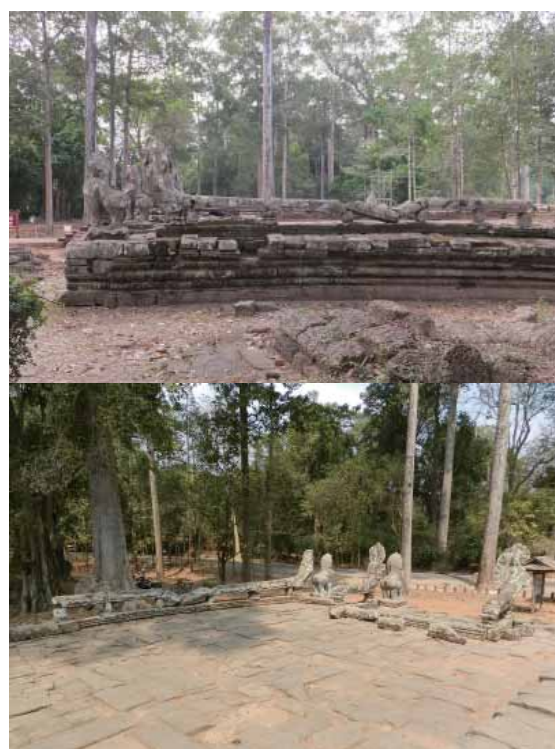
In this area, 1 Lion statue was restored (L-2: 71.1.1.9.1.2, 71.1.1.9.1.3, L-3:71.1.1.9.1.4).For 71.1.1.9.1.4, the ankle portion was lost due to breakage, and although it had been mortared and joined in the previous restoration, there was a risk that it would break again due to deterioration of this material. Therefore, new sandstone material was processed according to the required size, filled in, and joined.

**Before Restoration**

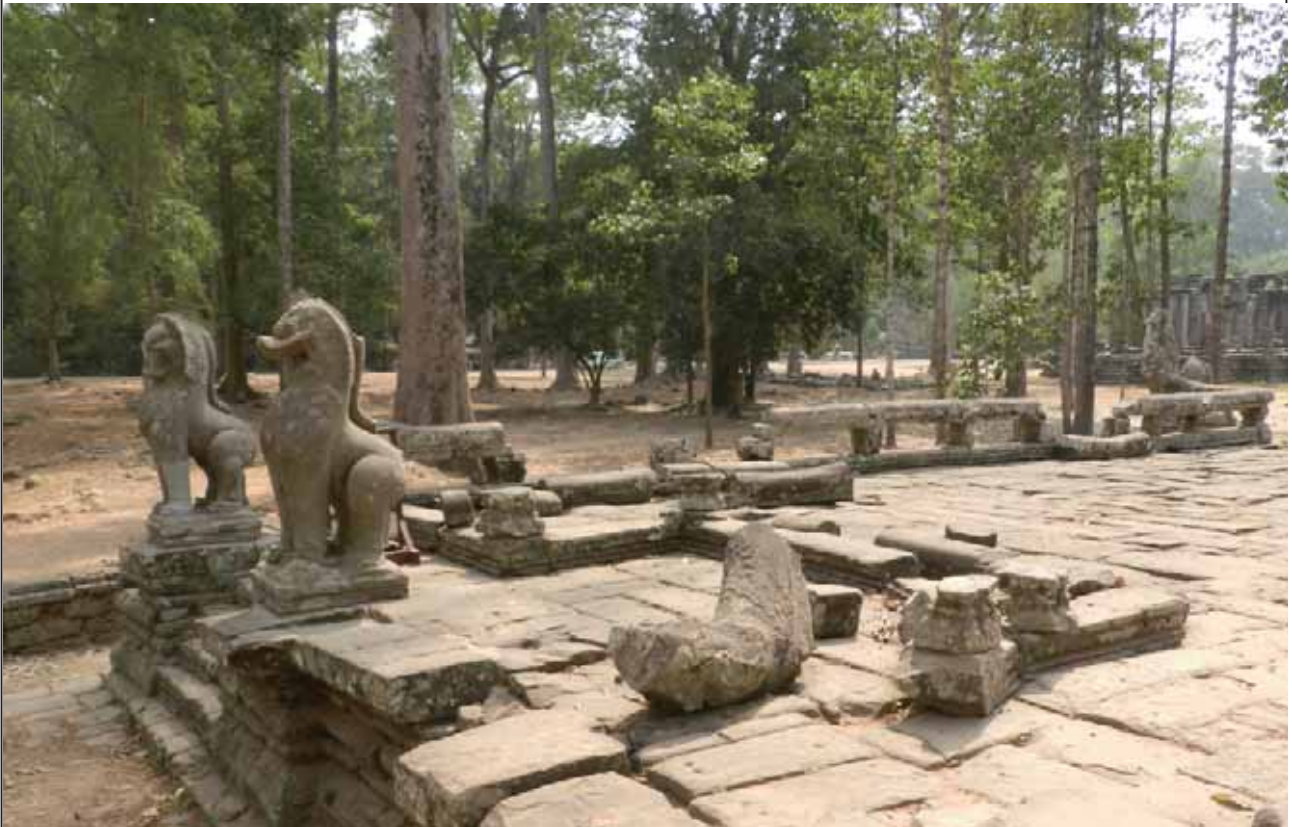
**Before Restoration**

From previous survey at the southern balustrade, we found that most basements are original and situated in original position. Although, some of the posts and handrails were fell down on the platform caused from distortion of platform. Also, most posts were substitute elements replaced in previous restoration, we decided to reuse these elements by result of trial assembling.

Uneven subsidence of platform structure was most remarkable at west edge of the balustrade, southeast stair of causeway, as we could see more than 60cm subsidence around here. This cause very unstable situation of balustrade including Naga statue and needed large scale adjustment in order to keep every balustrade at same level. In the maintaining work of the platform, we filled vertical and horizontal gap of platform with laterite blocks or soil 4 as necessary. Although, it was not enough to make Naga statue at same level as other handrails, we insert 4 sandstone blocks under basement.

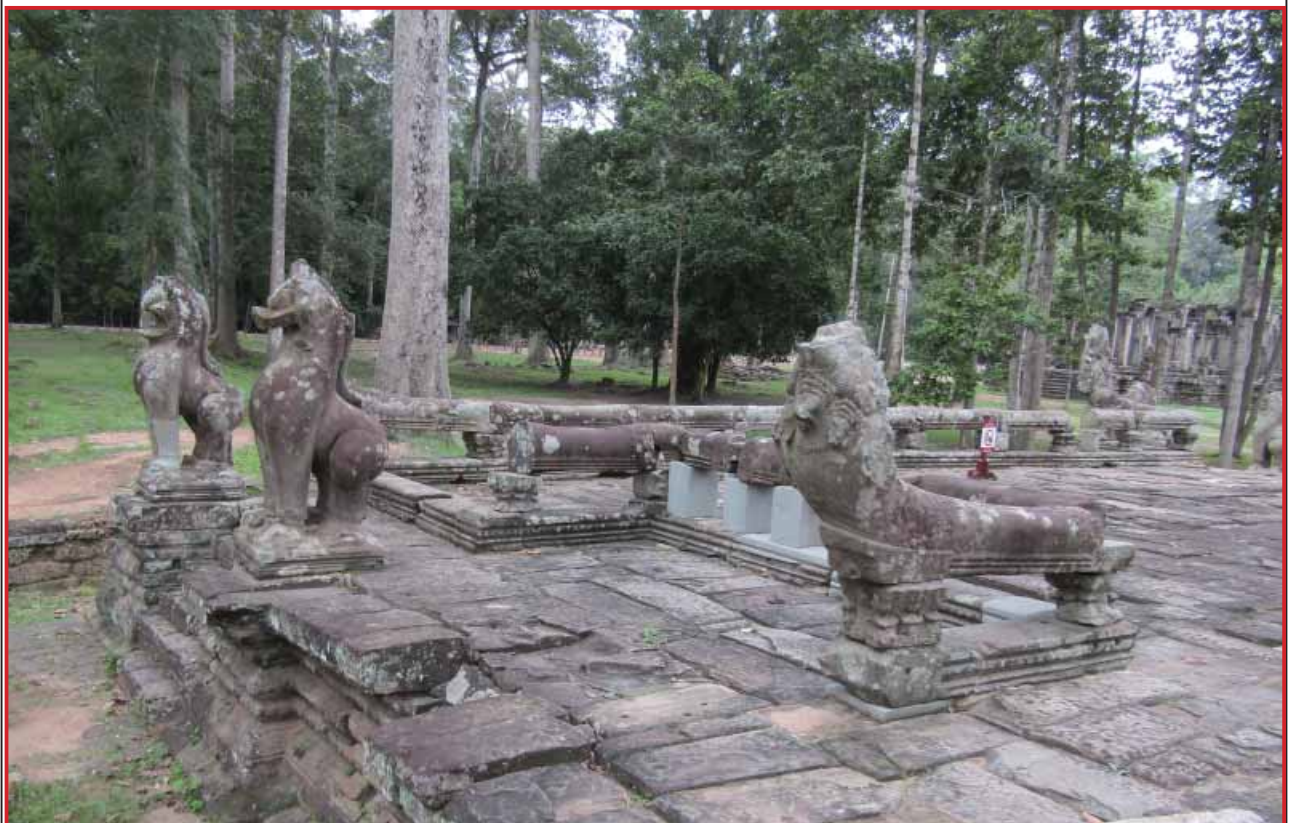
**After Restoration**

In our work, we installed these fallen handrails and posts. Also, mortar which inserted in the previous restoration between posts and handrails were replaced by new sandstone. For this area, the range of uneven subsidence of platform structure was more wide than other area to inner of causeway, and difficult to implement maintenance of platform only directly under the balustrade. Thus maintenance were performed 2m inside the balustrade.

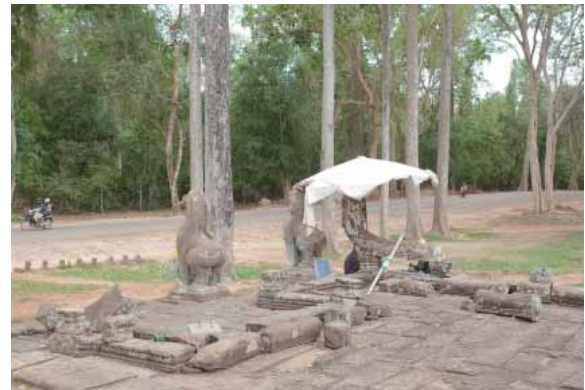
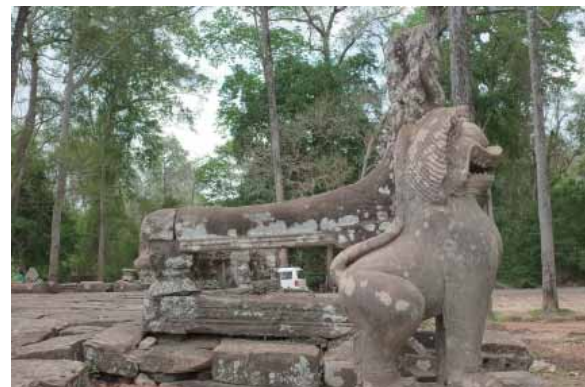
<Before restoration>

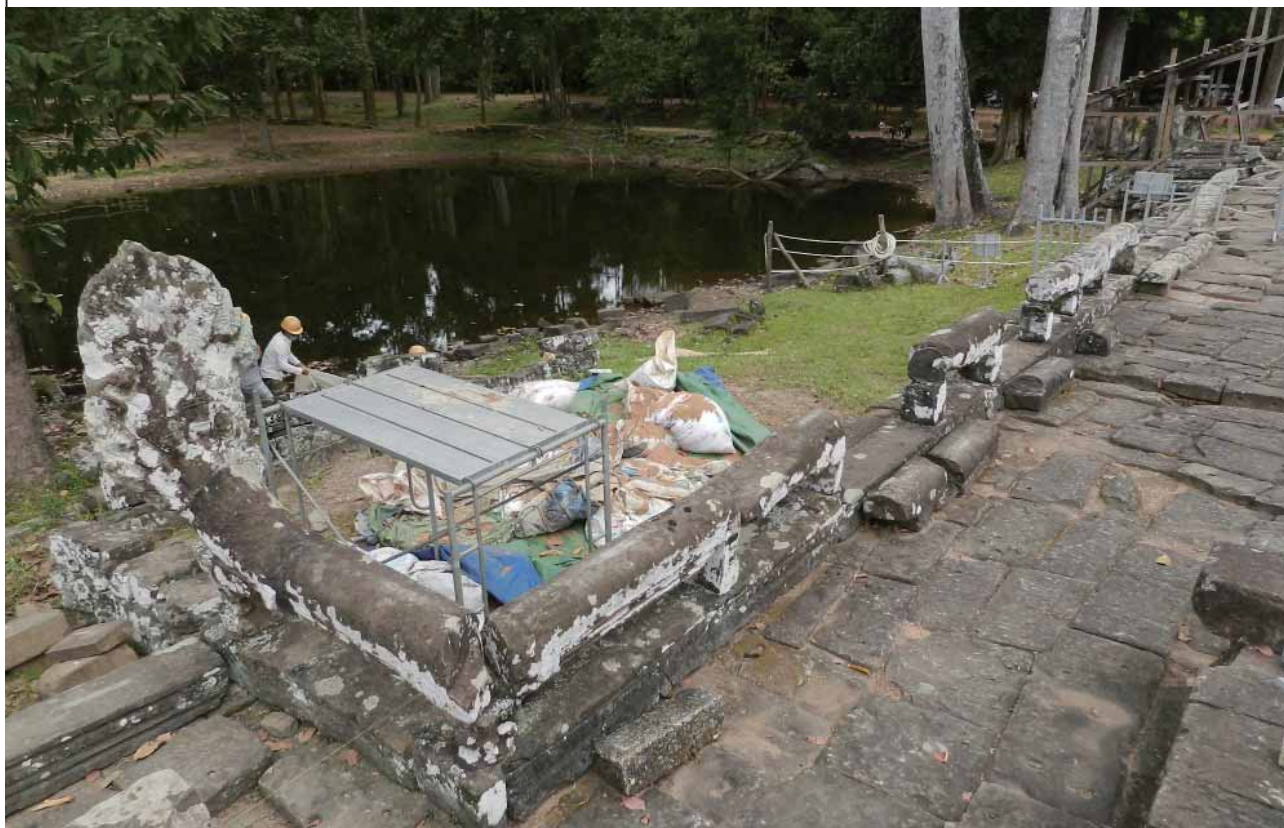
Before Restoration

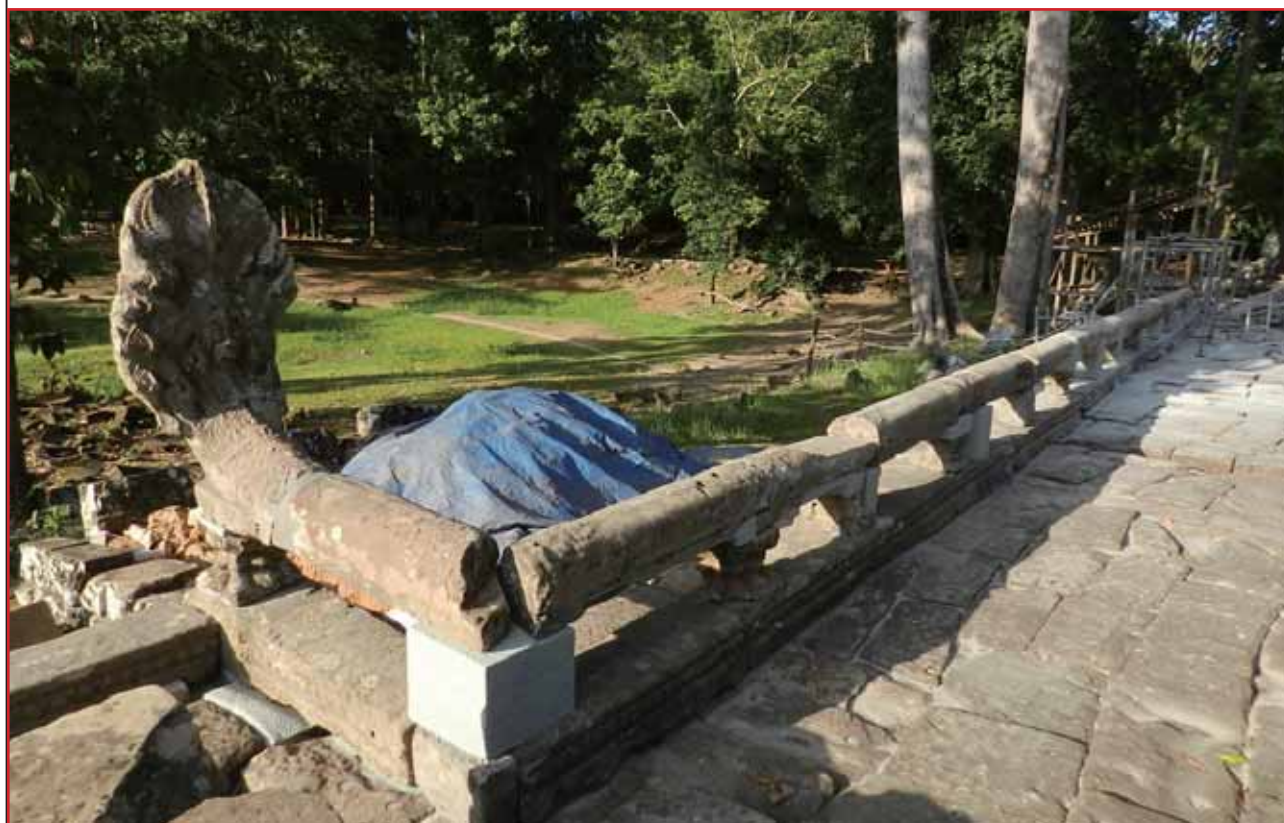
After Restoration

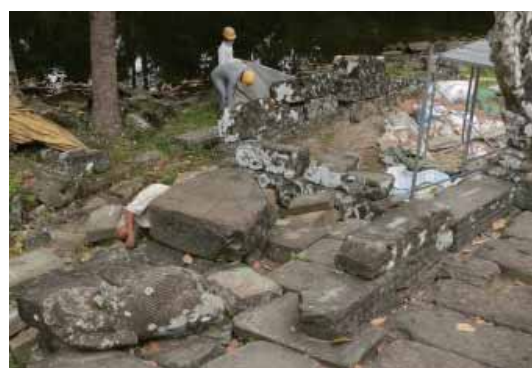
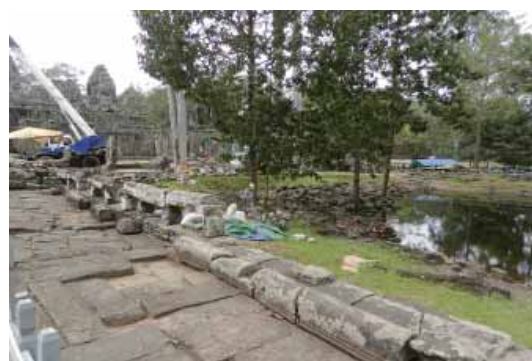
<Before restoration>

In Area 71.1-1, many balustrade elements had collapsed onto the platform, and investigation confirmed that many balustrade elements installed in this area during restoration in the 1930s were not in situ, but had been replaced during previous restorations and moved from other locations. Close examination of these members revealed considerable deterioration, including cracks, peeling, damage, and breaks in many of them. In addition, there were many scattered stones piled up around this area and at the edge of the reservoir on the north side of the approach, and it was confirmed that some of these elements were related to the balustrade.

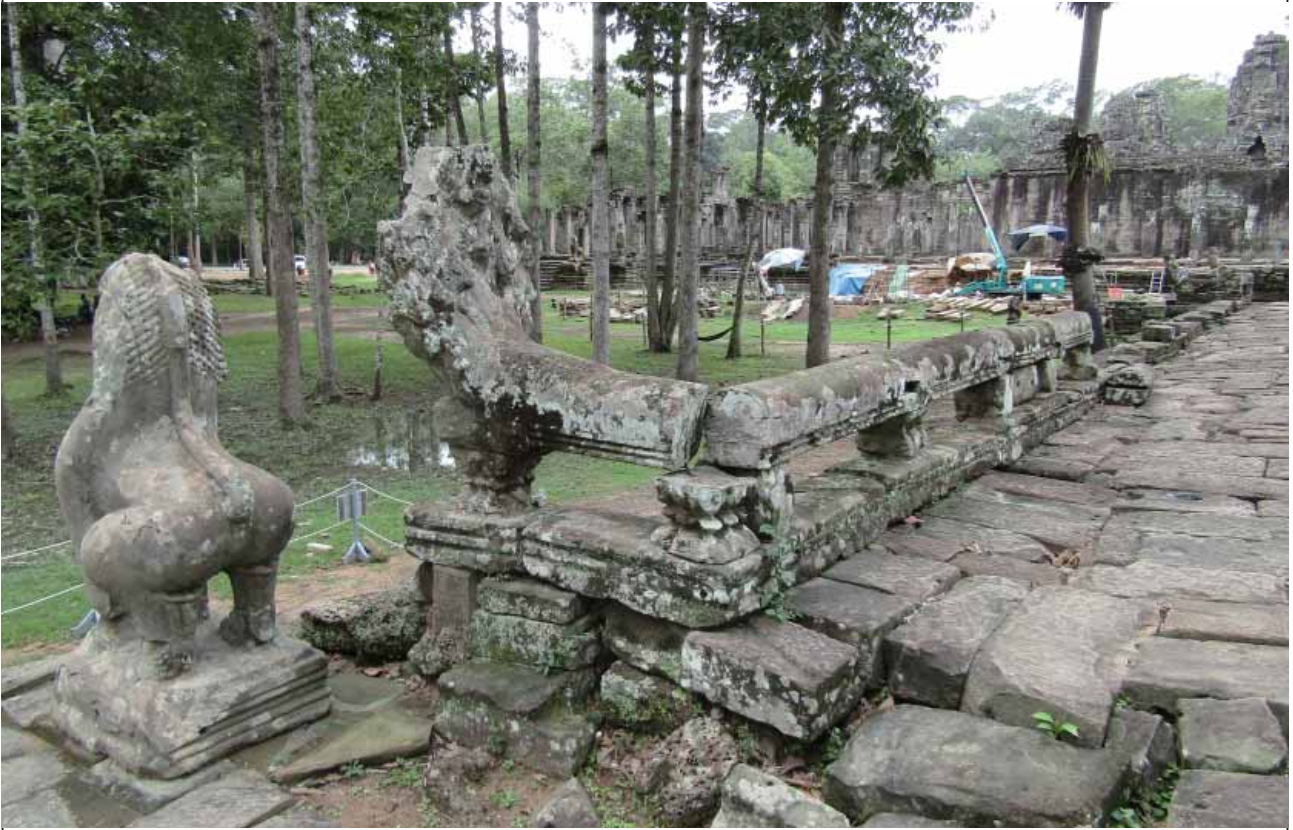
Area : C71.2-1 / West part Operated Term : 3 month

Before Restoration

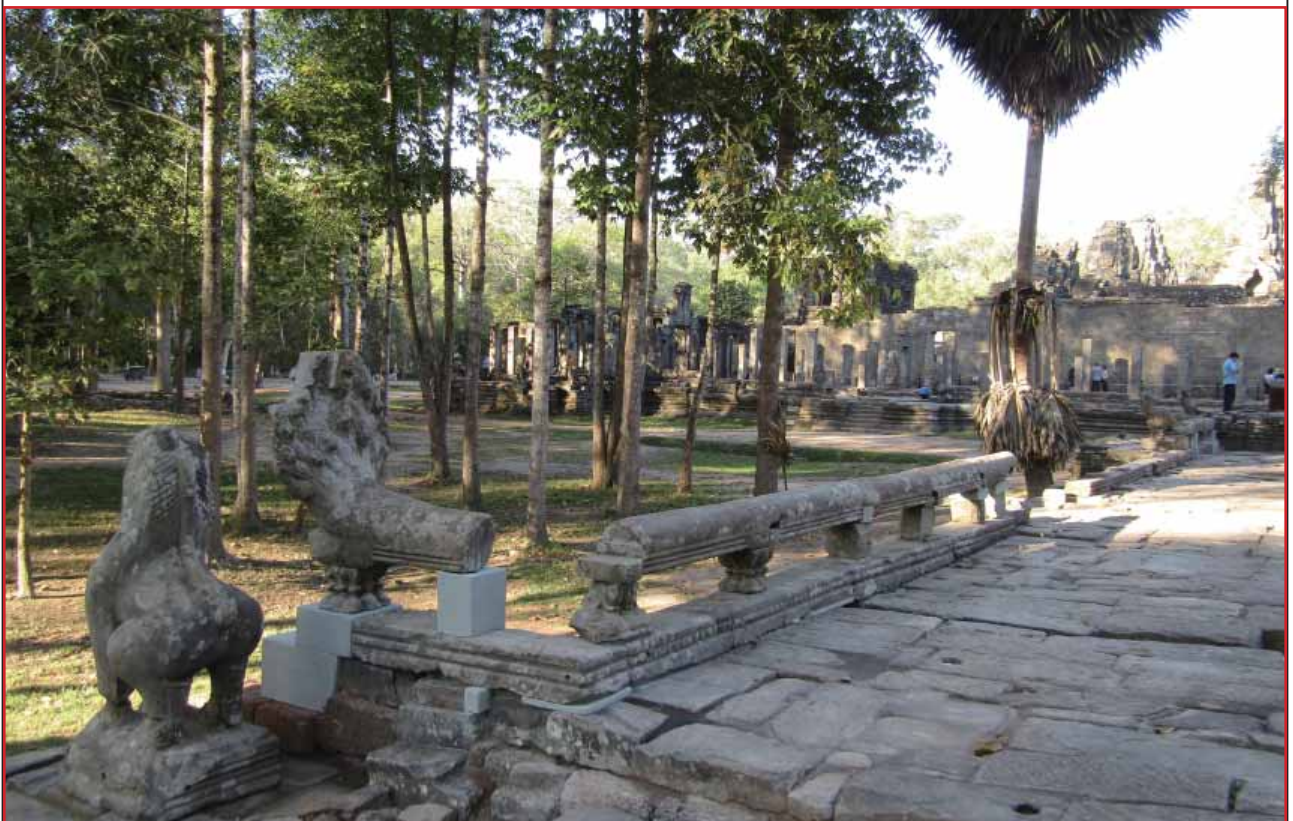
After Restoration

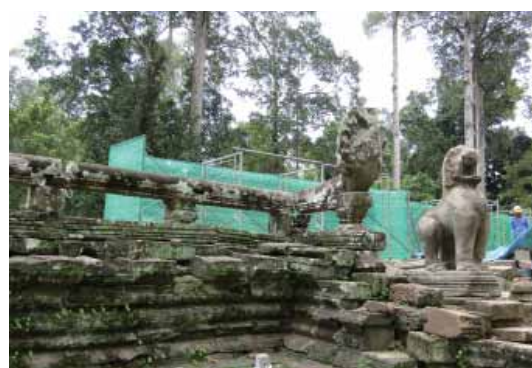
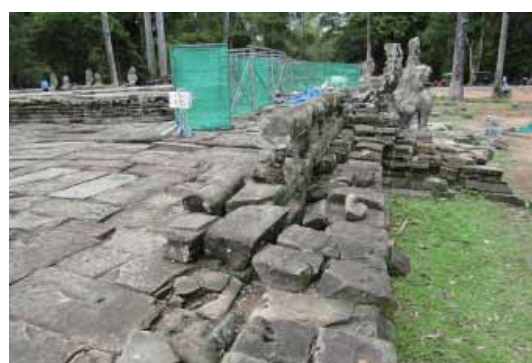
<Before restoration>

As for the state of Naga balustrade before restoration, many handrail and post elements were already missing at middle part, and also remaining basement elements were also scattering on the platform. For the western corner, some handrails were remaining and substitute elements of the post were inserted by past treatment but it could never be said that it was stable situation. Opposite eastern side, uneven subsidence of platform structure causing distortion of platform especially under the most eastern Naga head was inclined and in danger of falling.

After finished repairing all the elements, direction of the reconstructing was decided through trial assembling work. At west corner, we confirmed that to some of the substitute post would be difficult to reuse, we decided to make new substitute posts by new sandstone for supporting handrails. Also, new sandstone was supplied to some basements which were partially missing. At east corner, in order to stably install heavy Naga head, we judged the minimum platform improvement would be necessary to correct the distortion of the floor. Thus, in the range of 1.5 meter across the balustrade were dismantled. Also, some new sandstone support inserted under this Naga head for support.

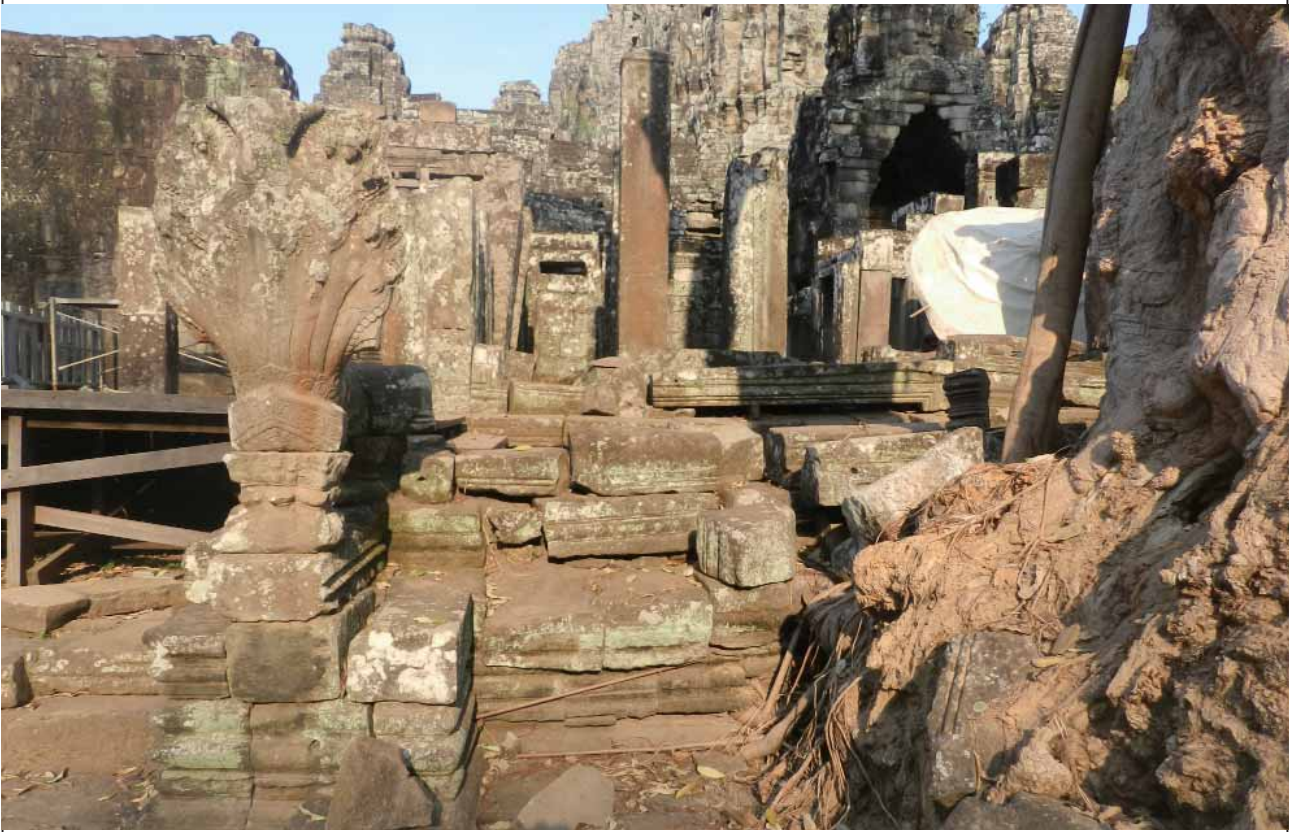
Area : C71.3 / Working Term : 5 month

**Before Restoration**

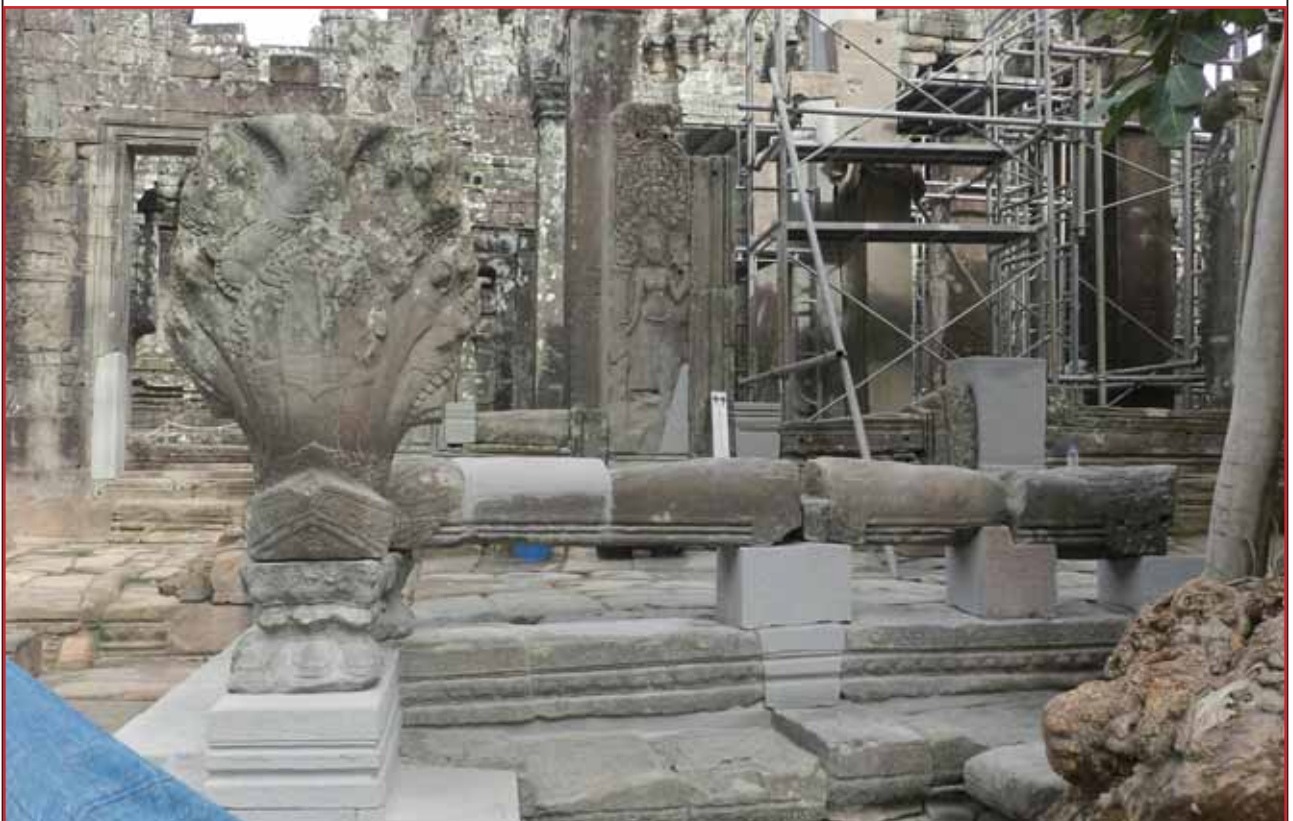
**After Restoration**

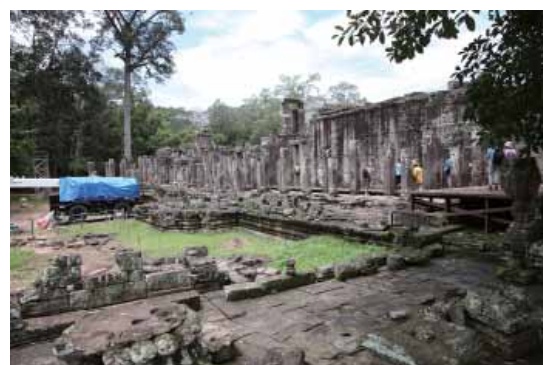
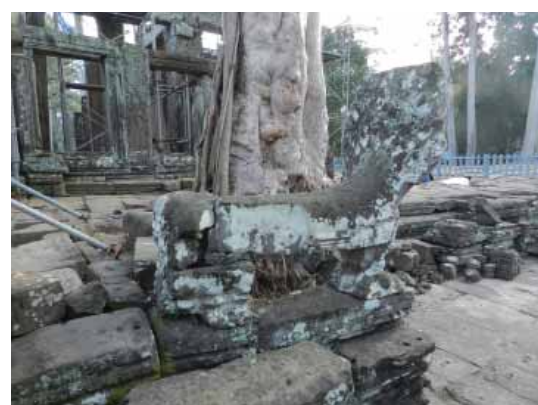
## Area : C71.3 / Working Term : 5 month

&lt;Before restoration&gt;

Area 71.4.1 is the place where we could see vivid influence of damage by fallen tree in some decades ago. Many elements of balustrade and Naga statues were broken and fell down on the platform. Platform was distorted by the changes over years, in particular, the most outer line of the surface layer were moved to the outside and causing the big gap with inner line that balustrade should be set on. Also, certain inclination could be seen that was too unstable to reconstruct without any treatment.

After basements finished put back, we start to back handrails. 3 of the posts need replacement by new sandstones because it was too unstable to use former substitute elements. Also one post out of 7 original posts need to fill with new sandstone to the missing part. Some of Naga body we put back as same place before dismantling, but some we changed the place according to the situation of the area. Such as; stone from scatter stones that we just found and connect, need to find the places to back it all.

In another part, the new sandstone processing work for supplement missing part by the new sandstone where went on to 3 elements (1 post and 2 handrails). These were found from scattered stone around this area.

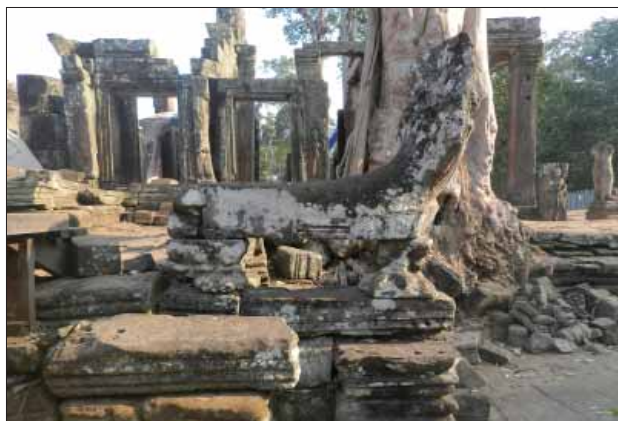
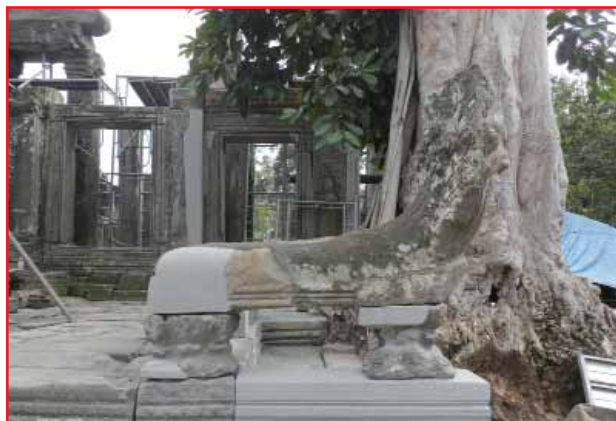
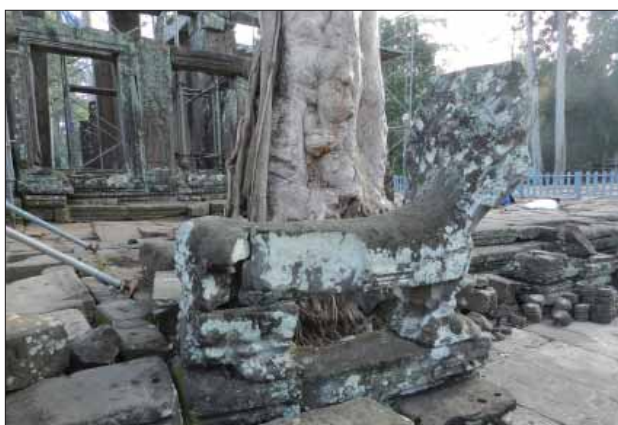
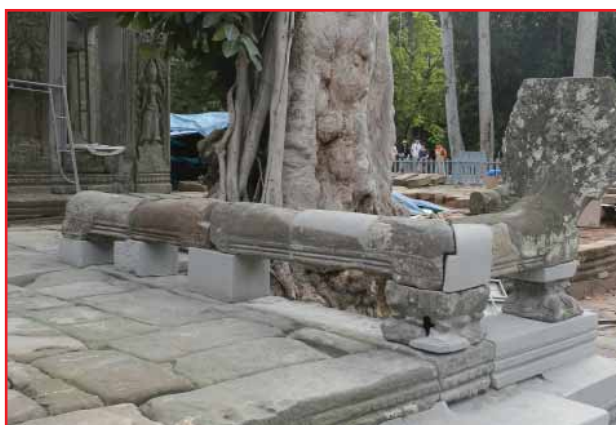
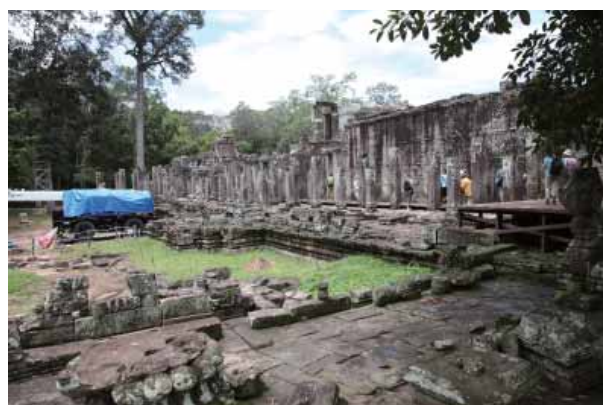
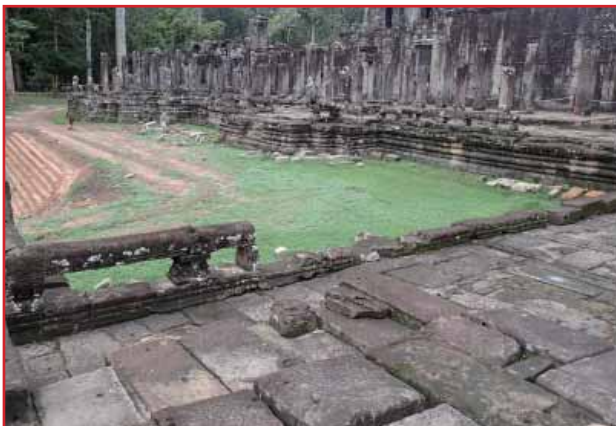
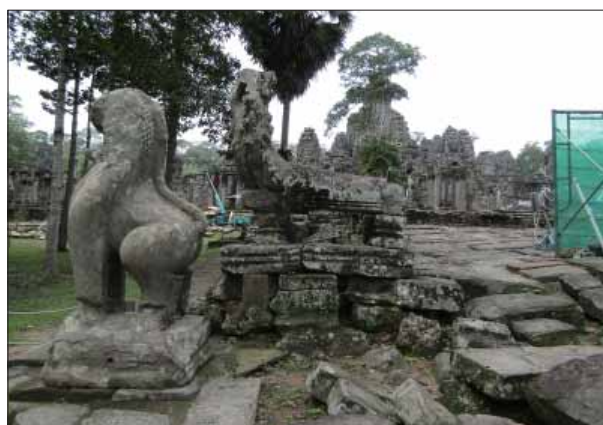
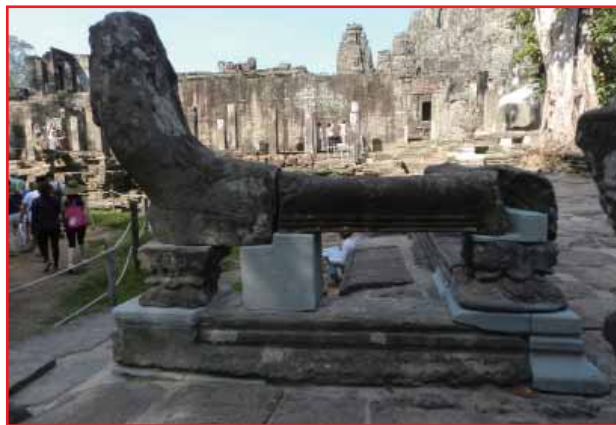
Area : C71.3 / Working Term : 5 month

<Before and after restoration>

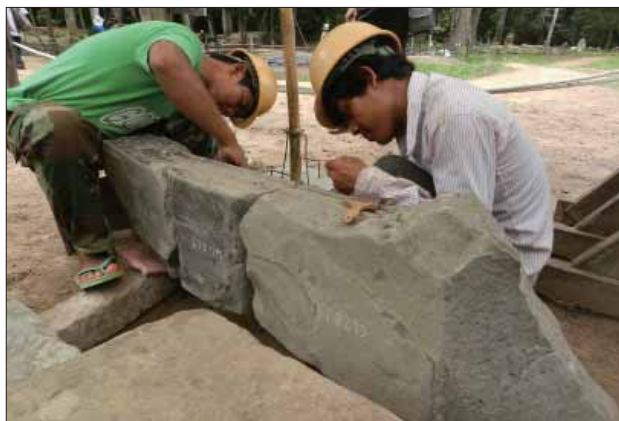
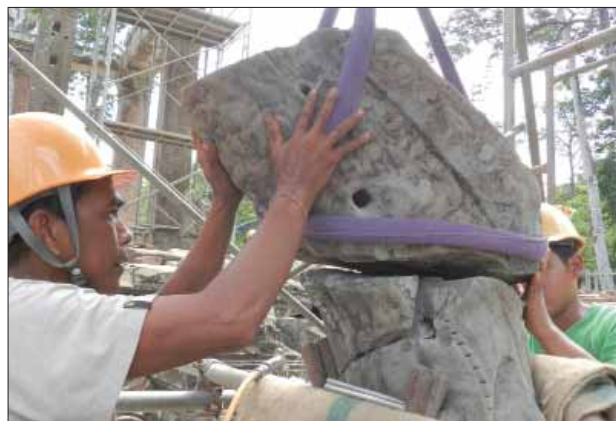
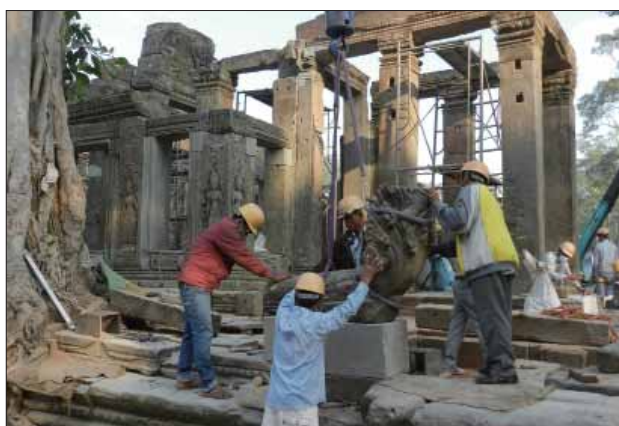
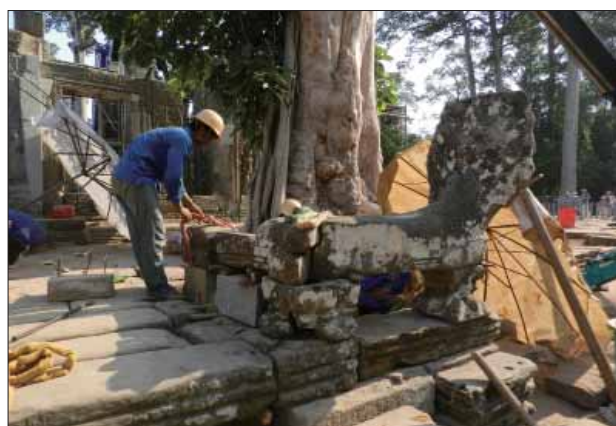
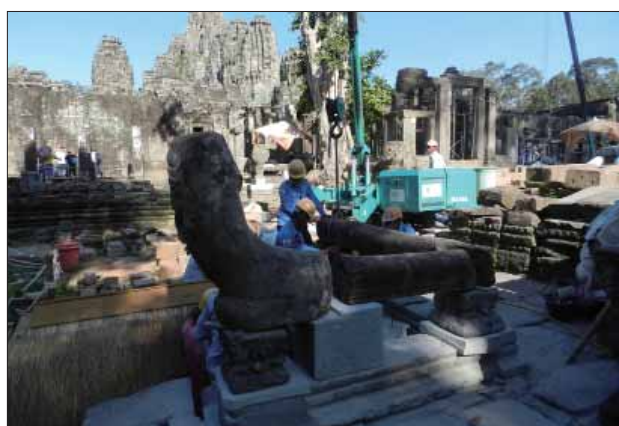
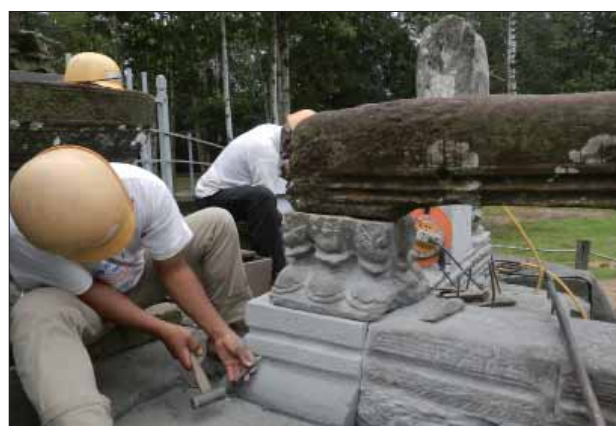
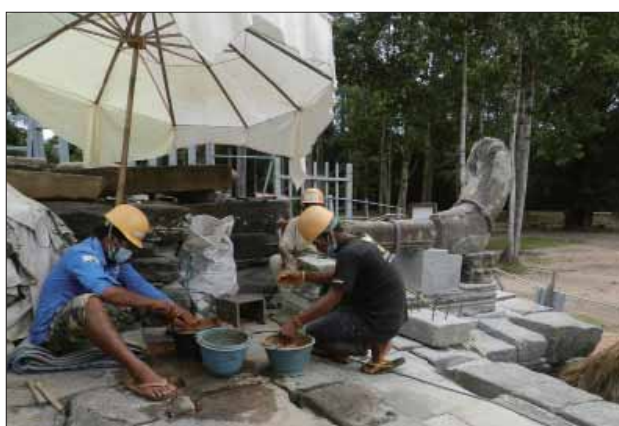
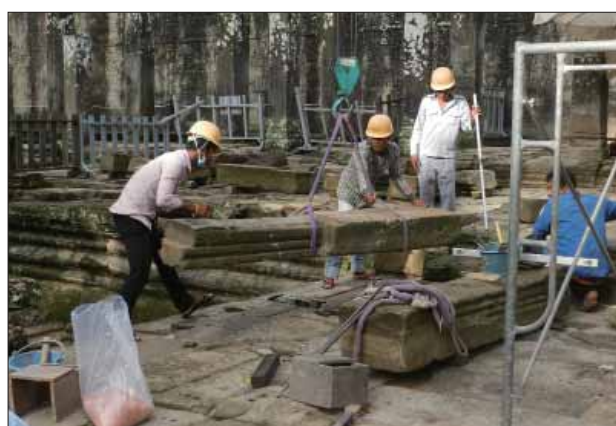
Area : C71.3 / Working Term : 5 month

<Photos during restoration>

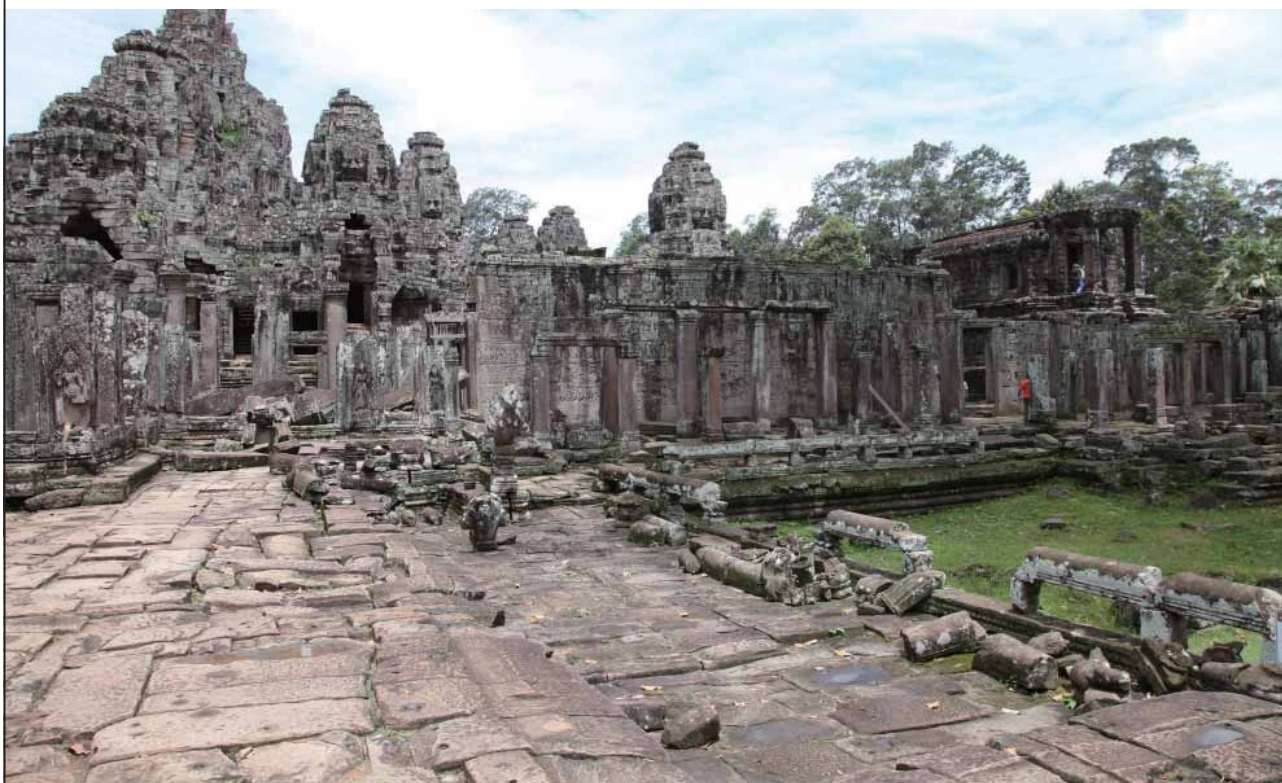
Area : C71.4 / Operated Term : 6 month

**Before Restoration**

Area 71.4.1 is the place where we could see vivid influence of damage by fallen tree in some decades ago. Many elements of balustrade and Naga statues were broken and fell down on the platform. Platform was distorted by the changes over years, in particular, the most outer line of the surface layer were moved to the outside and causing the big gap with inner line that balustrade should be set on. Also, certain inclination could be seen that was too unstable to reconstruct without any treatment.

After basements finished put back, we start to back handrails. 3 of the posts need replacement by new sandstones because it was too unstable to use former substitute elements. Also one post out of 7 original posts need to fill with new sandstone to the missing part. Some of Naga body we put back as same place before dismantling, but some we changed the place according to the situation of the area. Such as; stone from scatter stones that we just found and connect, need to find the places to back it all.

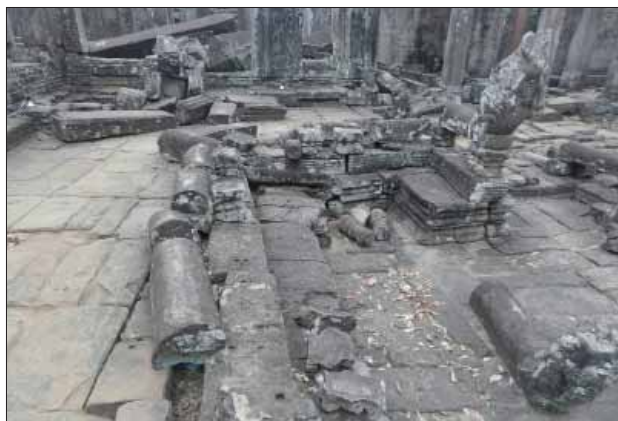
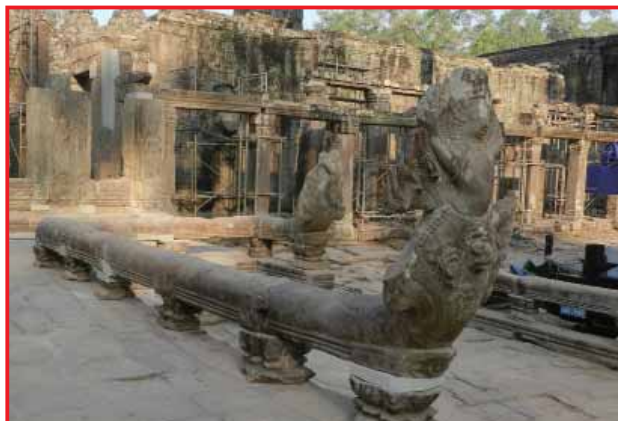
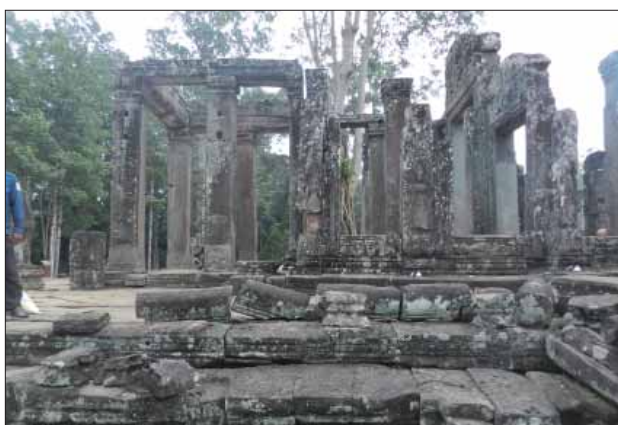
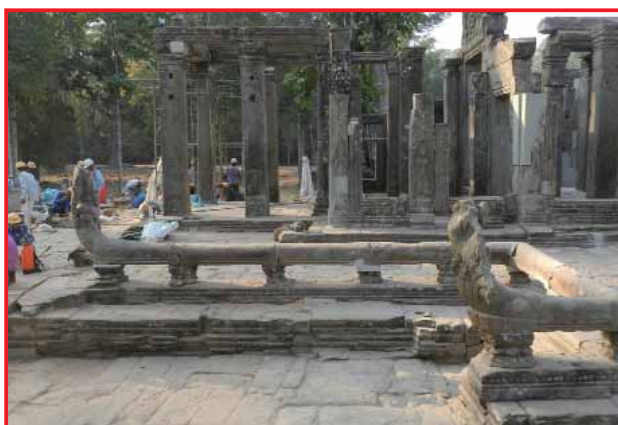
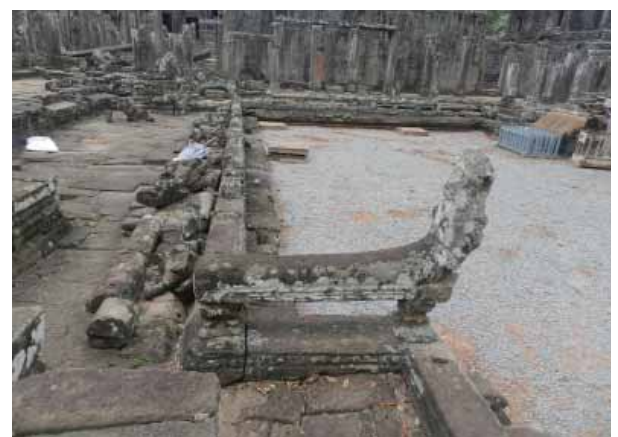
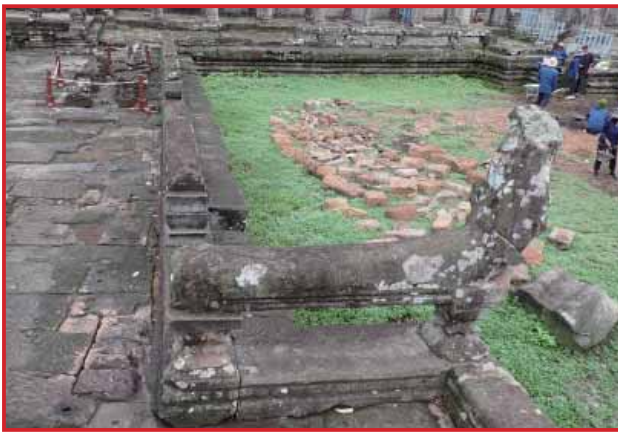
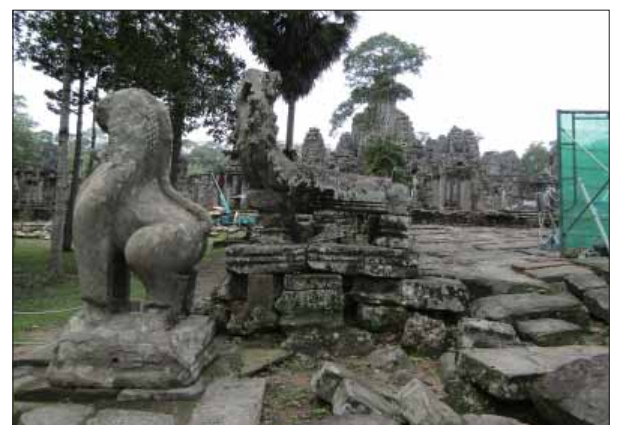
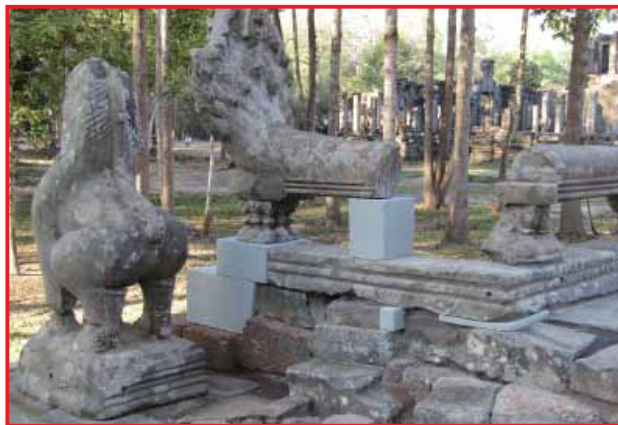
Area : C71.4 / Operated Term : 6 month

<Before and after restoration>
