# ***APPENDIX I***

## ***Restoration activities for each area***

*Report on the Conservation and Restoration work of  
LION and NAGA Balustrades at the Causeway and Outer  
Gallery of BAYON  
Angkor, UNESCO World Heritage Site.*

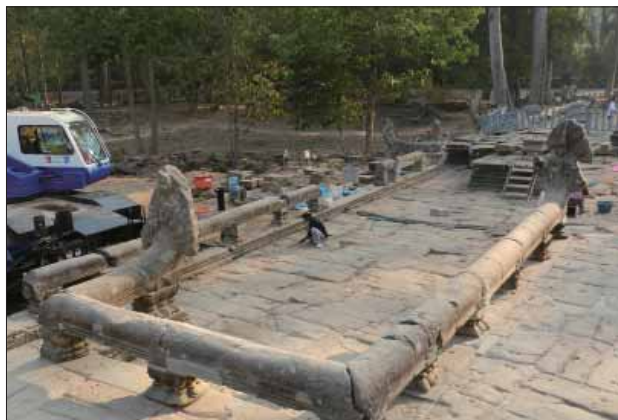
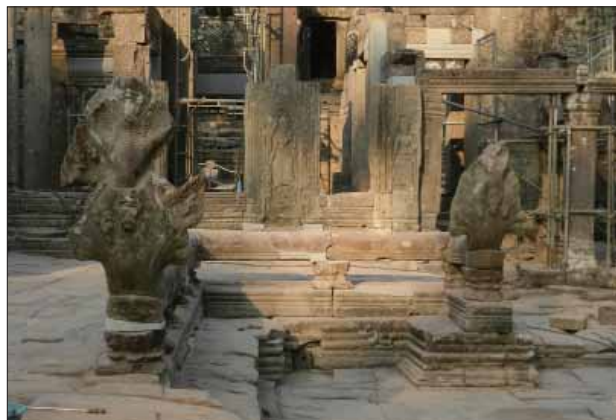
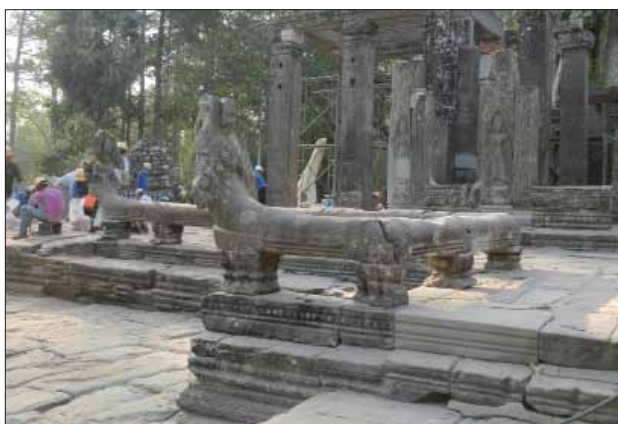
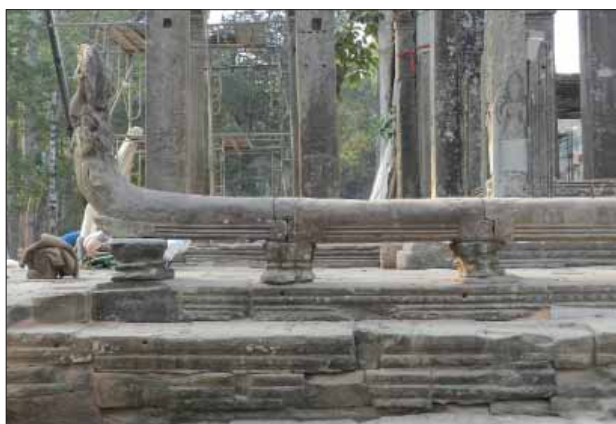
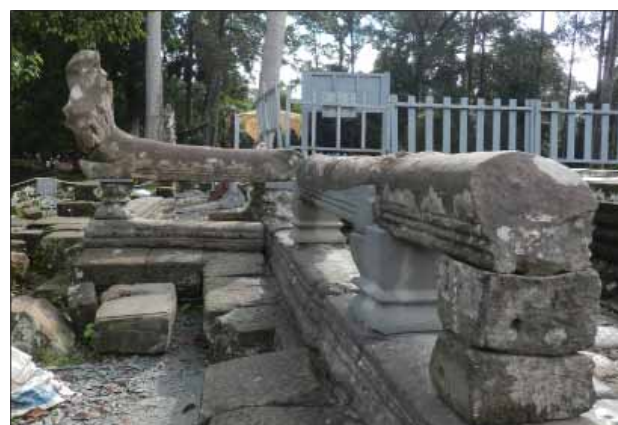
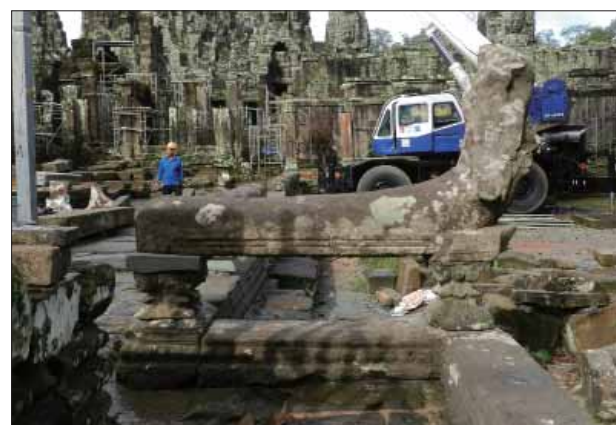
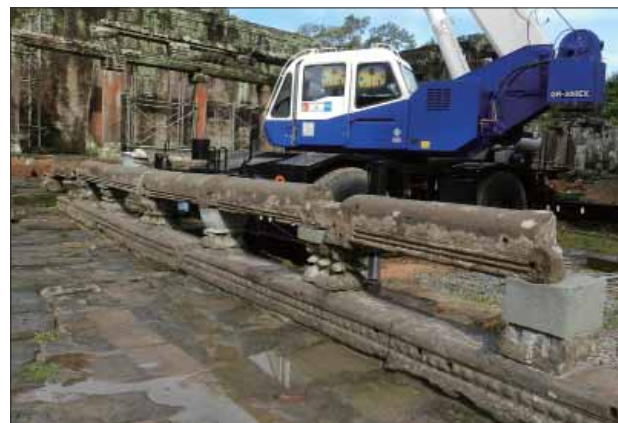
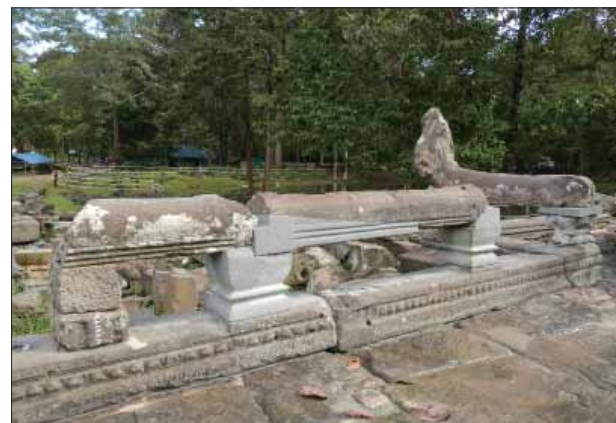
Area : C71.4 / Operated Term : 6 month

<After restoration>

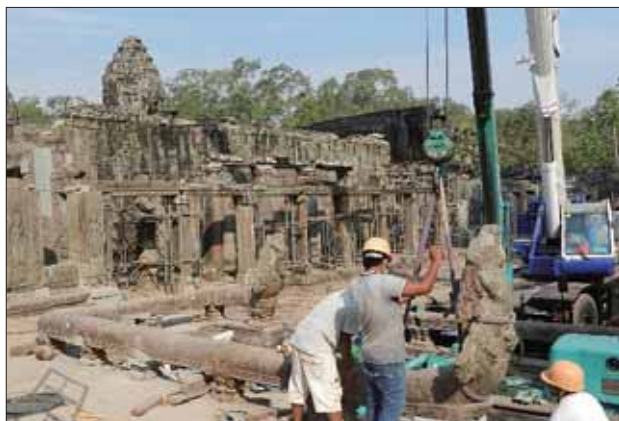
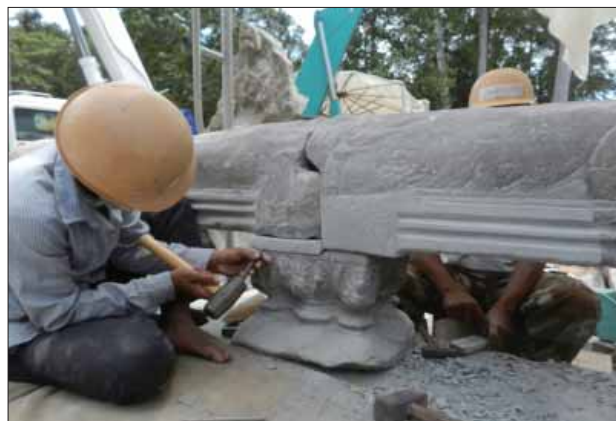
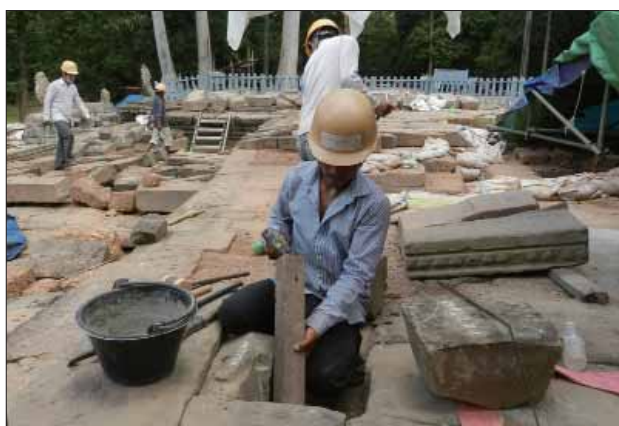
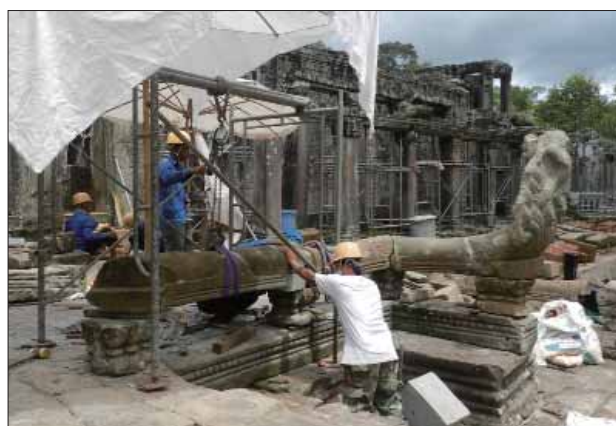
Area : C71.4 / Operated Term : 6 month

<Photos during restoration>

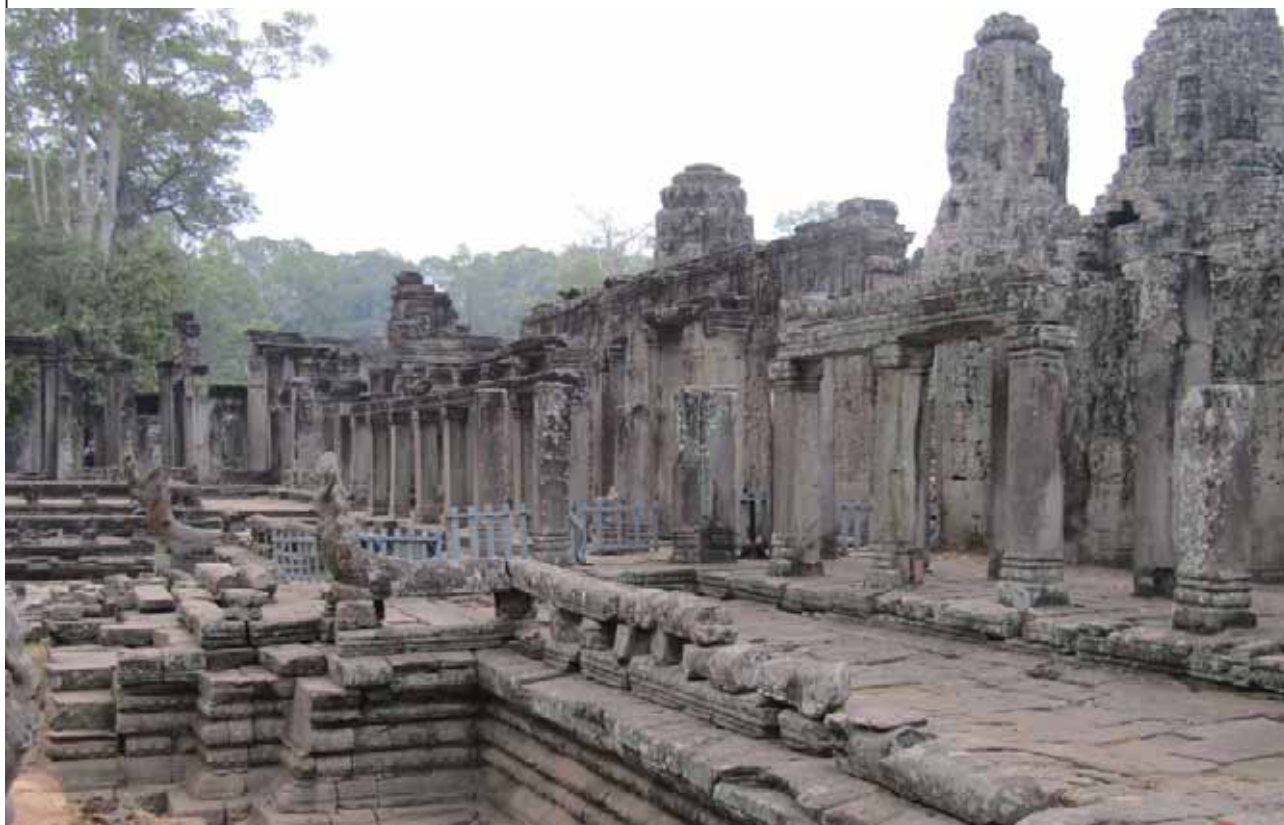
**Before Restoration at T70.1**

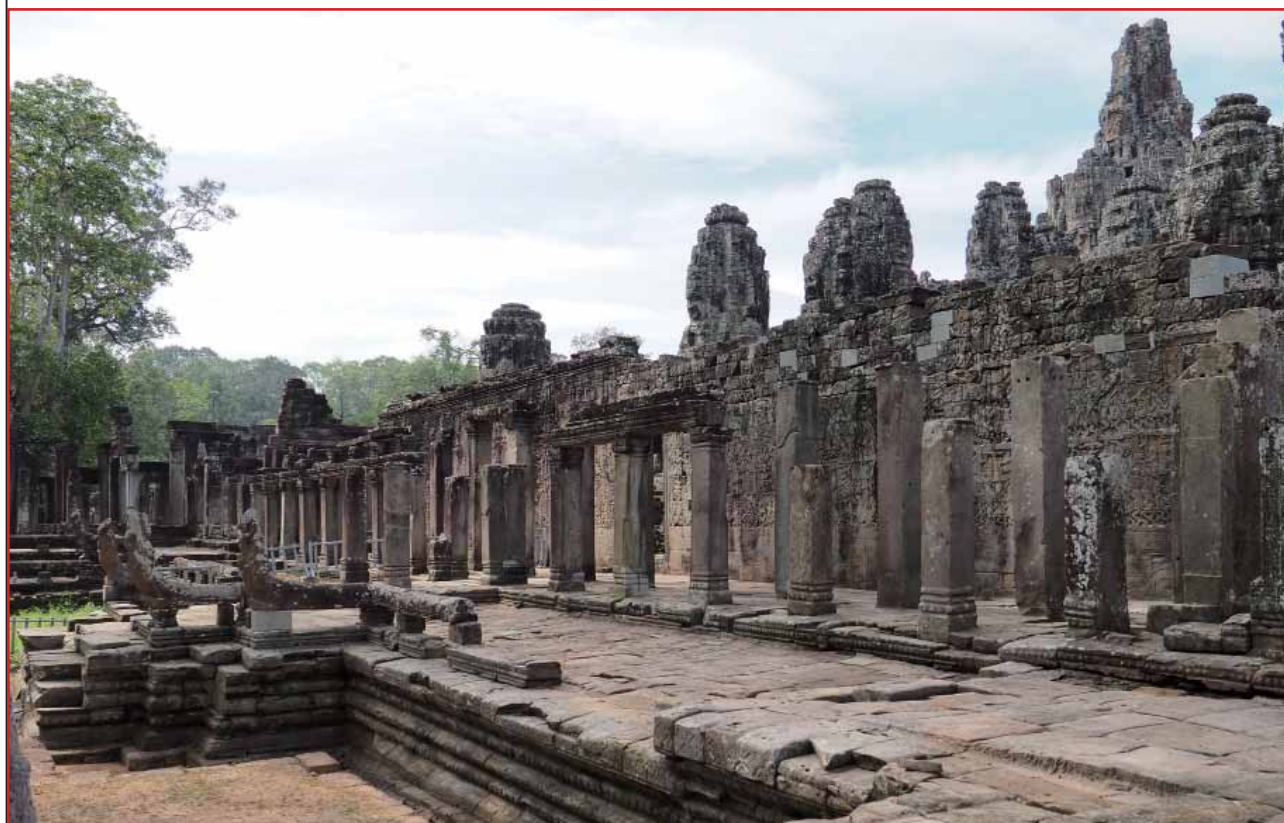
**After Restoration at T70.1**

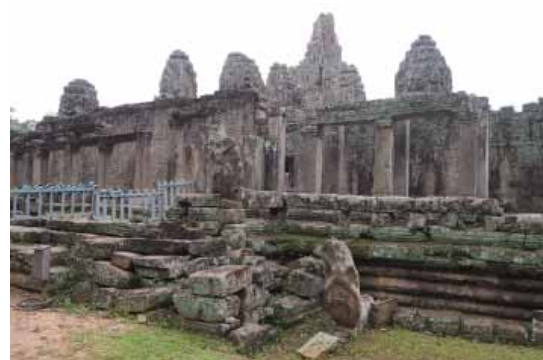
<Before restoration at T70.1>

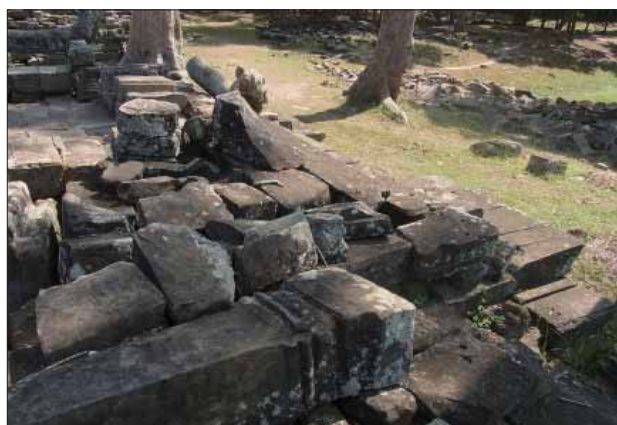
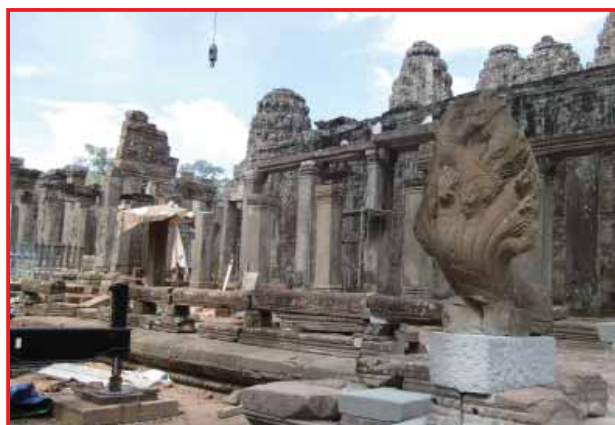
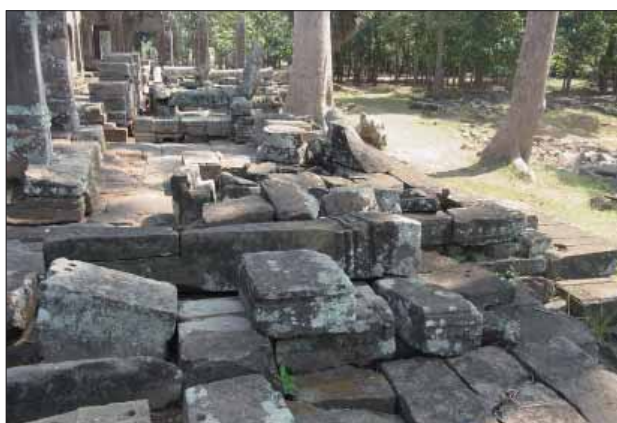
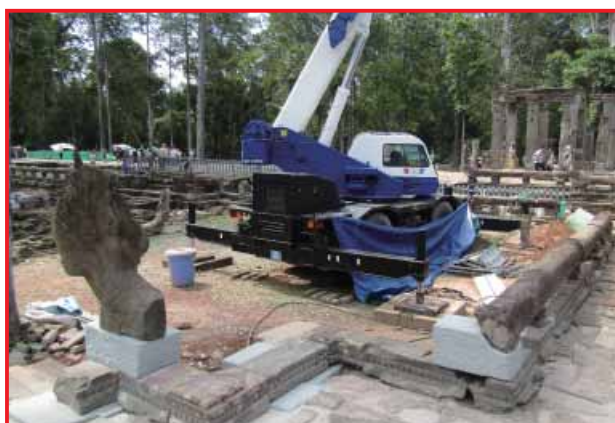
<Before and after restoration at T70.2>

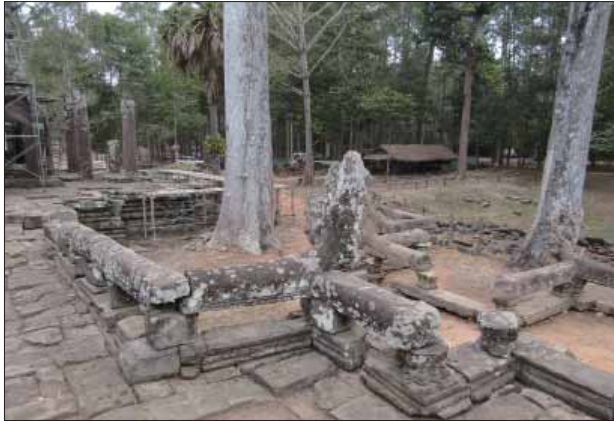
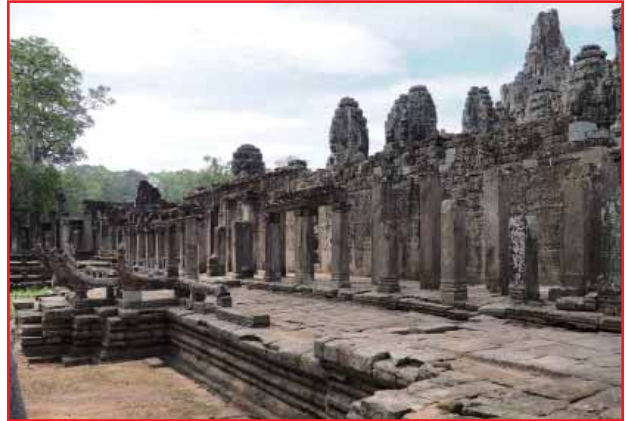
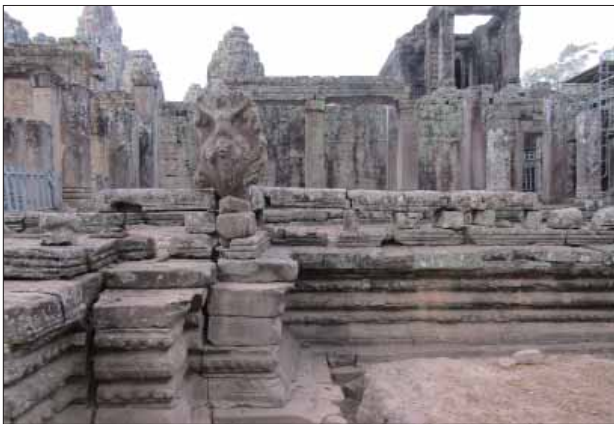
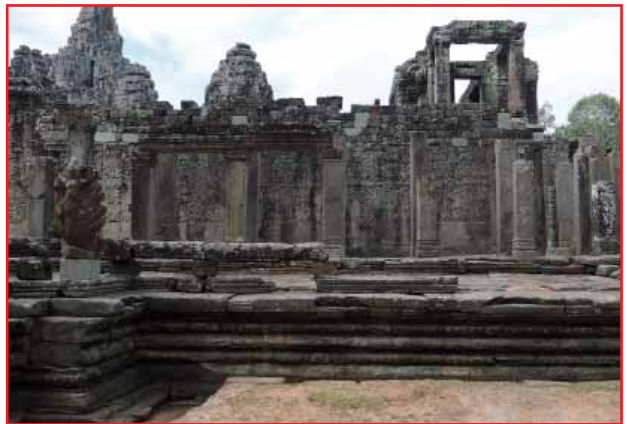
<Before and after restoration at T70.1>

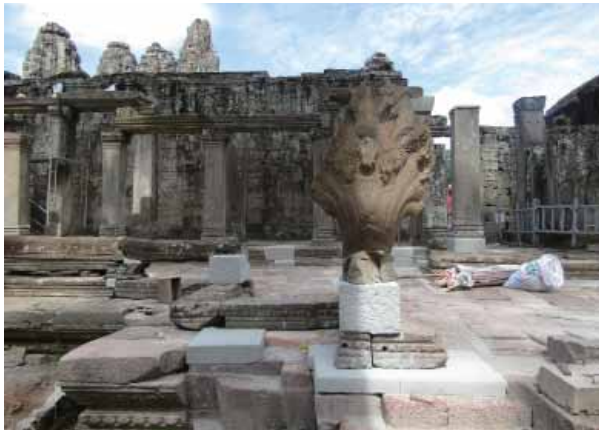
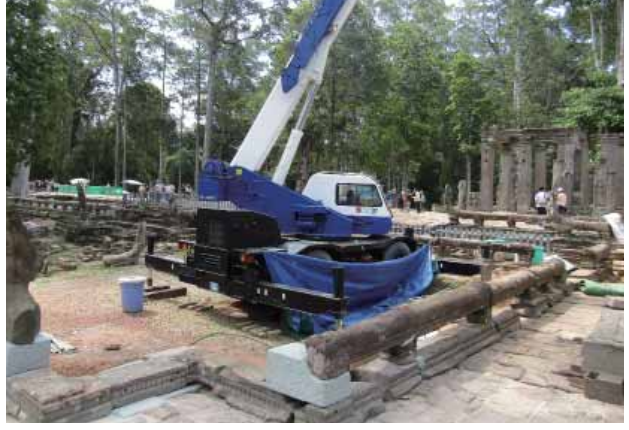
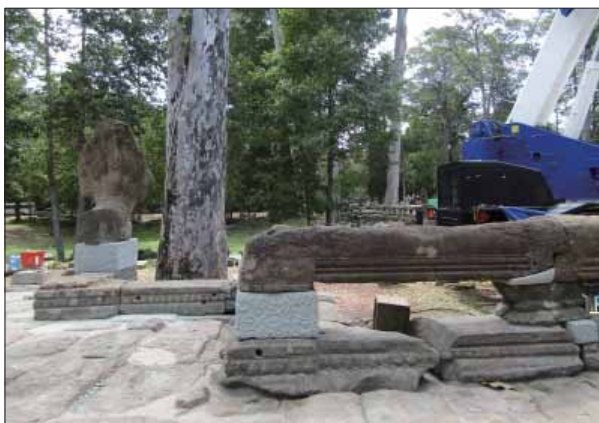
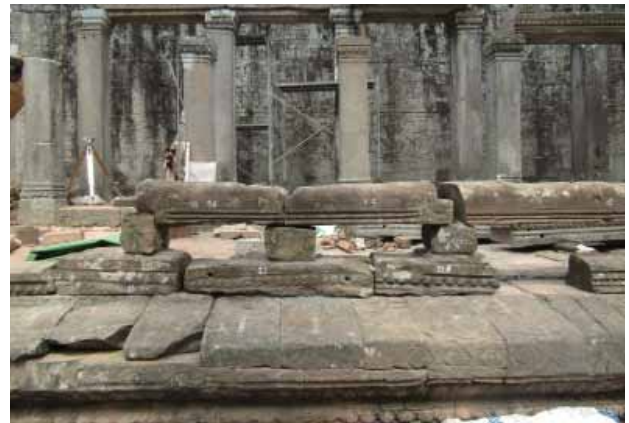
<After Restoration at T70.2>

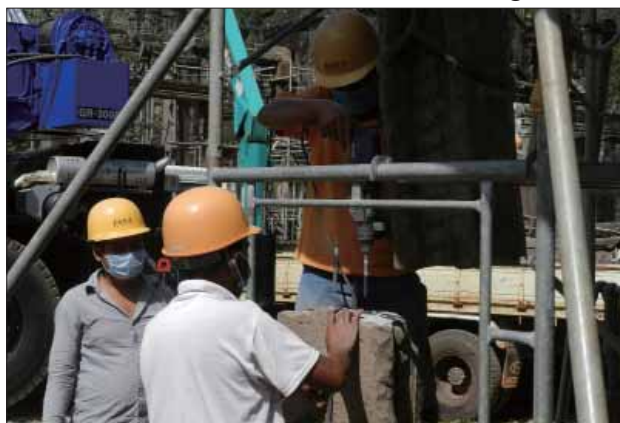
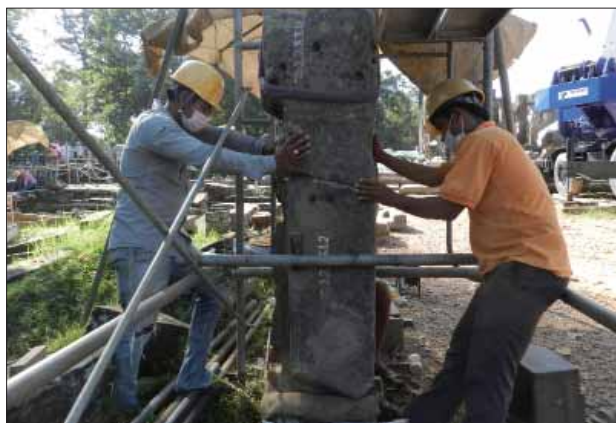
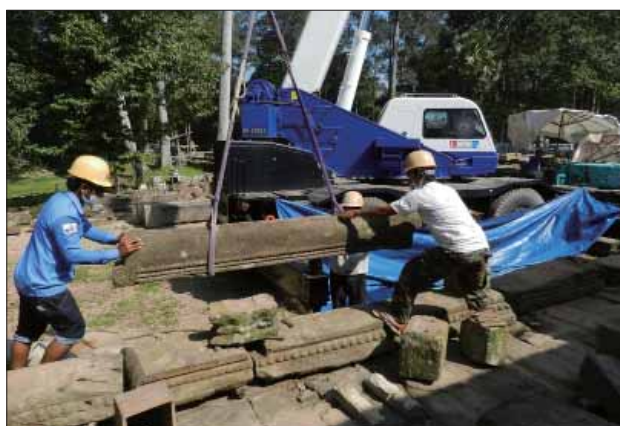
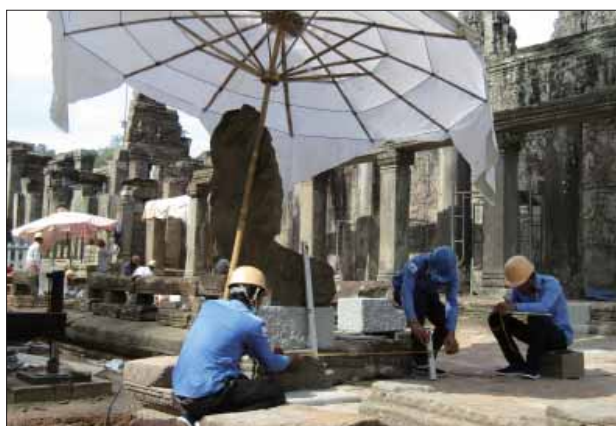
<During restoration at T70.2>

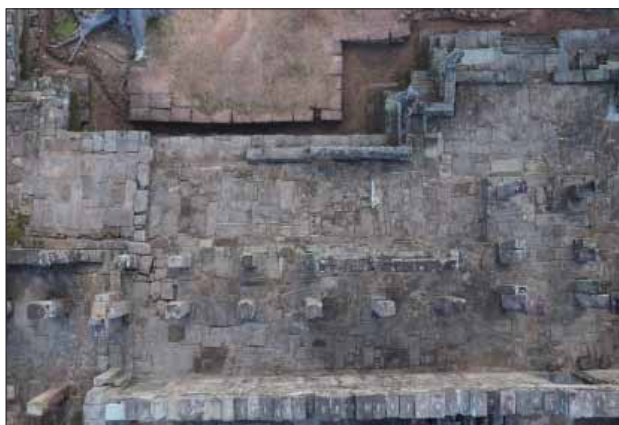
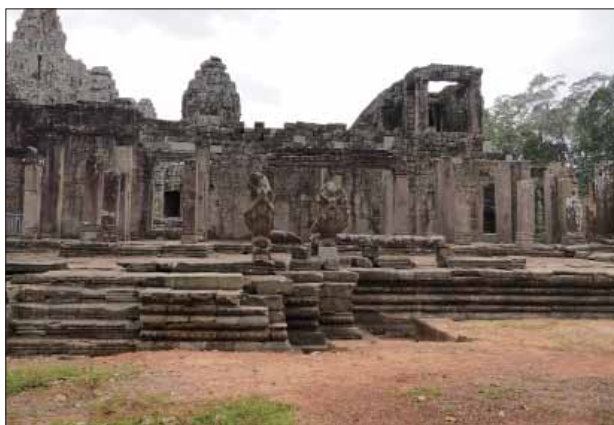
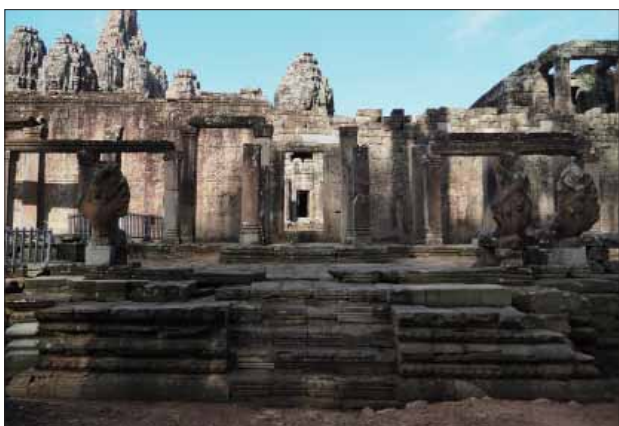
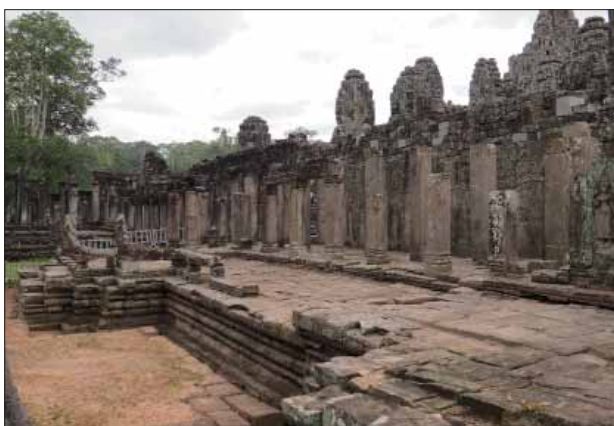
<After restoration at T70.1>

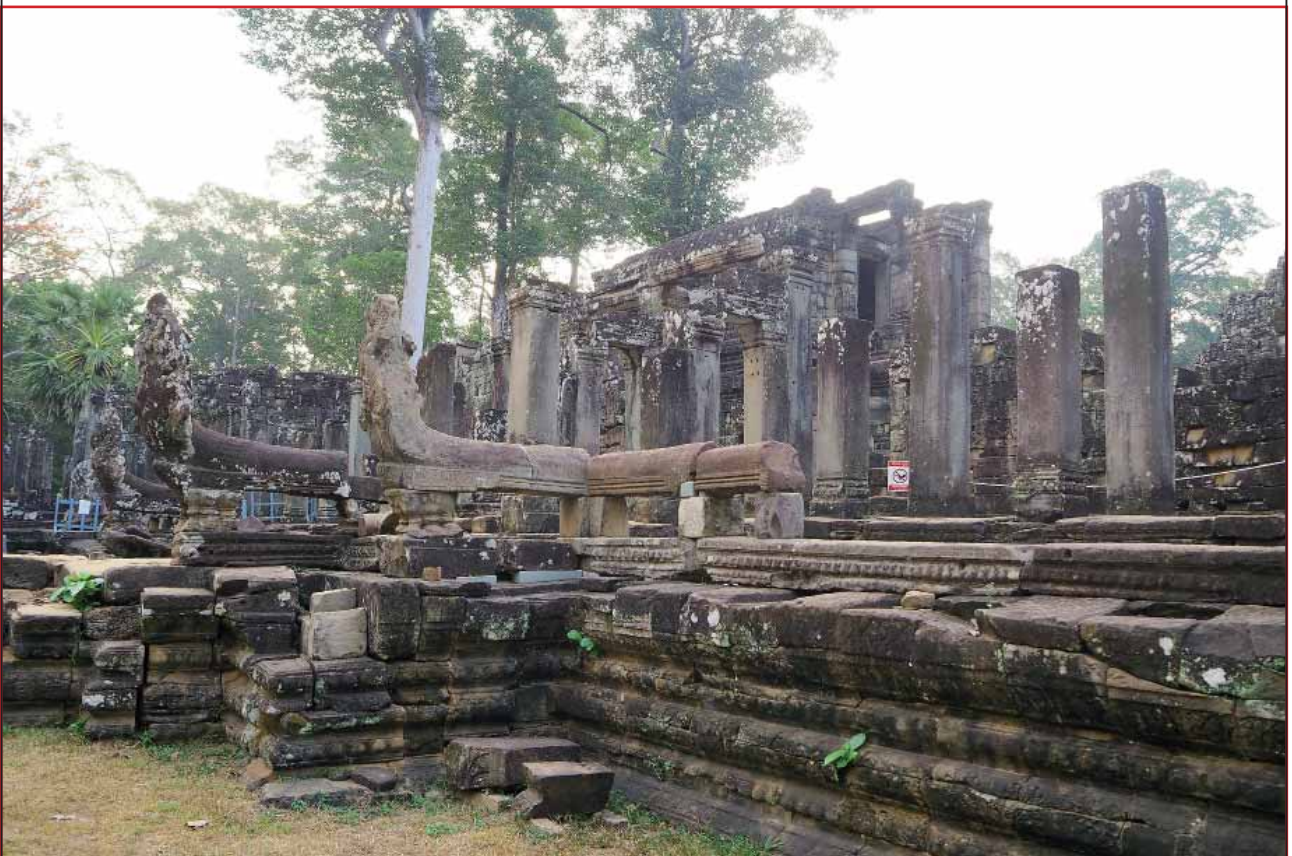
**After Restoration**

Except around porch, most handrails and posts were missing in this area. There are two Naga statues at this area. Whereas eastern Naga statue was in stable condition, western Naga (68.1.8.1.4) statue was broken in two pieces and in unstable situation. Thus we decided only dismantle western Naga statue. Previous treatment of this NAGA was already deteriorated and again broken. Also the basements under this statue were in unstable condition caused from horizontal direction gap between the floor of platform. One basement (67.1.8.3.2) were broken in 2 pieces, thus we decide to dismantle this basement and related posts and handrails.

In this area, we set mini crane at northwest of this area. Dismantled elements were moved to JASA restoration hat and had repairing. At reconstruction work after connection of Naga statue and basements, Some sandstone plates were inserted between basement and platform floor, as platform around porch caused serious uneven subsidence. Also, small piece of sandstone support was inserted under a handrail.

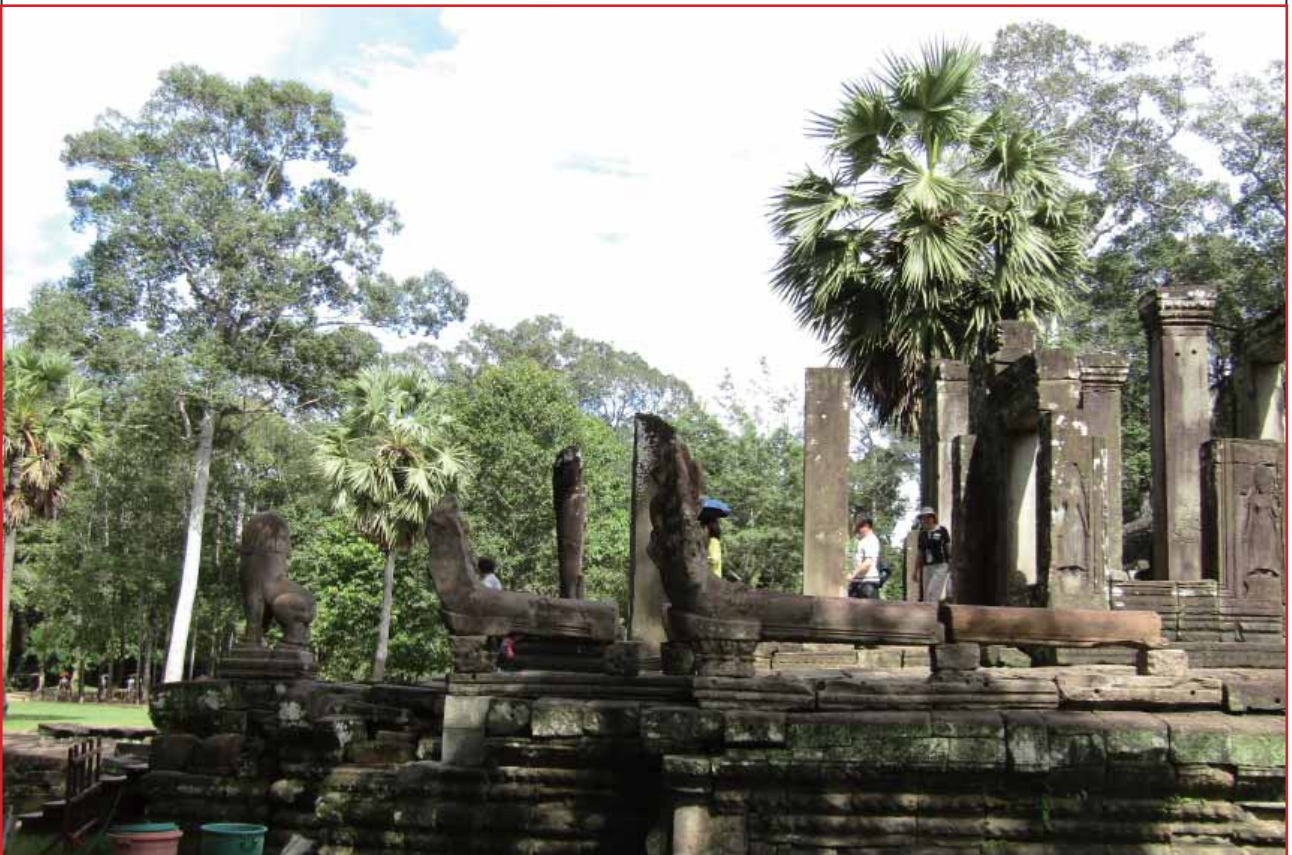
After Restoration

There are 2 Naga statues in this area. For the eastern Naga statue(67.4.8.1.1), two elements of the platform directly under the Naga statue's basement were missing and concrete support was inserted under the basement of Naga statue. However this concrete support was deteriorate and needed replacement with new sandstone supports. Also, the trunk of the other western Naga statue (67.4.8.1.4) was broken and had no previous repairing, just supported by substitute post. Thus we decided to connect this broken Naga statue and so that we could remove substitute support.

Also, one lion statue in this area was broken into two pieces(front legs and pedestal was separated ) and also very unstable situation caused from uneven subsidence around the statue.

There were scattering stones around this are, thus first of all, we had to secure the space for set mini crane. We took photo records before moving these scattering stones and move to other place. Also many tourist walk pass T67 for gate, we set temporary enclosure around restoration area in consideration of safety and noise. After that, we carefully dismantle lion statue and other balustrade. After repairing of each elements, we confirmed how much and where sandstone plates and lead plates should be inserted. From discussion with JASA experts, we decided to insert two new sandstone support under Naga statue 67.4.8.1.1. For this new supports, we mark rough texture for surface finishing. Naga statue 67.4.8.1.4 was connected and install without substitute post when reconstructing.

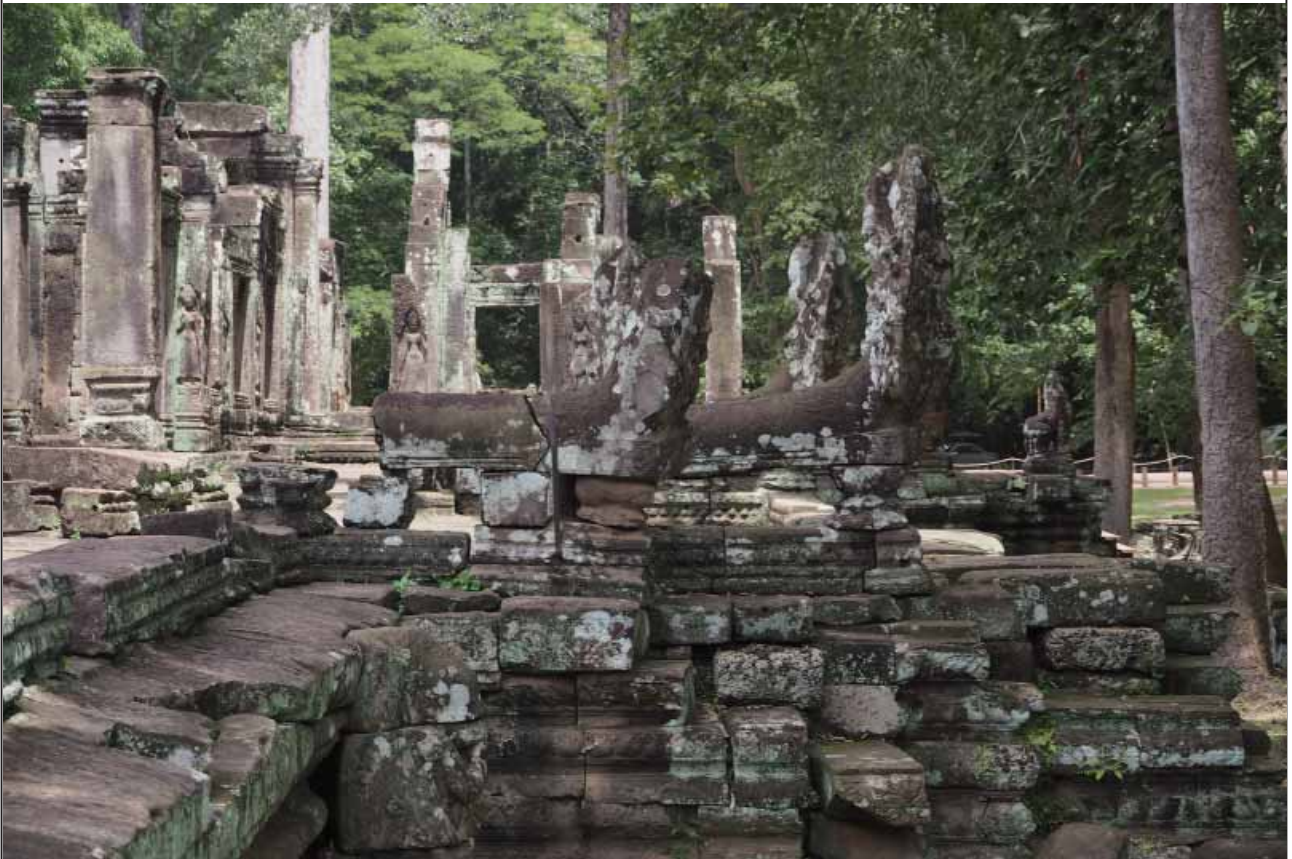
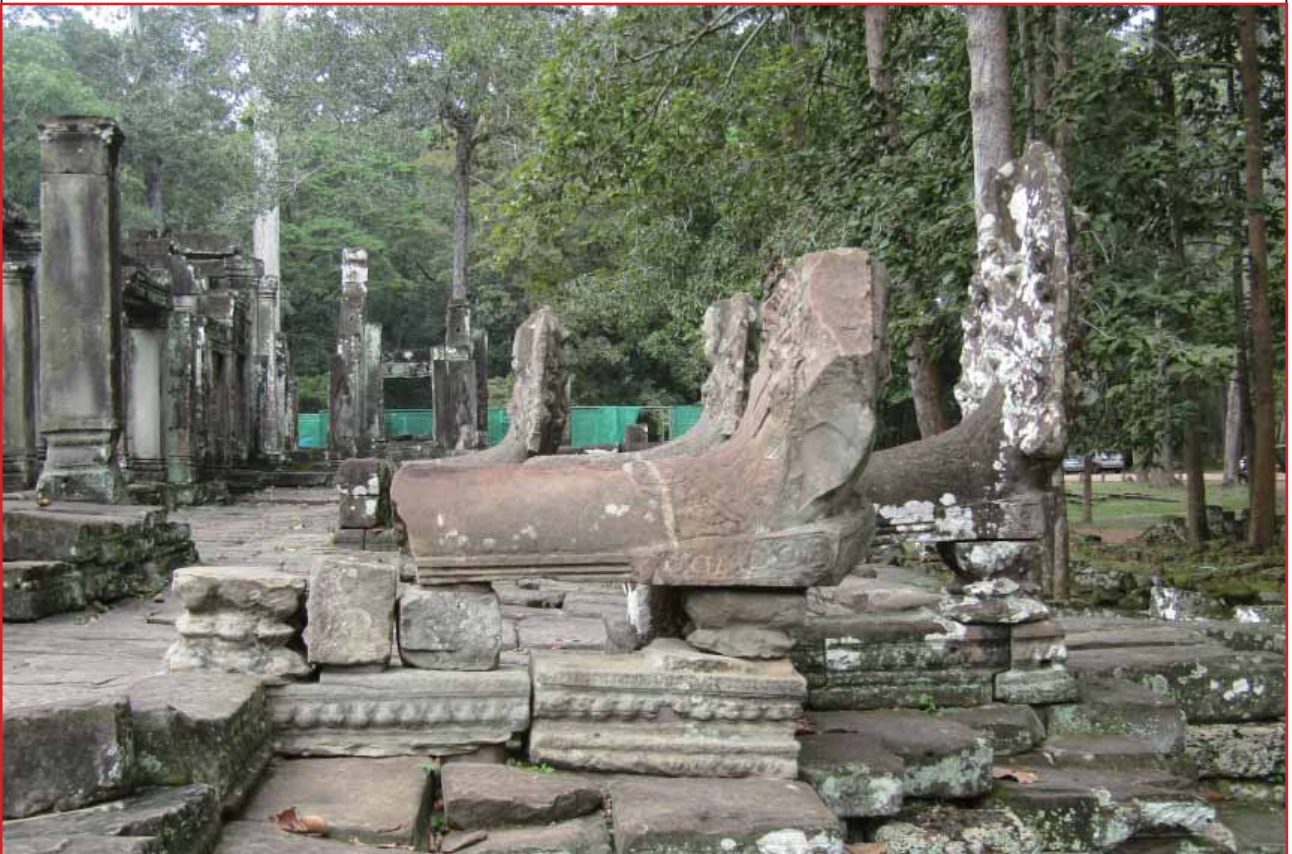
Area : T66.2 work period : 8 weeks

Eastern Naga statue(66.2.8.1.1) was broken into 2 pieces and combined with post and basement by iron belt in past restoration in order to stand. Although, the iron belt was nearly fall out and in danger of fall. Thus we decided to dismantle this Naga statue and elements concerning to this statue.

We set mini crane at northeast space of this area and started work. In this area we didn't move dismantled elements to other area, repaired at the on-site platform, as dismantled elements were few. Remove previous iron belt of Naga statue, and combined using 3 stainless steel. We could remove one substitute post under this statue when reconstructing. Also, the outer edge of the platform was subsided and the Naga statue was inclined to outside, thus we inserted sandstone plate and lead plate under the basement in order to secure stable situation.

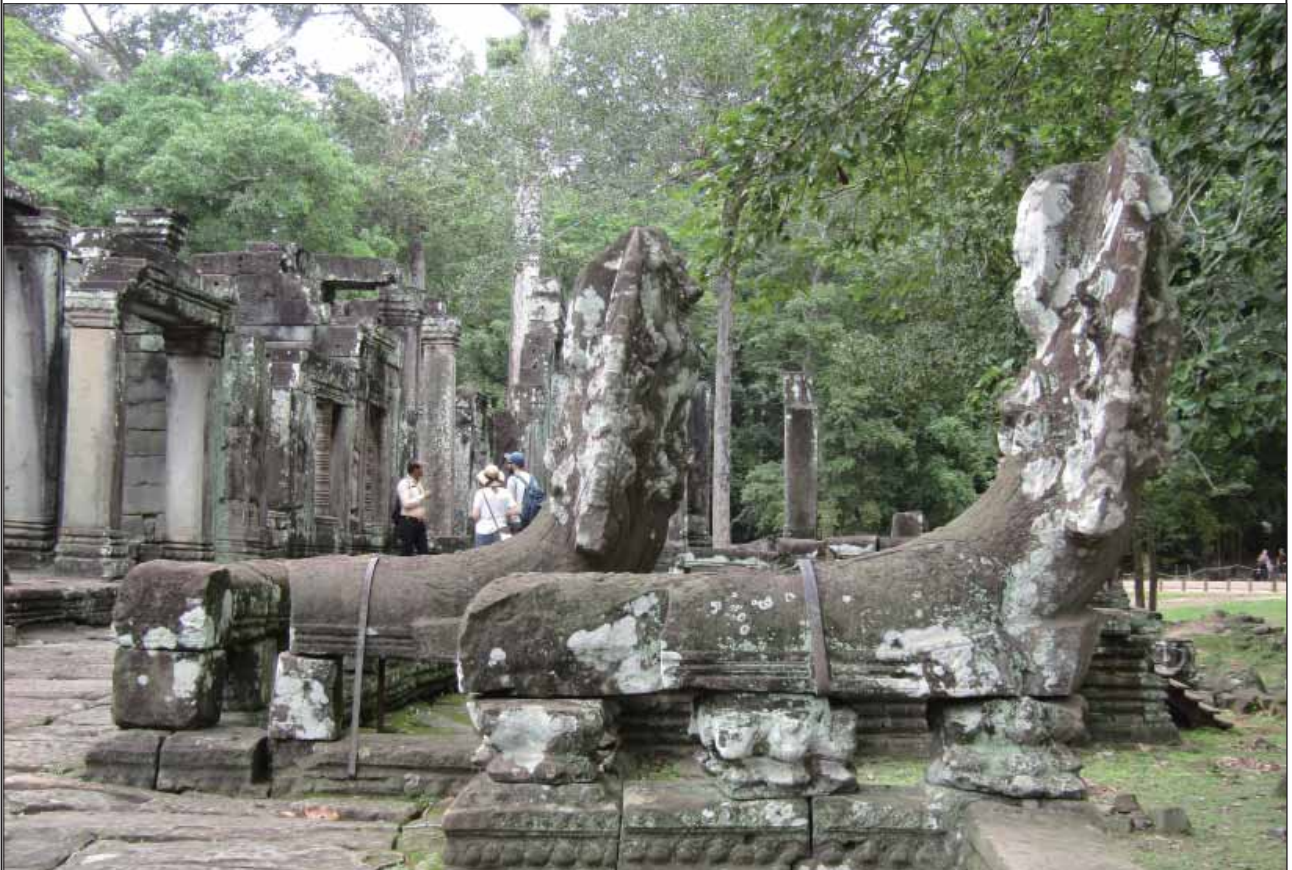
Area : T66.1 work period : 11 weeks

Before Restoration

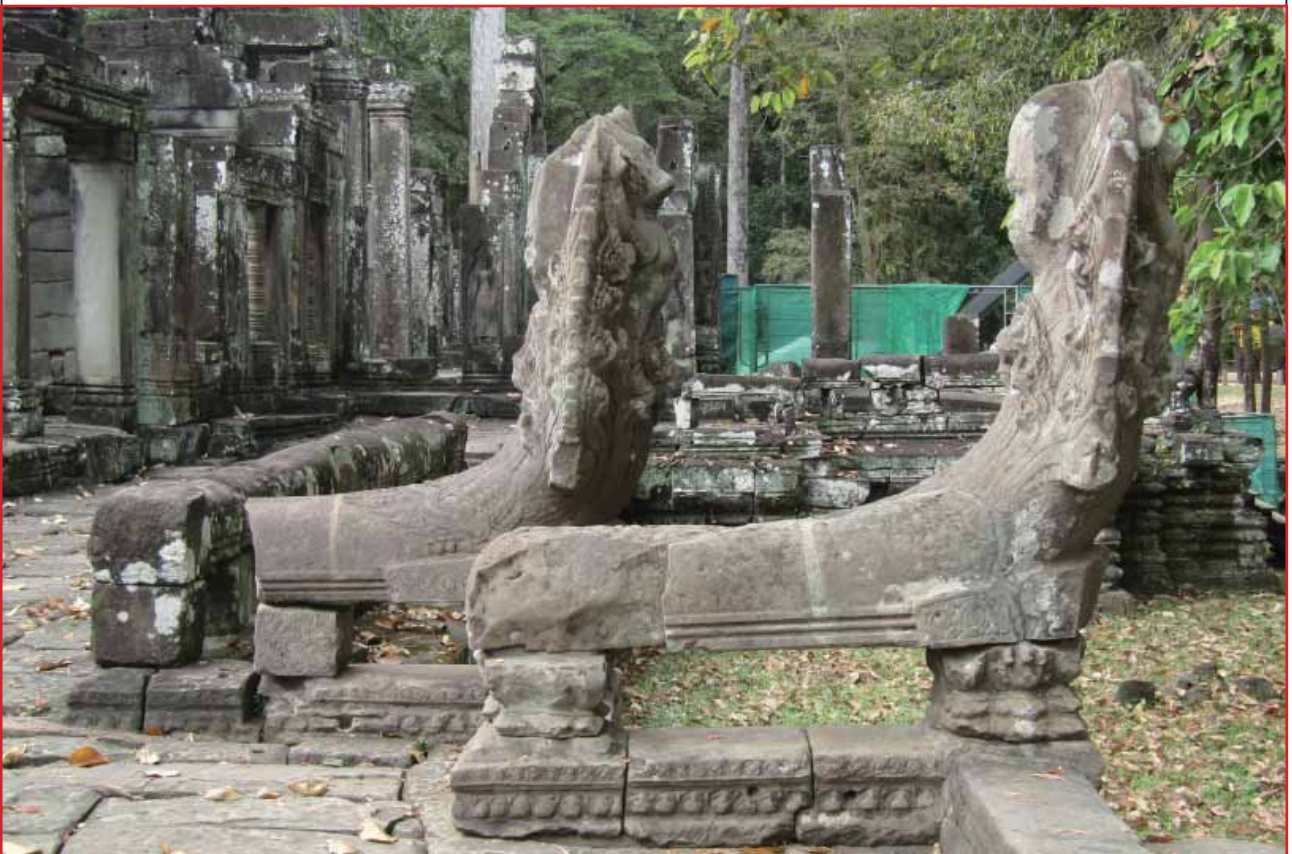
After Restoration

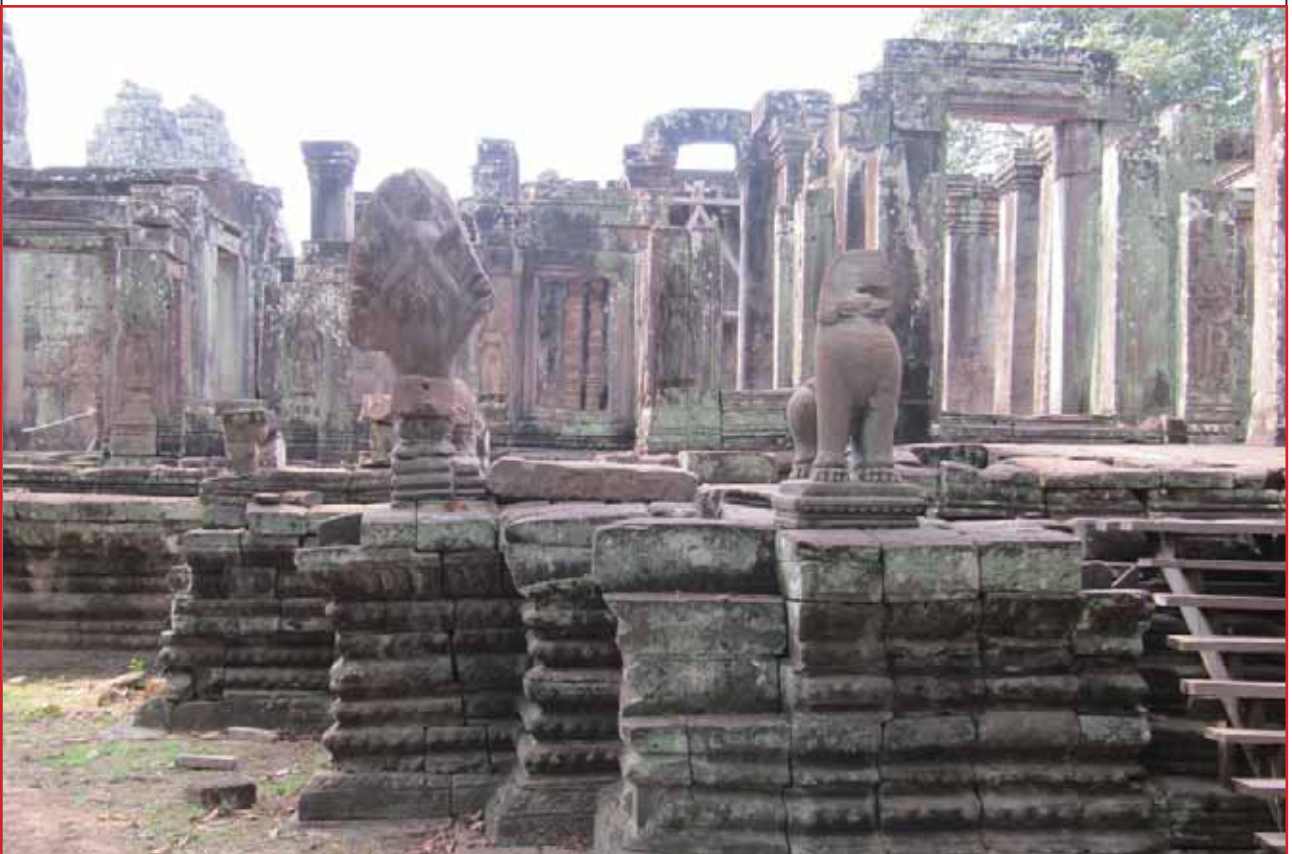
Area : T65.1 work period : 6 weeks

The Naga statue of this area (65.1.8.1.1) was inclining to the outside due to broken of the basement. For the other part, is seems comparatively stable.

In this area, we decided to dismantle only Naga statue and handrail beside this statue, and posts and basement under these handrails. As a result of dismantle, as there some were uneven settlement of the platform, there were no gaps at floor, thus we decided to re-install the elements without touching platform. For the Naga statue 65.1.8.1.1, part of Naga head was broken and connected in the previous restoration, though deterioration of the connection was concerned, we reconnect this part. Also, we also connected broken basement which caused inclination of Naga statue. When reconstructing, some leadplate were inserted between basement and post and Naga statue to eliminate the inclination of the Naga statue.

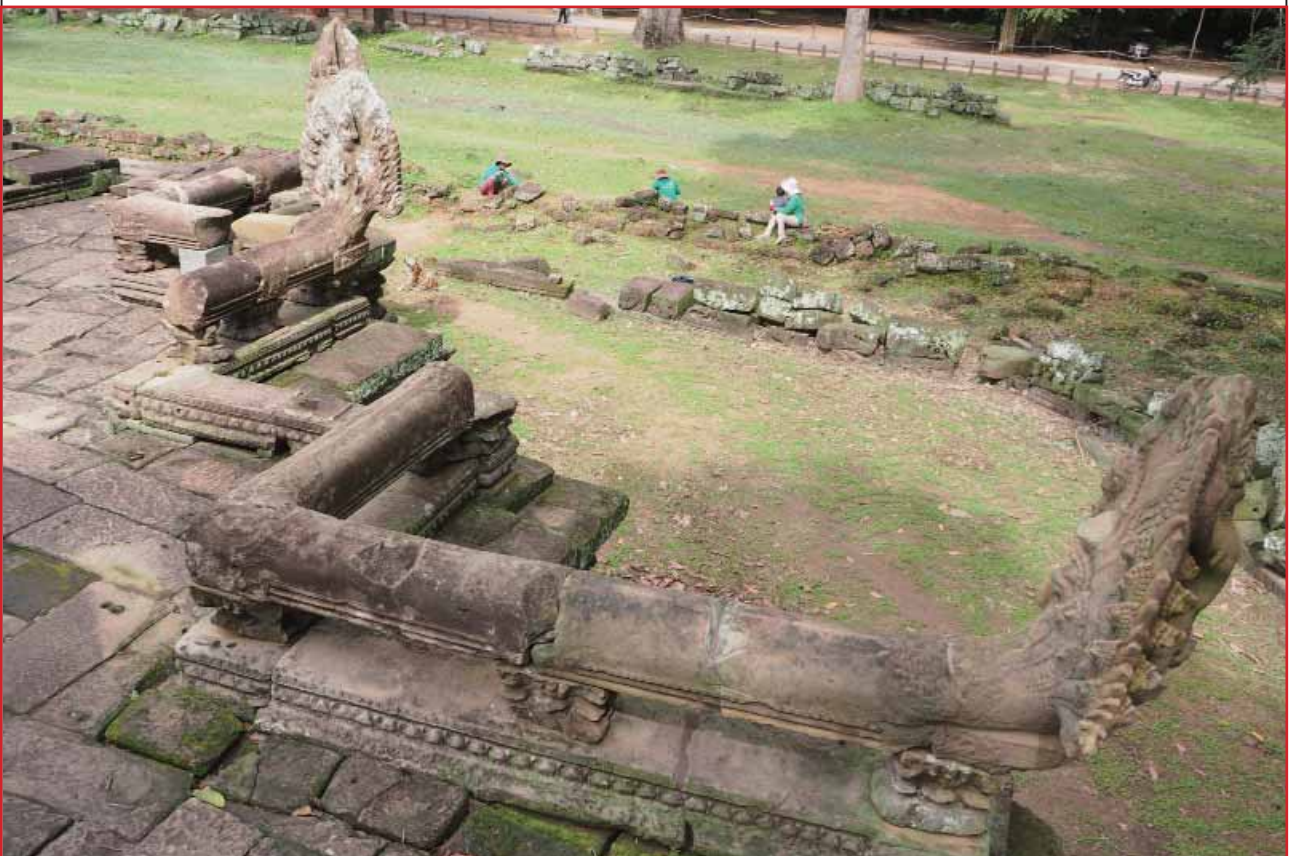
After Restoration

Uneven settlements of the platform forming big gaps and breakage of the basement, and caused many falling of handrails and posts. Also, it was clearly visible that rest unfallen NAGA statue was installed at unoriginal position by previous restoration. Furthermore, in the rain season, ground around this area was covered with rain water, these fallen elements was also submerged in water and causing further deterioration.

First of all, we begun from setting site around this area after records of the scattering stone. Specific work was which find the combination of fragments that could be joined and identification work of the original position was carried out carefully. One of the largest progress in this work is we found that one Naga statues installed at T64.2 and piece of handrail could be joined and originally positioned at western edge of balustrade in this area. Finally all scattering stones on the ground and platform could installed in this area. Also simple platform improvement was done before reconstructing work.
