# ***APPENDIX I***

## ***Restoration activities for each area***

*Report on the Conservation and Restoration work of  
LION and NAGA Balustrades at the Causeway and Outer  
Gallery of BAYON  
Angkor, UNESCO World Heritage Site.*

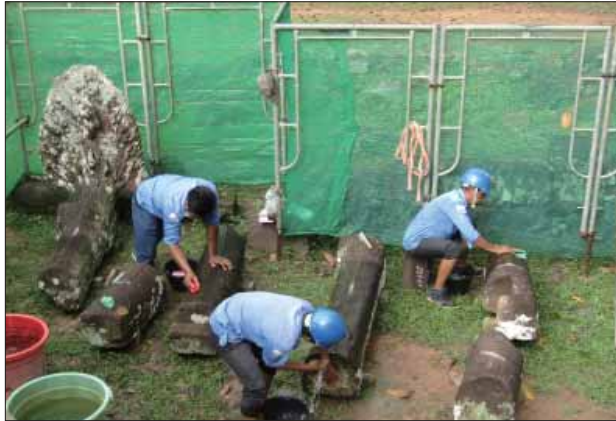
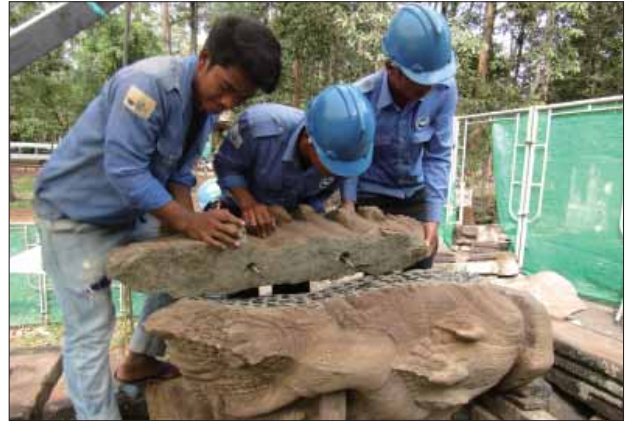
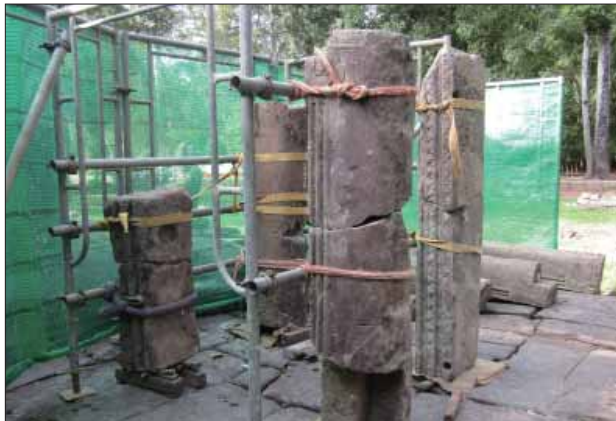
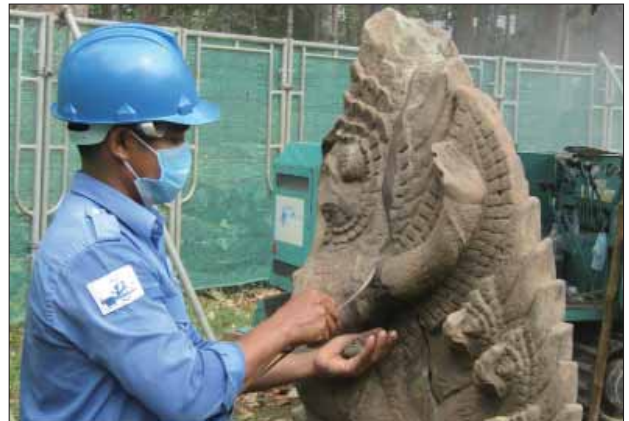
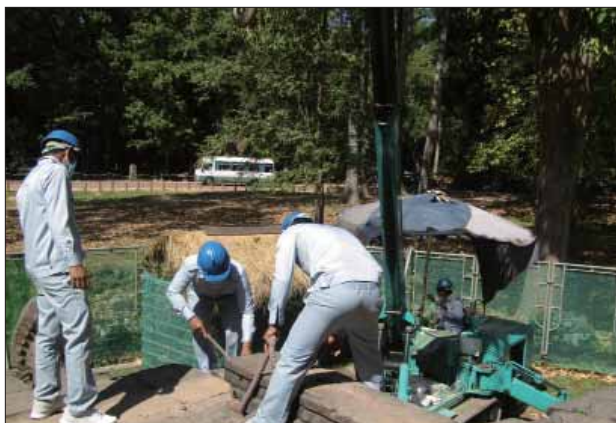
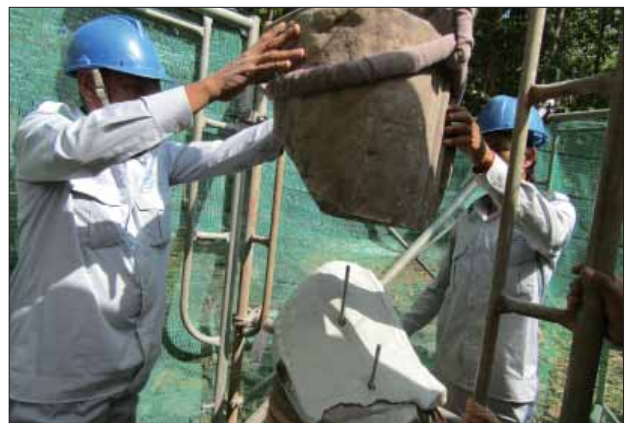
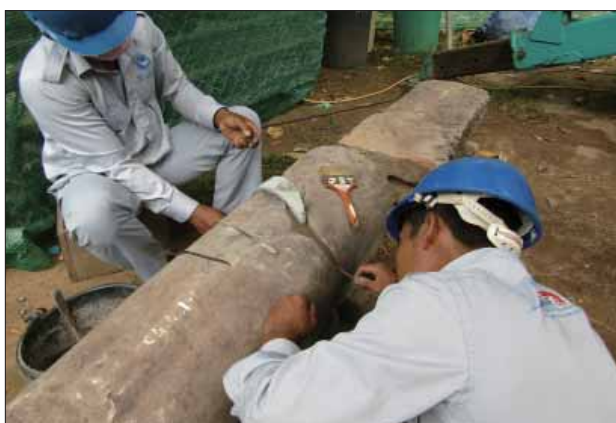
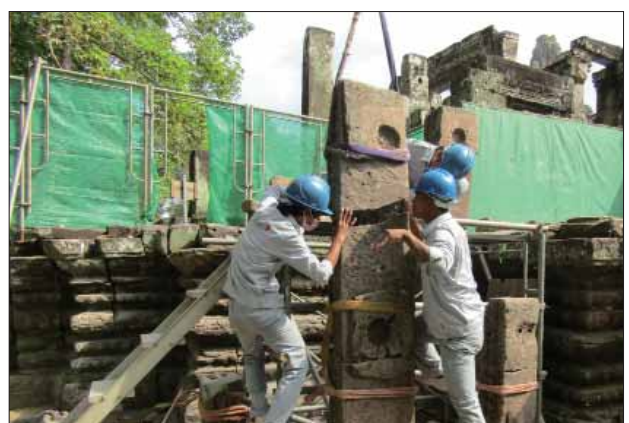
Area : T65.4 work period : 20 weeks

<Photos during restoration>

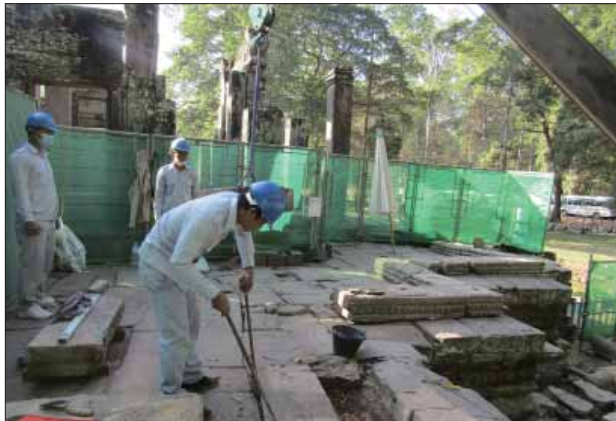
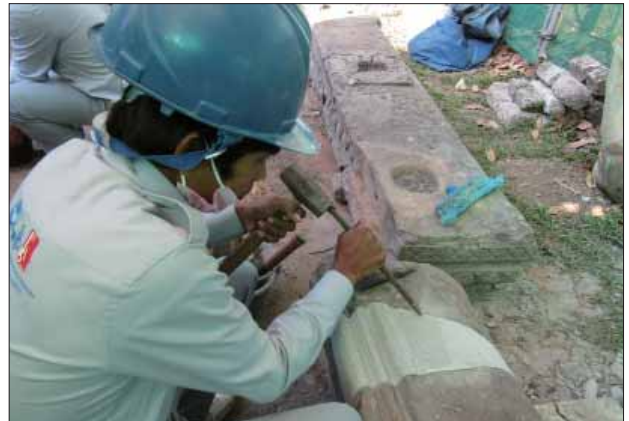
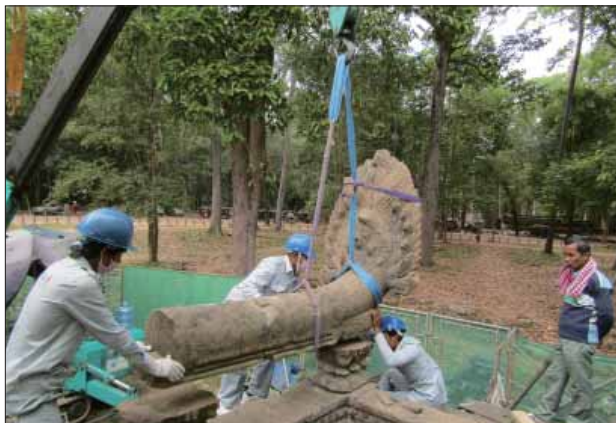
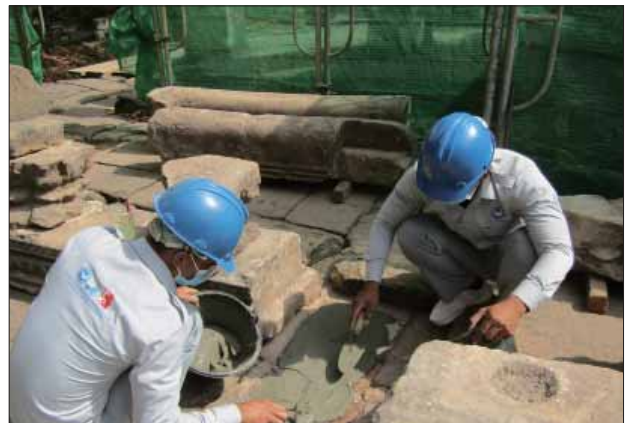
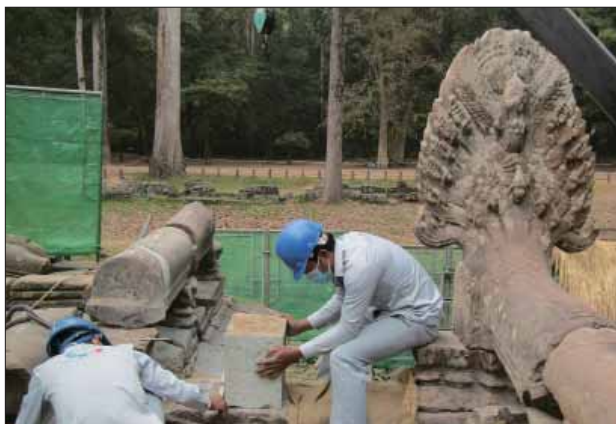
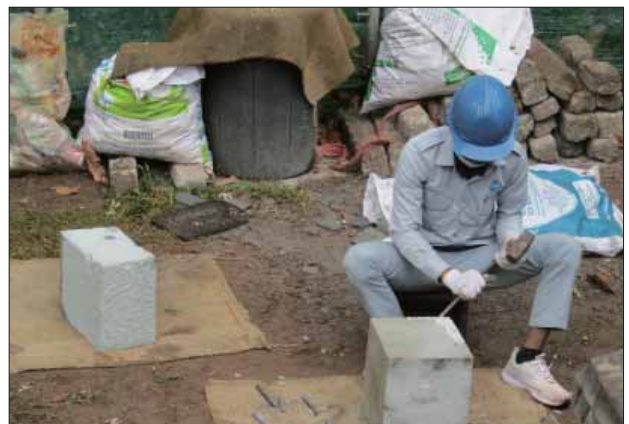
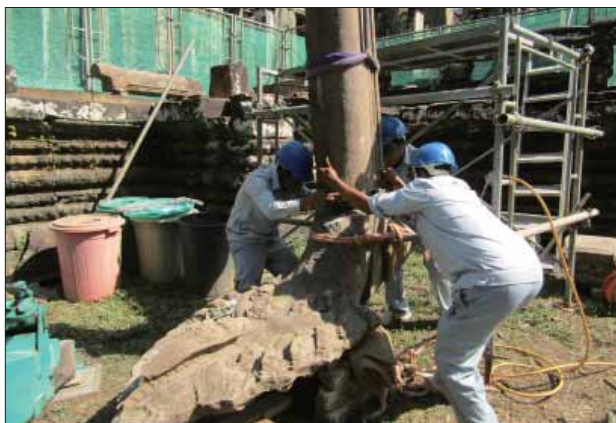
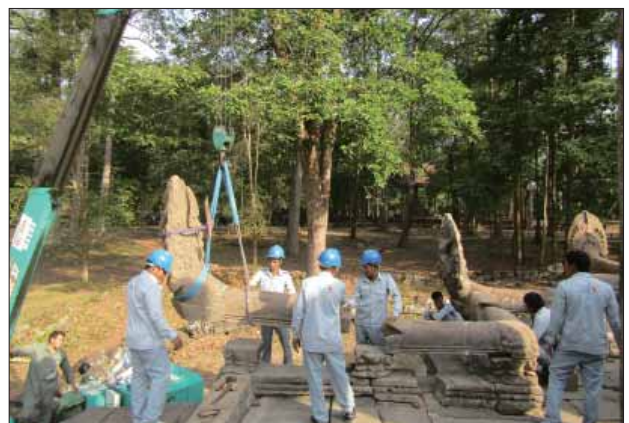
Area : T65.4 work period : 20 weeks

<Photos during restoration>

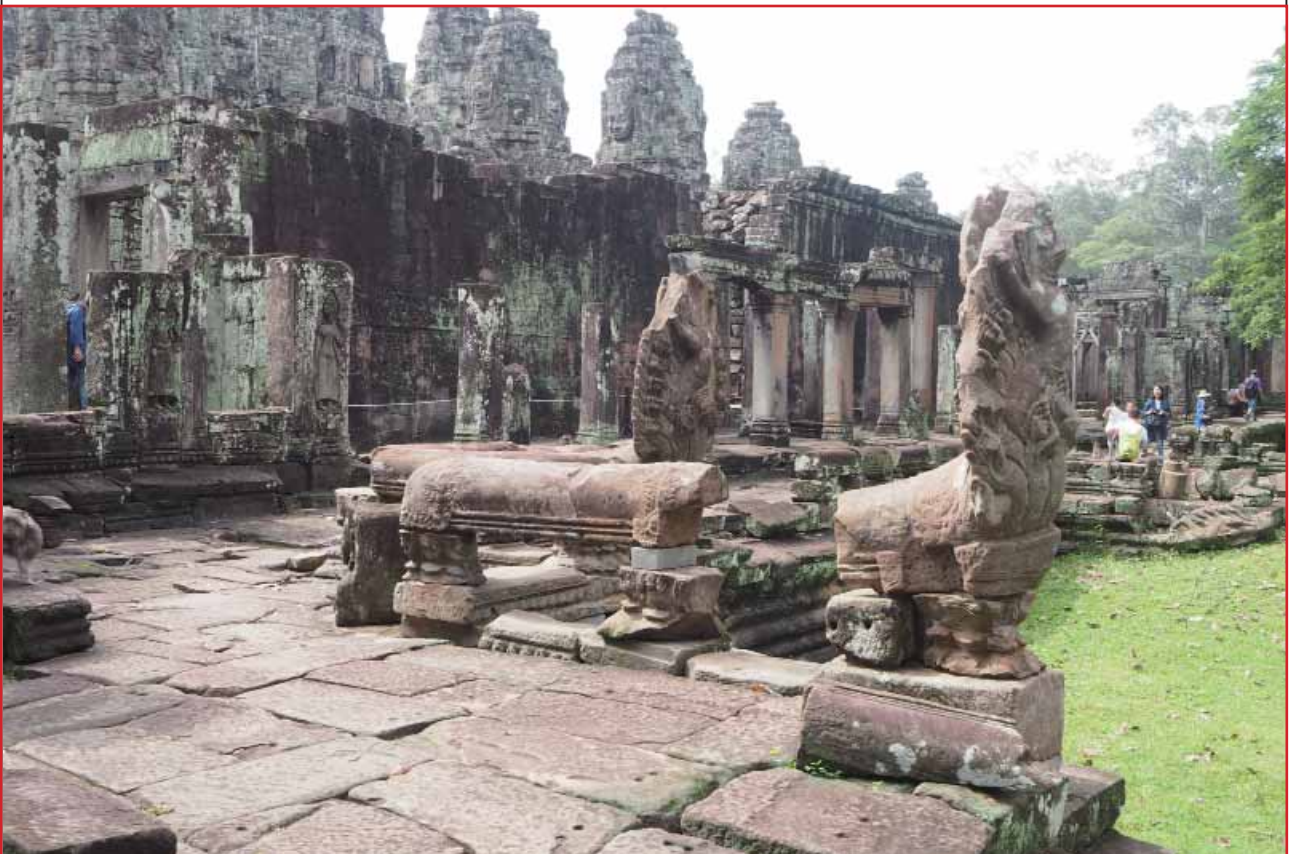
Area : T65.3 work period : 10 weeks

After Restoration

There are 2 Naga statues in this area. Western Naga statue (65.3.8.1.1) was missing whole trunk and fixed with iron clamps and pin to the substitute post and basement. The other Naga statue (65.3.8.1.5) was broken into two pieces. Also, some of the basements has delamination and broken into fragments.

For one lion statue stood in this area, some cracks and other deterioration are recognized. Thus we decided to dismantle this statue and implement filling of cracks exfoliation.

For the situation as above, we decided to dismantle most of the elements of balustrade except few basements and posts at western edge. Also, these deterioration of the elements caused from uneven settlement of the platform. Thus we dismantle first upper layer of the platform in order to remove the soils which enter into the gap and eliminate the gap between platform floor.

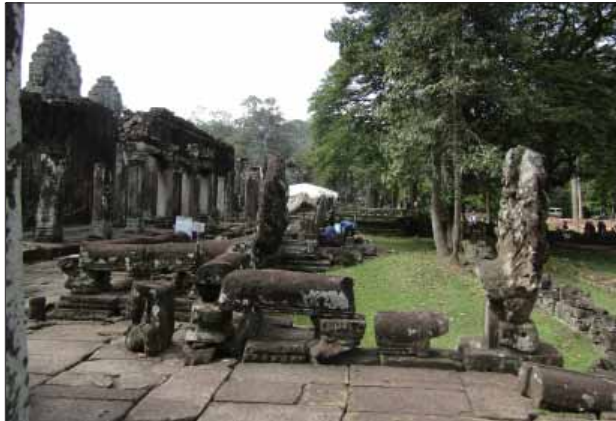
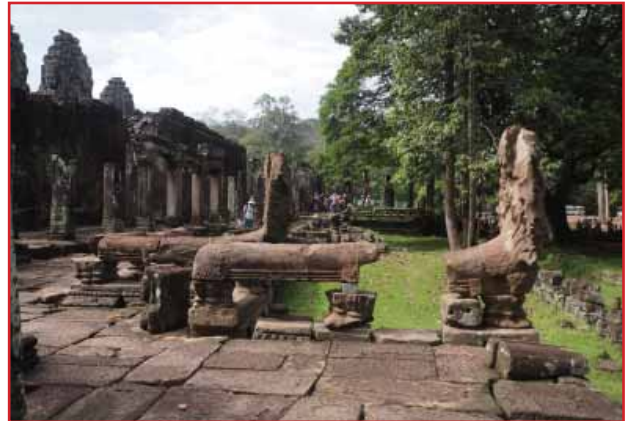
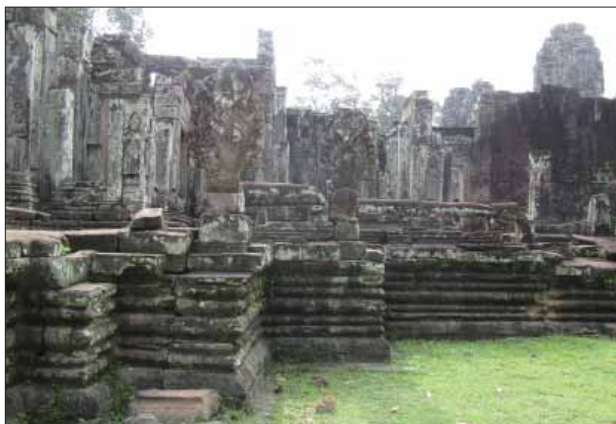
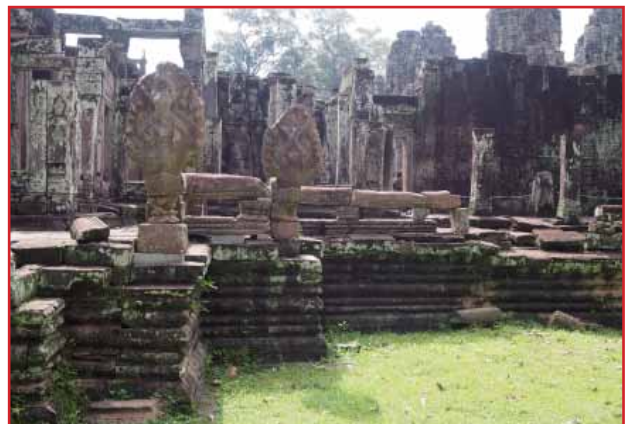
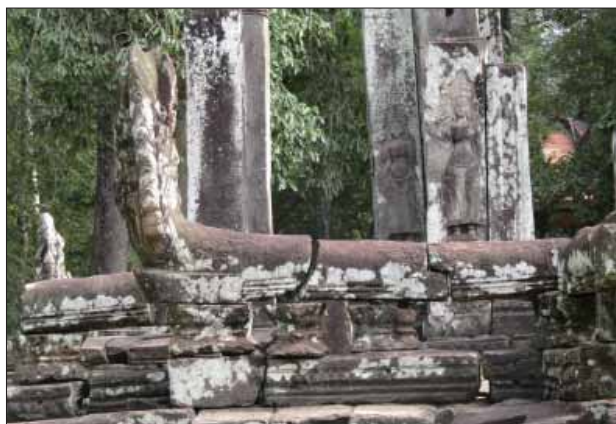
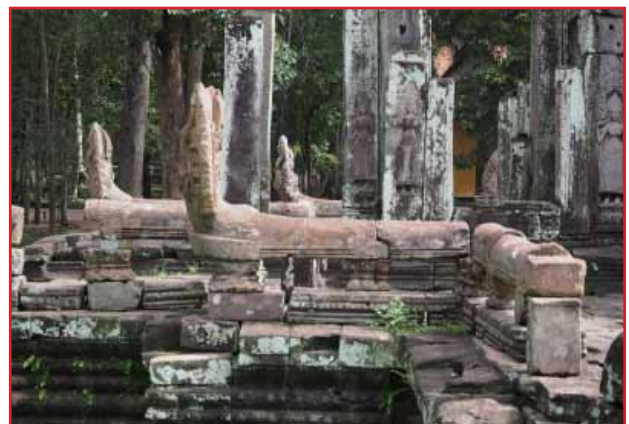
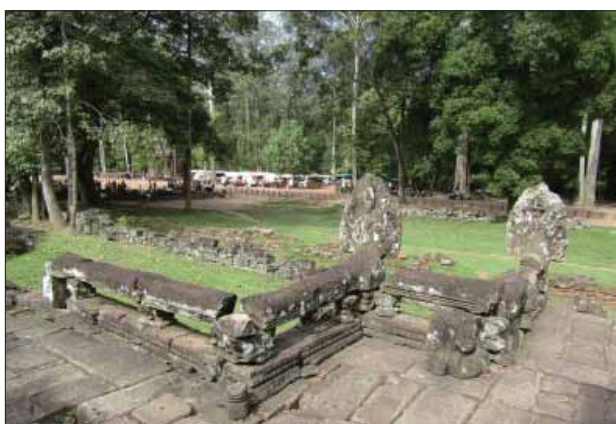
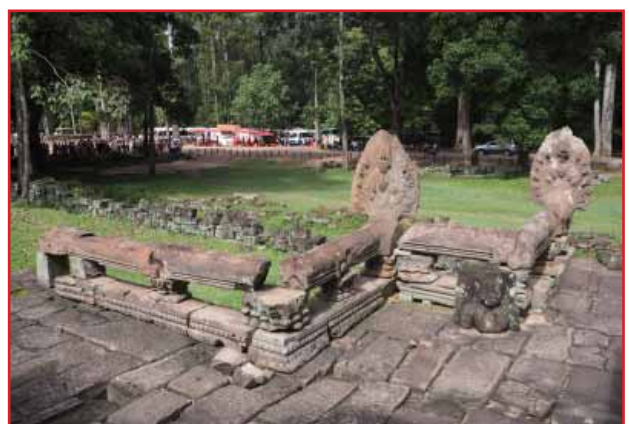
Area : T65.3 work period : 10 weeks

<Before and after restoration>

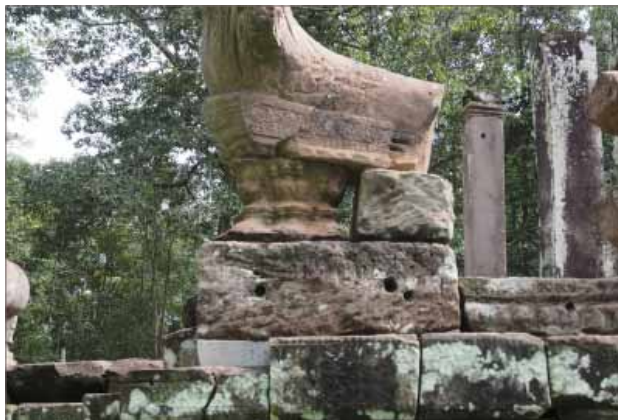
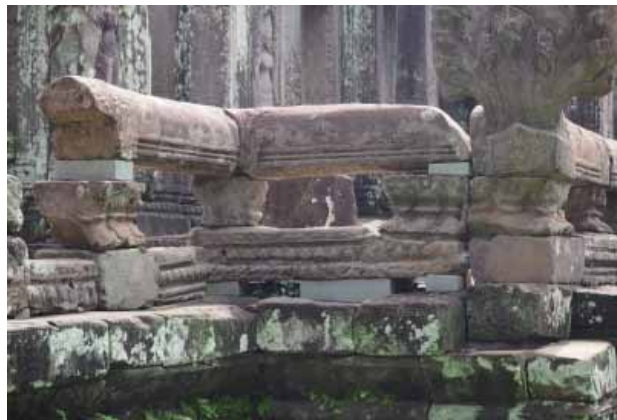
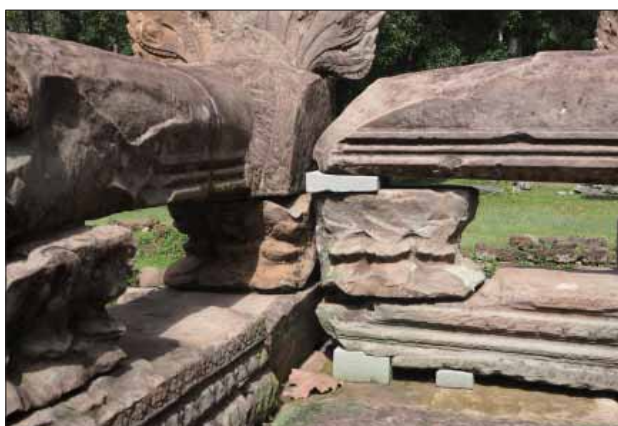
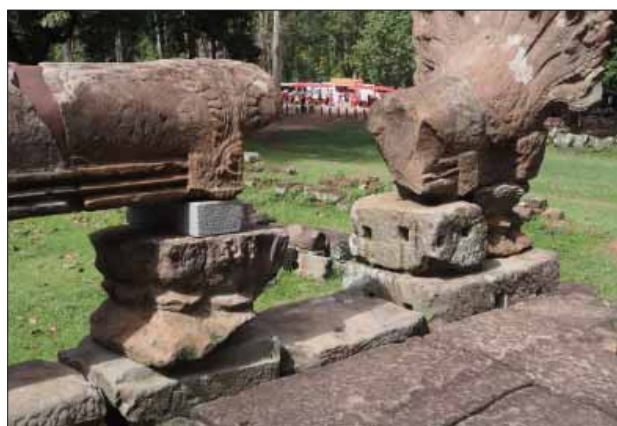
Area : T65.3 work period : 10 weeks

<After restoration>

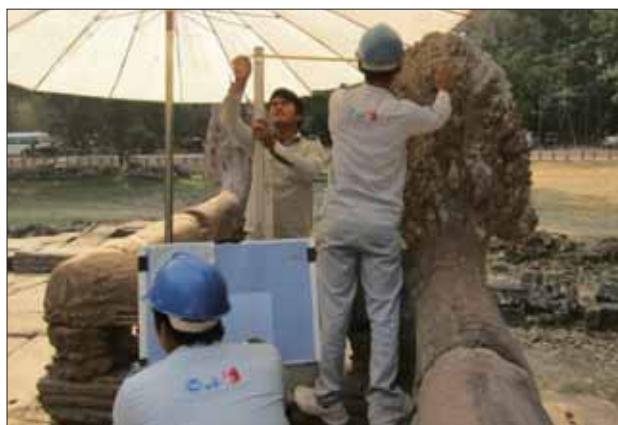
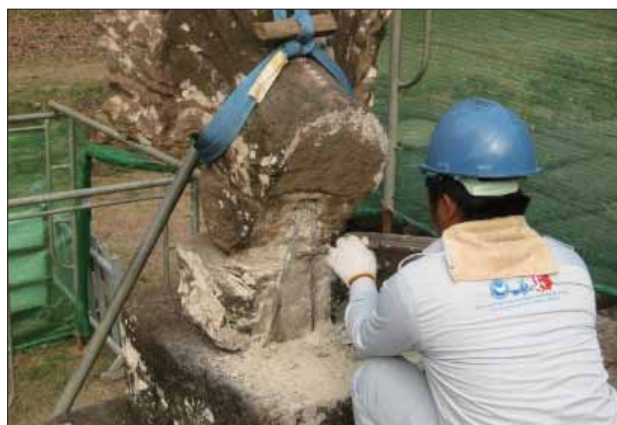
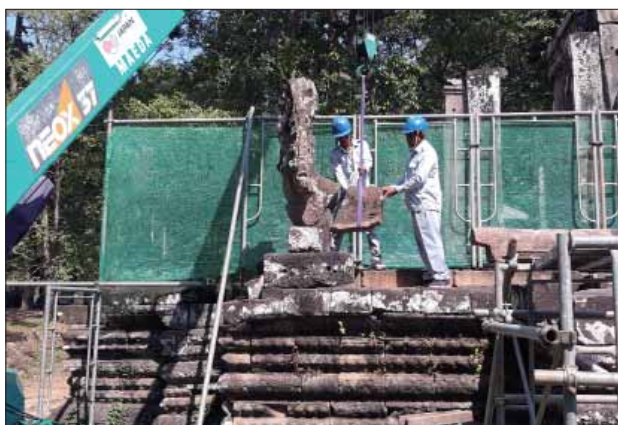
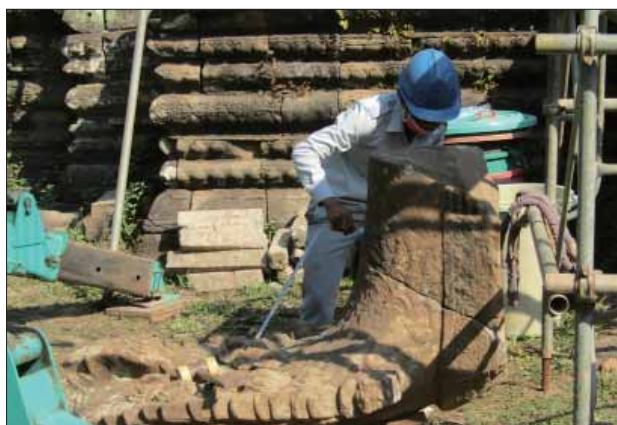
<Photos during restoration>

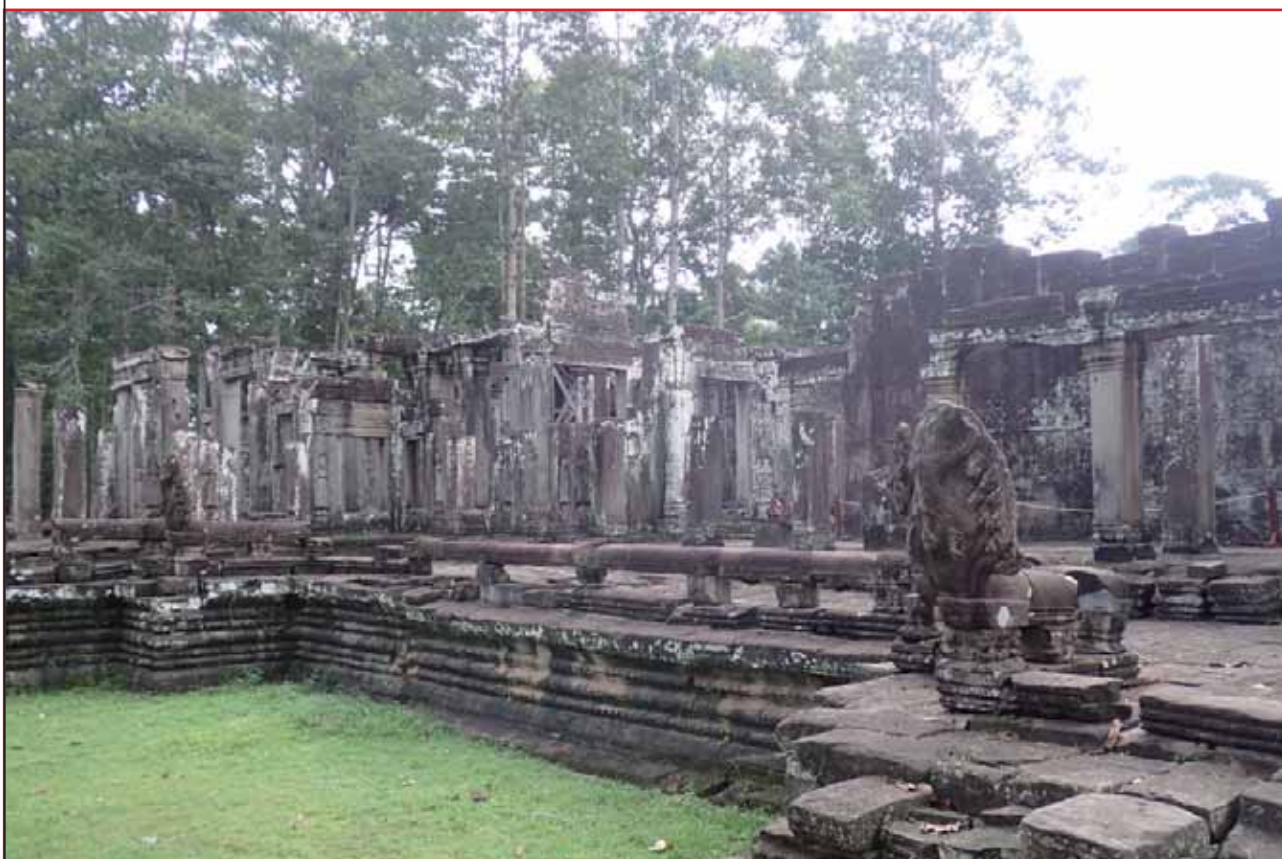
**After Restoration**

Restoration work in this area began in October 2019, after the completion of the earth clearance work around the platform of Area T64. As a result of the clearance work, many balustrade elements and fragments related to the Naga statues were found, so investigations were carried out in T64.1, T64.2 and the adjacent area T63.4 to determine which elements could be combined and to identify their original locations. Finally, it was found that many elements could be returned to the previously missing parts, in particular, all the elements of the T64.1 Handrails were found in perfect order. Also, many small fragments were found that could be joined to the Naga statues that had collapsed on the platform.

- One collapsed Naga statue □ C6.1.1, can connected not only with also collapsed body, but also with small head pieced found from mound by clearance work.
- It was confirmed that C6.1.19, C6.1.12-15 were joined with 64.1.8.
- C5.2.10 + C5.1.11.1 + C5.1.11.3, C5.2.8.1 + C5.2.9.1, were also confirmed to have formed a single handrail element, so they were joined and installed.
- In order to install the newly discovered handrail in places where had been lost, a new sandstone basement (N64.1.8.3.1) was inserted.

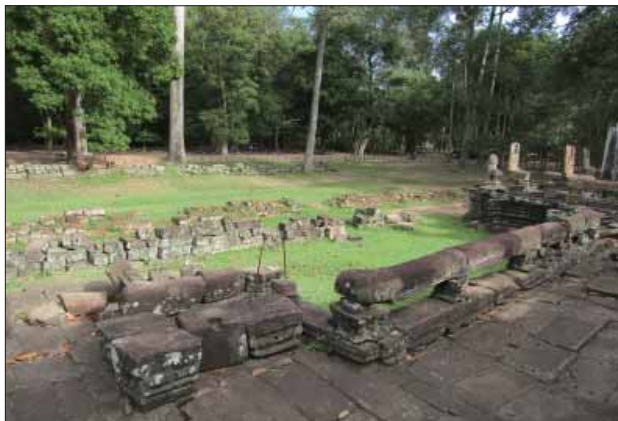
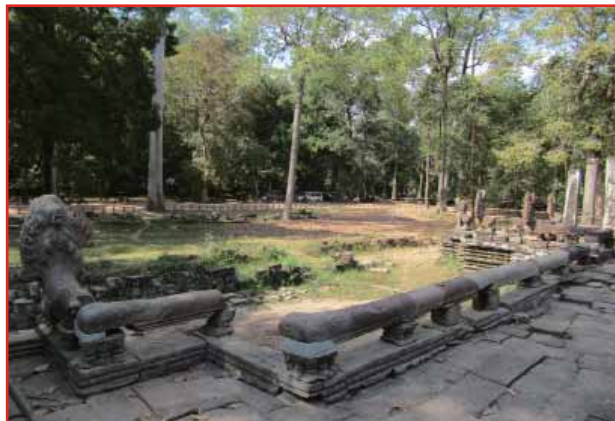
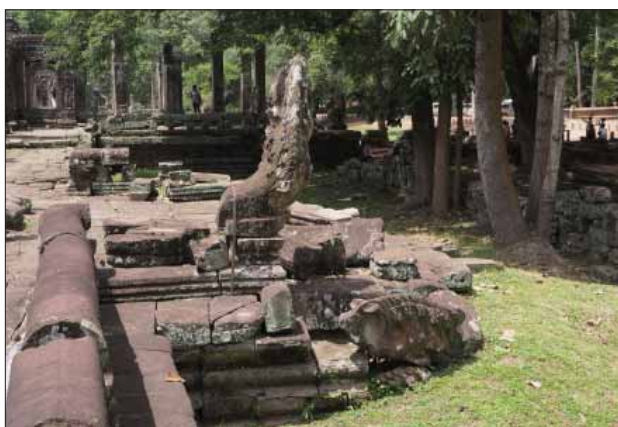
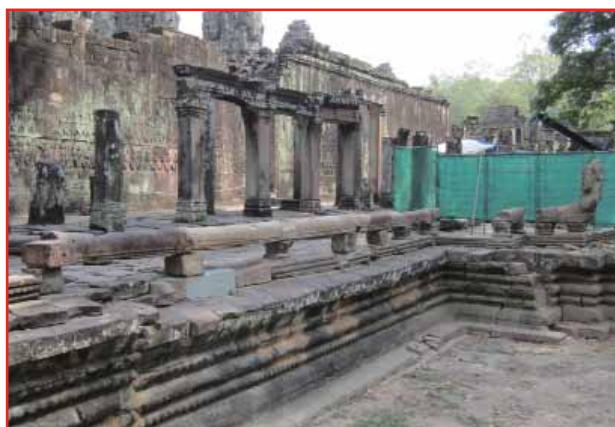
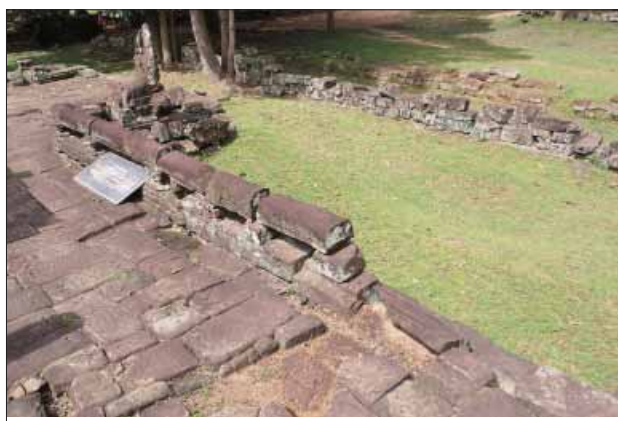
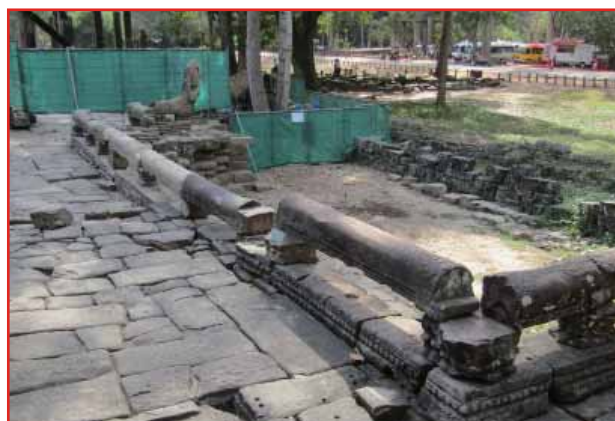
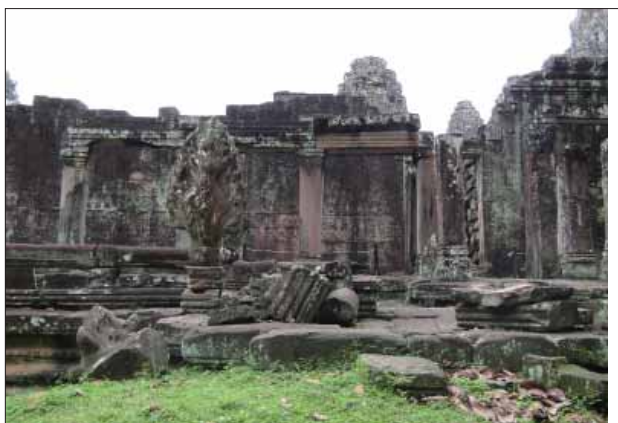
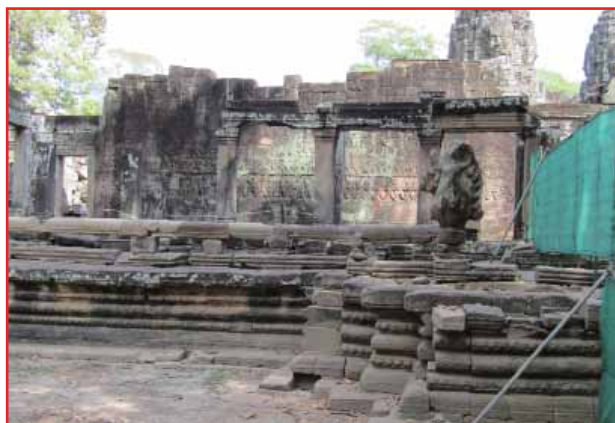
Area : T64.1 work period : 8 weeks

<Before and after restoration>

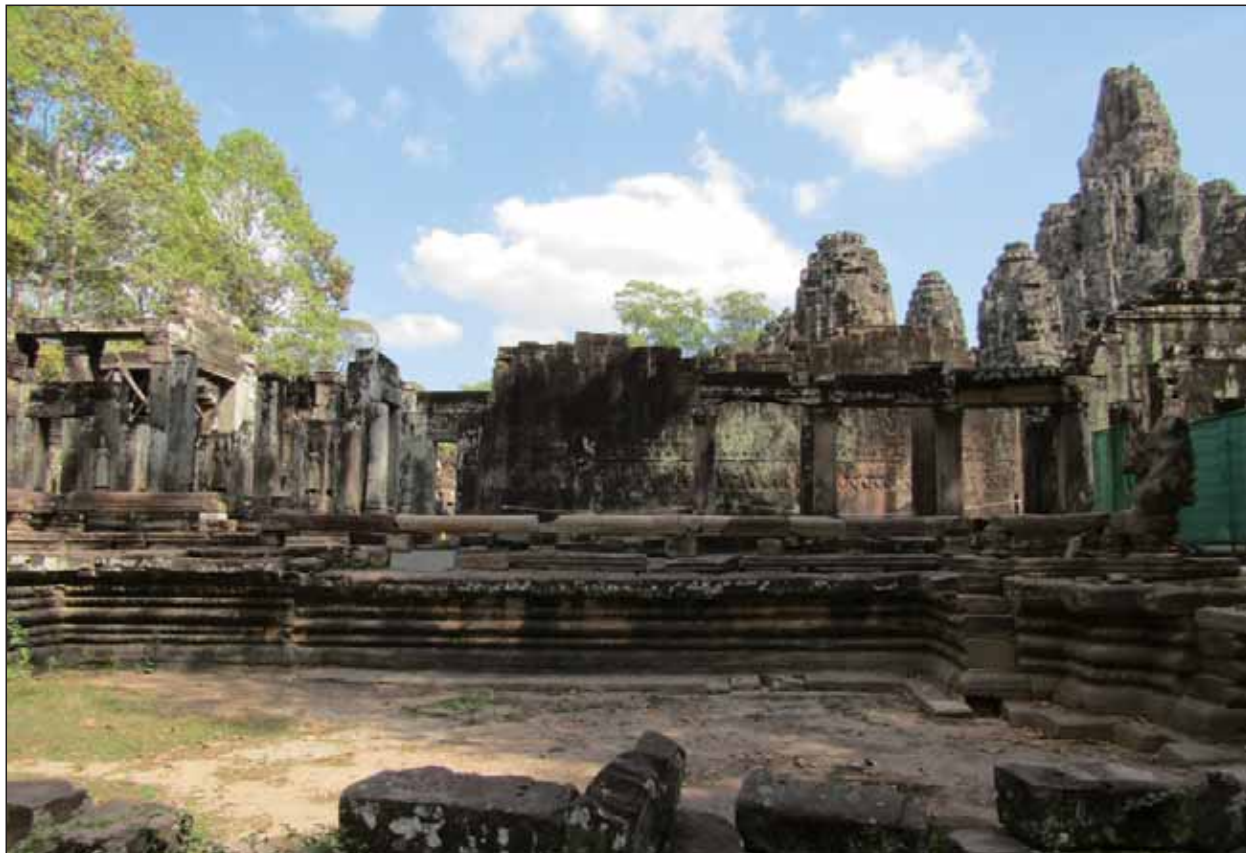
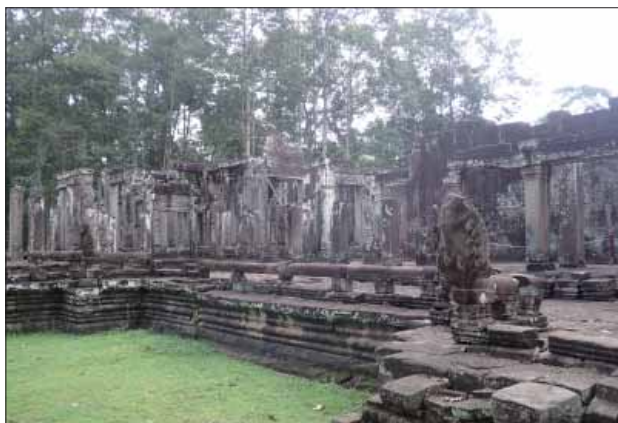
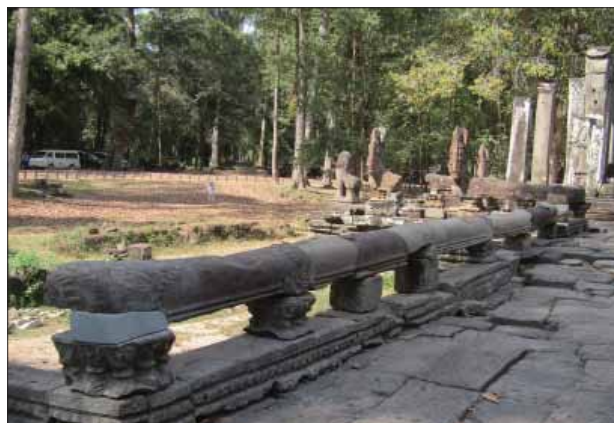
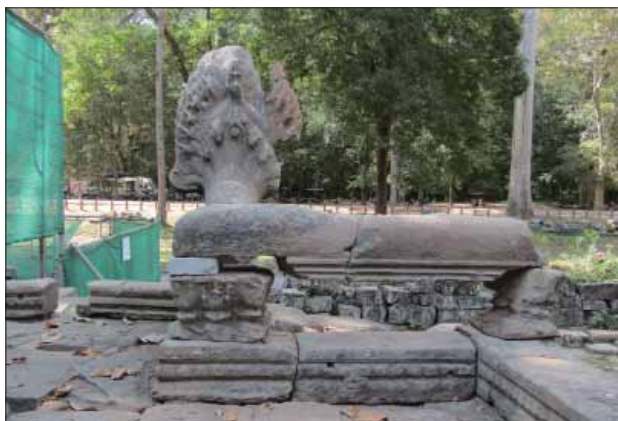
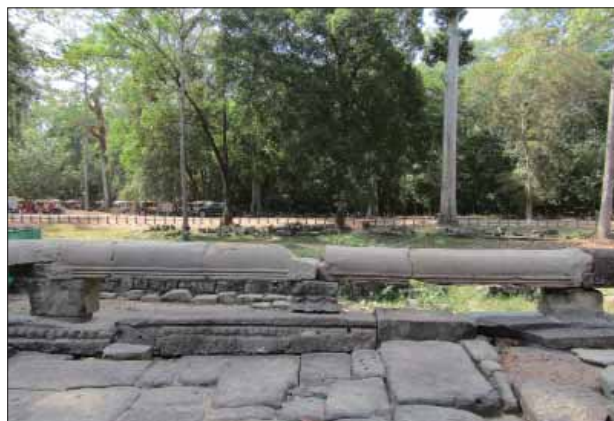
Area : T64.1 work period : 8 weeks

<After restoration>

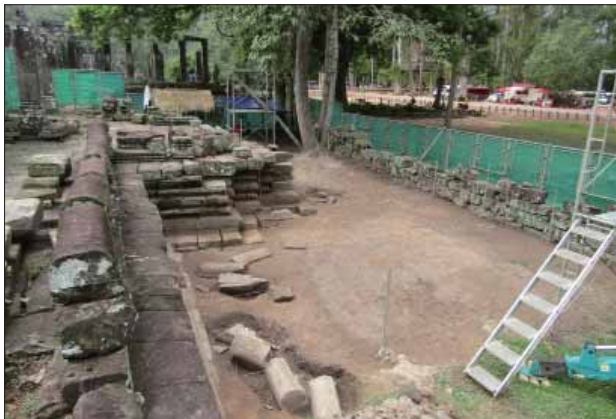
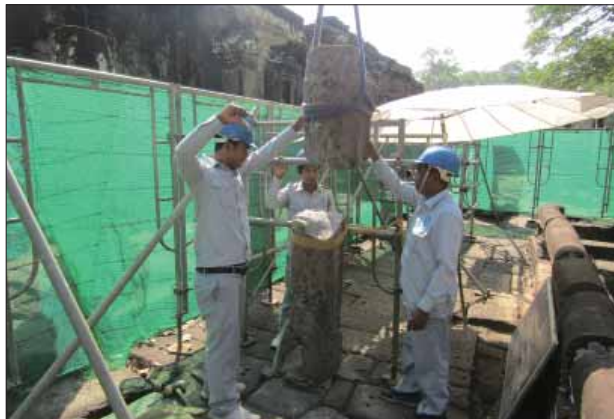
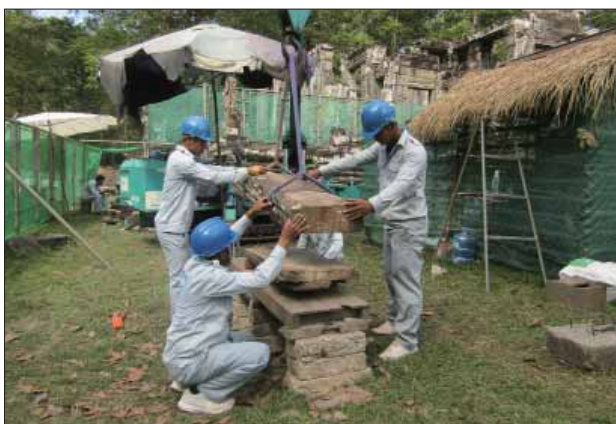
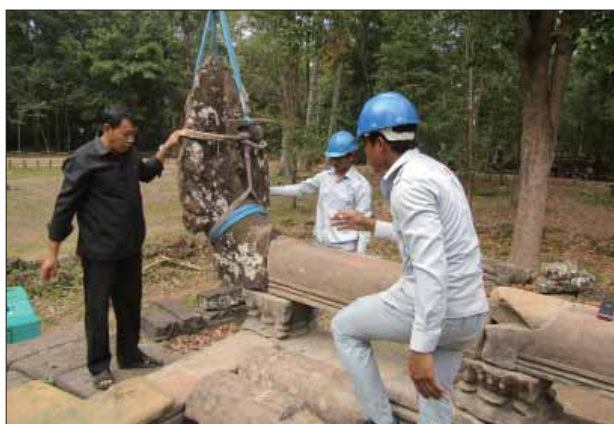
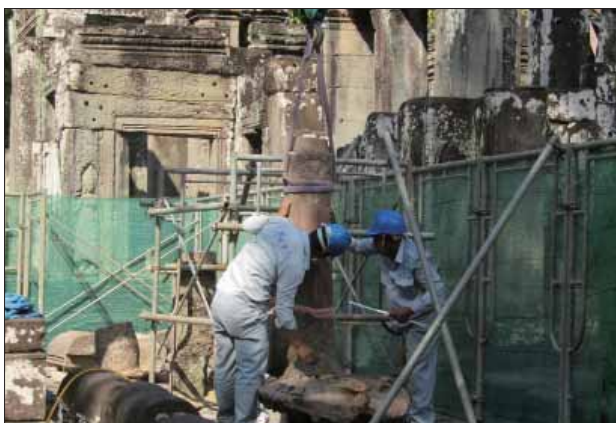
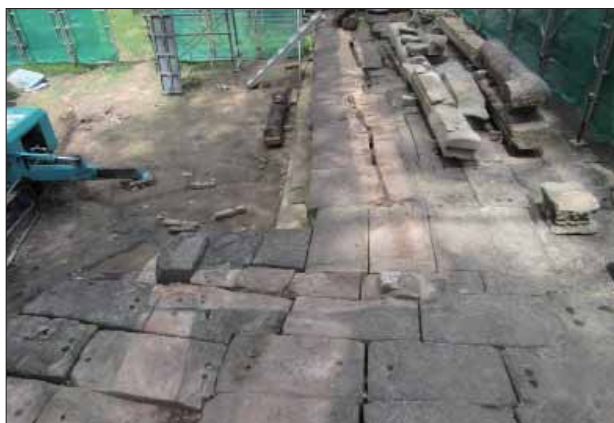
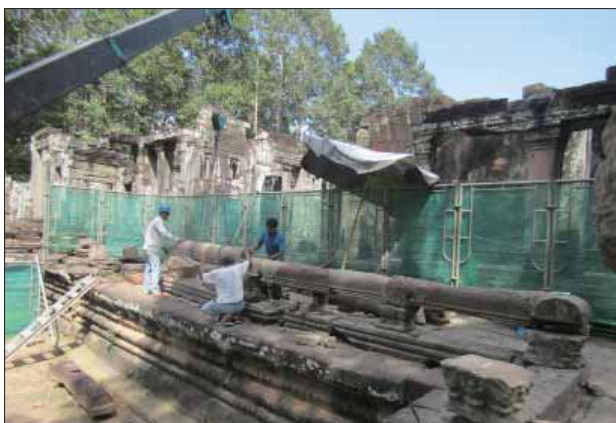
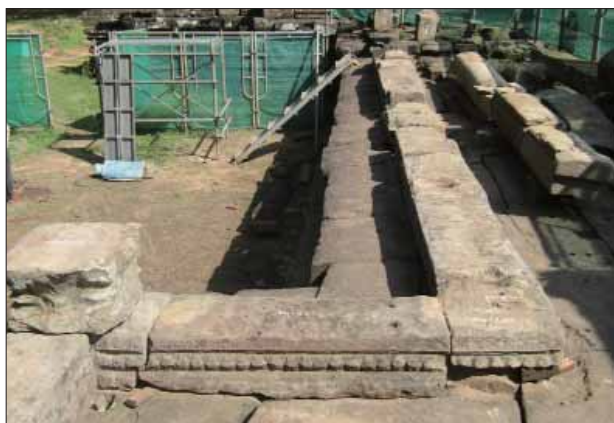
Area : T64.1 work period : 8 weeks

<Photos during restoration>

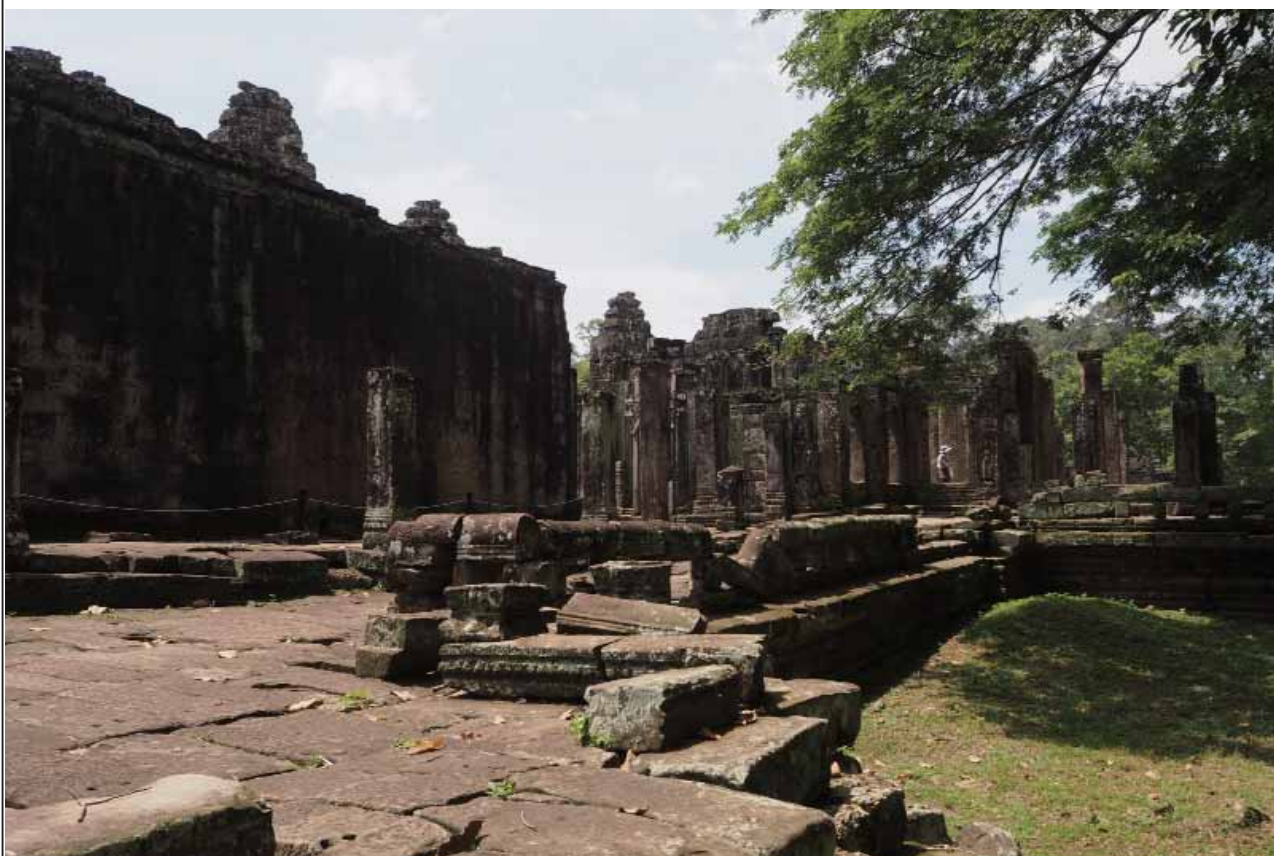
Area : T64.2 work period : 12 weeks

**Before Restoration**

T64.2 was complicated by the fact that the restoration of the existing structure had originally connected two elements that did not match, and almost the entire structure was installed in an out-of-situ location. In the adjacent area T64.1, the missing elements were excavated from the mound immediately below, so it was relatively easy to determine the original location by lining them up, but T64.2 was more difficult because it was necessary to identify the elements over a wide area, including the surrounding area.

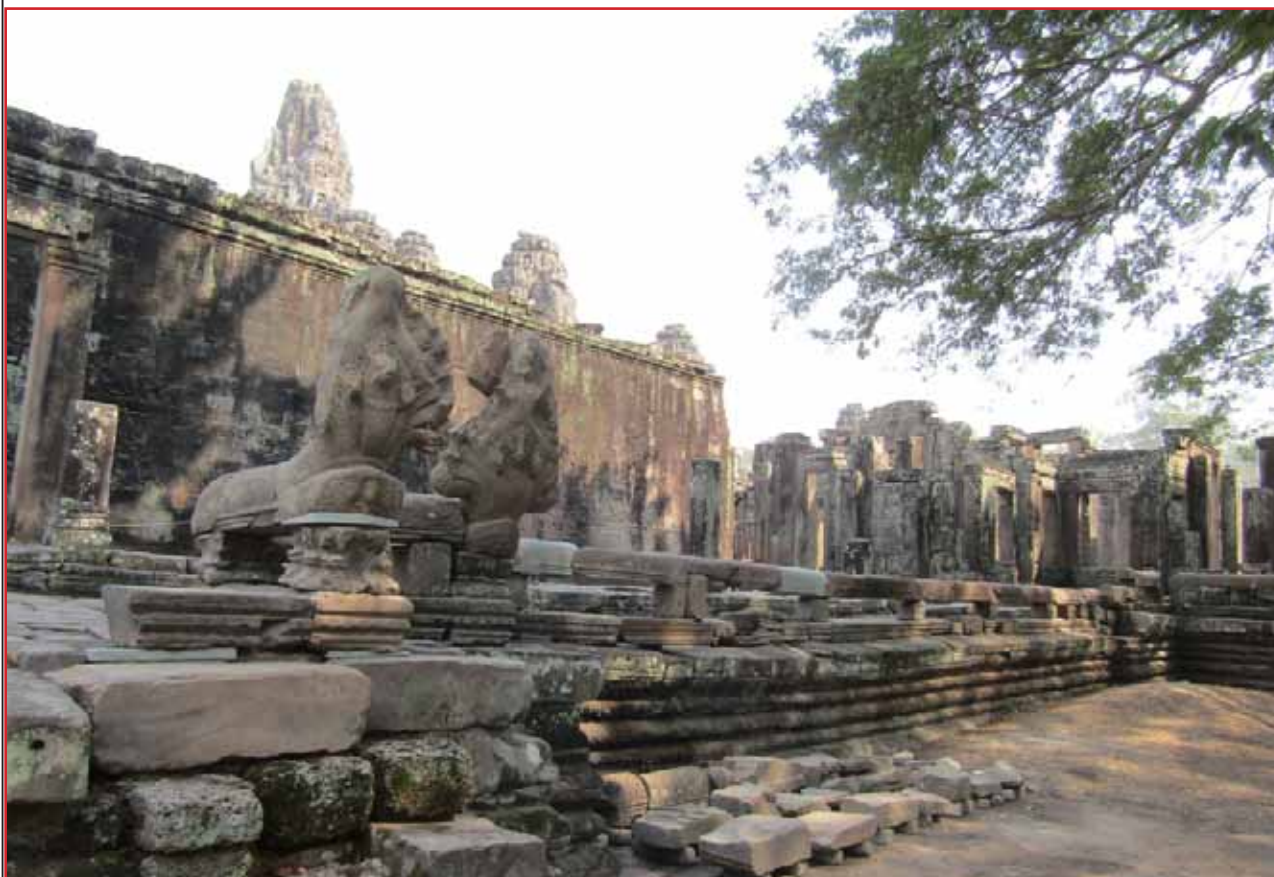
**After Restoration**

Typically, the Naga head (No. C6.2.13) and body (64.2.8.1.7(2)), which had been identified prior to clearance and had fallen by the staircase, were found to be in situ at the balustrade corner directly above it, and were joined and reinstalled.

- -Since C6.2.20 excavated from the ground was part of 64.2.8.1.7, it was possible to join these pieces and recover the complete form of the original Handrail. Similarly, 64.2.8.14 + 64.2.8.1.13 and T64.2.8.1.8 + 64.2.8.1.5 were also confirmed to be one piece of the elements found in the ground.

- -Since the location of the balustrade handrails was identified and the size of the missing handrails could be accurately determined, new sandstone material was inserted here to compensate for the missing handrails in two places.

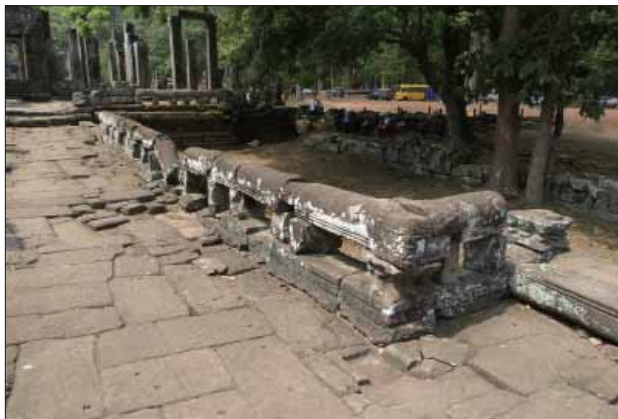
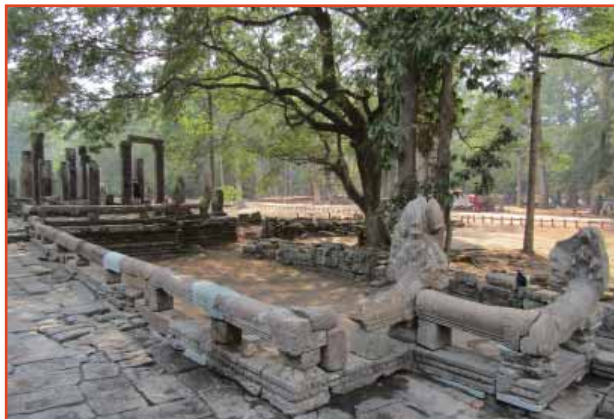
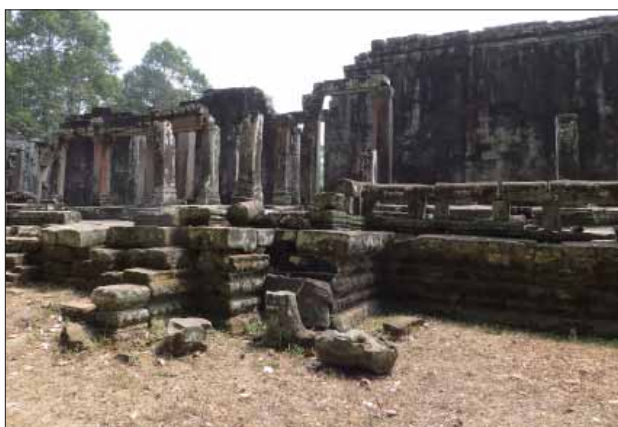
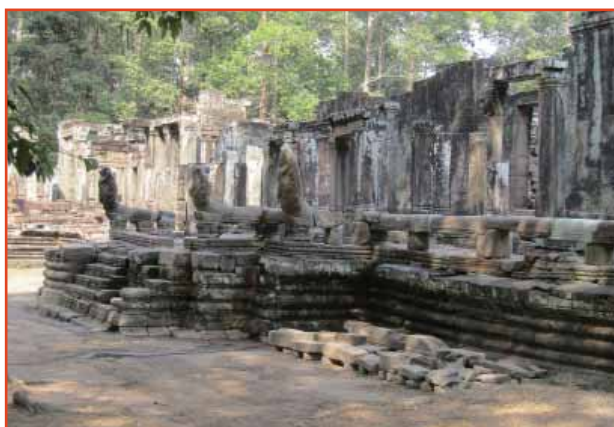
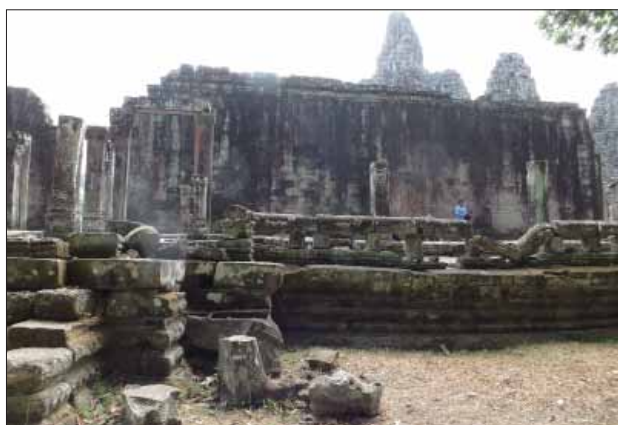
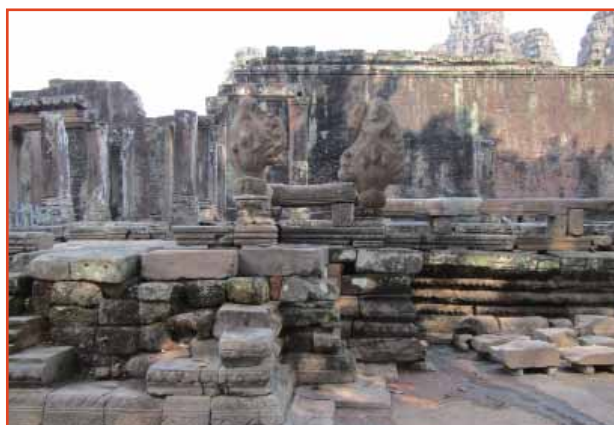
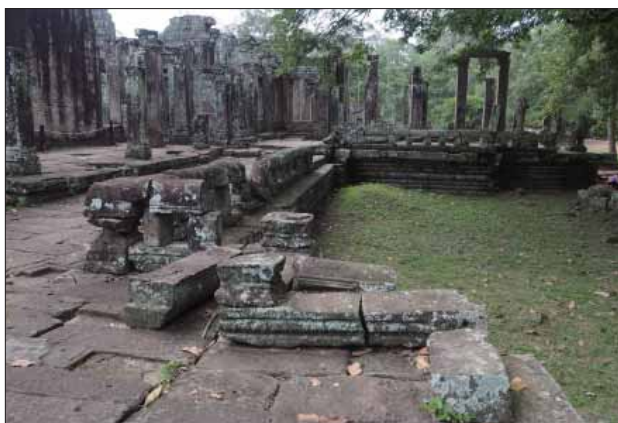
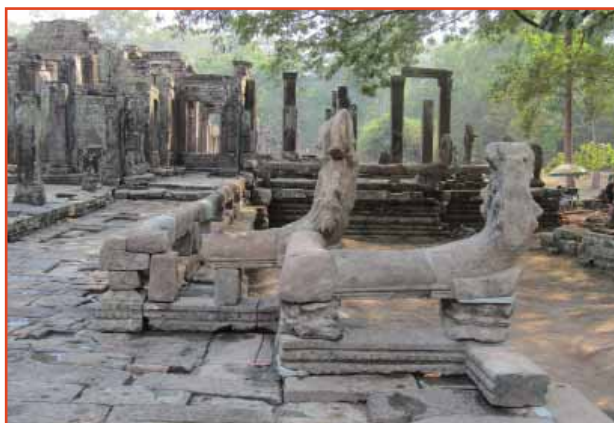
Area : T64.2 work period : 12 weeks

- -Initially, both C6.2.13 and C6.2.14, which had fallen just below the platform, were considered to belong to T64.2, but after identification research, it was found that 63.4.8.1.3, which was installed at T63.4, belonged to T64.2. Accordingly, C6.2.14 and its debris elements are now installed in T63.4.

- -No. C6.2.20 was connected to 64.2.8.1.7(2) in the previous restoration, and it was confirmed that it originally formed a single piece with 64.2.8.1.13 and 64.2.8.1.14. Following this single timber, 64.1.8.1.8, C6.1.52, and 64.2.8.5(2) were found to be in their original positions.
