# ***APPENDIX I***

## ***Restoration activities for each area***

*Report on the Conservation and Restoration work of  
LION and NAGA Balustrades at the Causeway and Outer  
Gallery of BAYON  
Angkor, UNESCO World Heritage Site.*

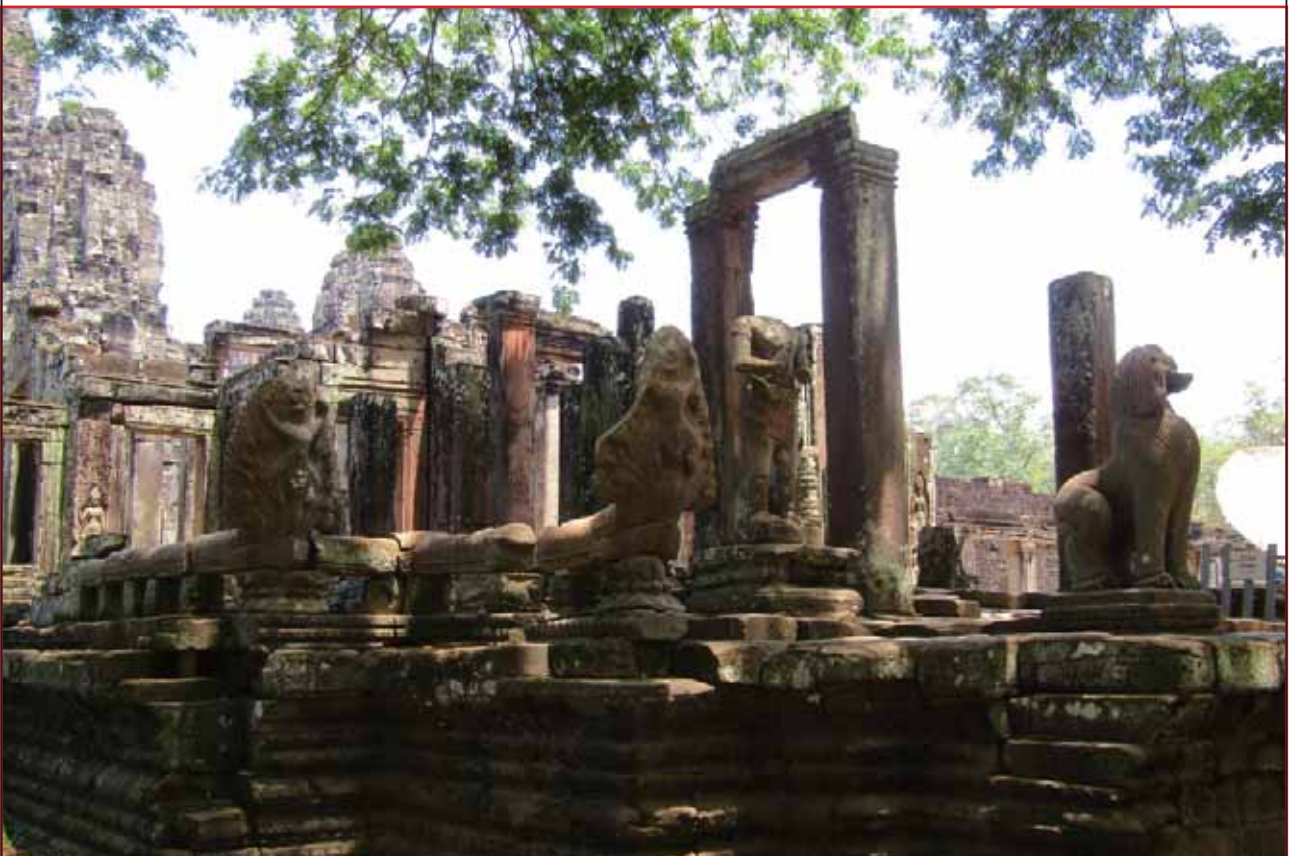
Area : T63.4 work period : 4 weeks

For T63.4, for which restoration was once completed in April 2018, there had been several elements that had not been found in their original location and had been re-installed in positions in accordance with the previous restoration, but as a result of the sediment clearance around T64 (see 5.3) and identification work, these were instead found in their original location. As a result, this area was also able to be fully aligned with the trestle following T64.1.

- Of the two Naga statues at T63.4, the southern Naga statue 63.4.8.1.3 was known not to be from T63.4, but as the Naga statue (C6.2.14 and associated elements) excavated during clearance was found to be from 63.4, it was decided to install this at T63.4. Accordingly, Naga 63.4.8.1.3.2, which had been installed at T63.4, was to be moved to T64.2.
- The handrail 65.4.8.1\* from T65.4 was joined with C6.2.13 excavated from near T64 and its original location was found to be the Naga head C6.2.14 matching element mentioned above, so this element was also moved from 65.4.
- It was observed that 6.2.8.1.4, installed at T64.2, joined 63.4.8.1.4 and 63.2.8.1.10 to form a single handrail element.
- It was confirmed that girders 62.8.1.9 and 62.8.1.11, also located at T64.2, were joined to elements at 63.4 to form a single handrail element.

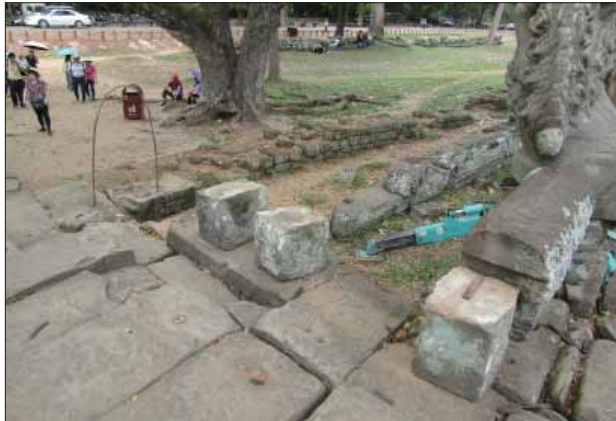
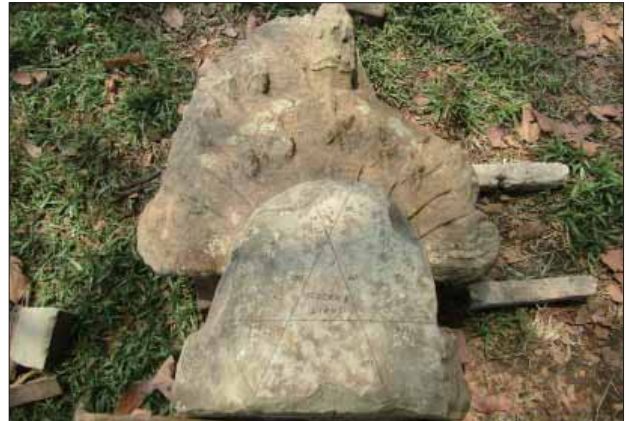
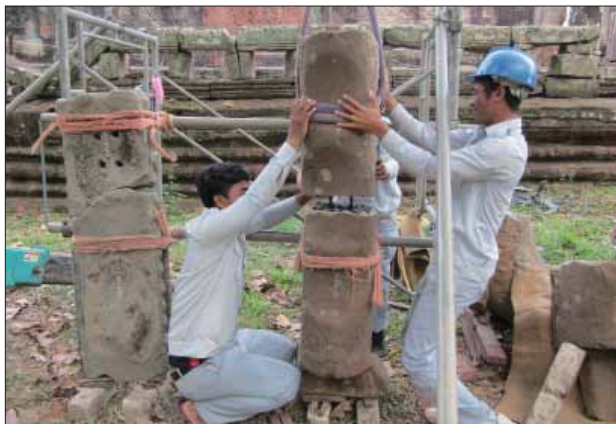
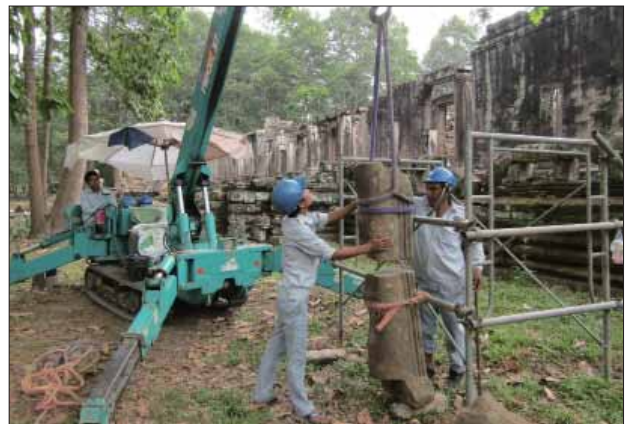
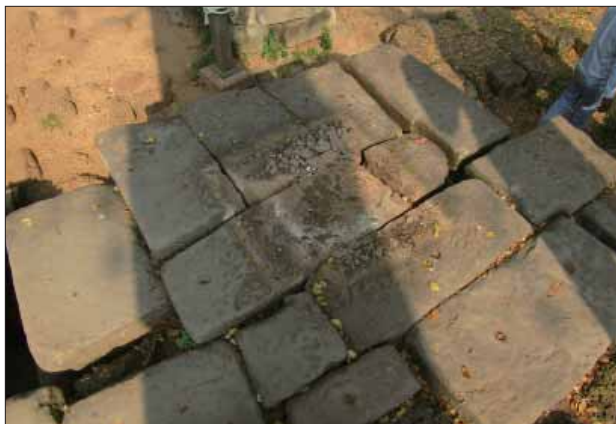
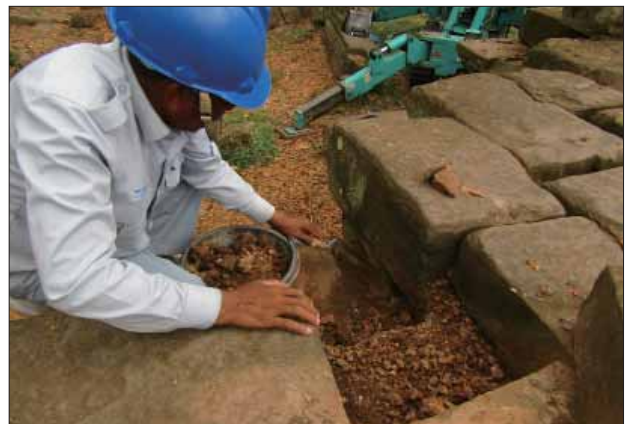
Area : T63.4 work period : 4 weeks

<Photos during restoration>

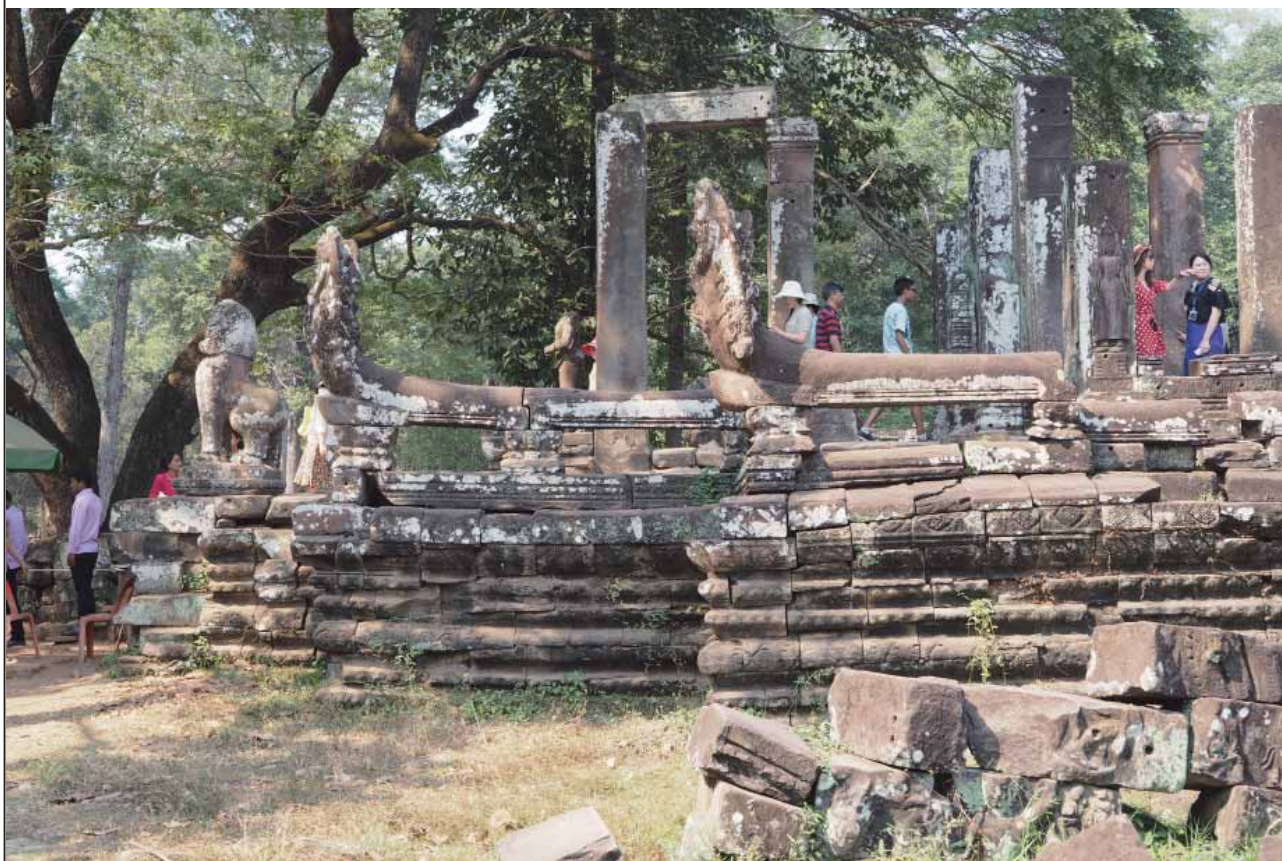
Before Restoration

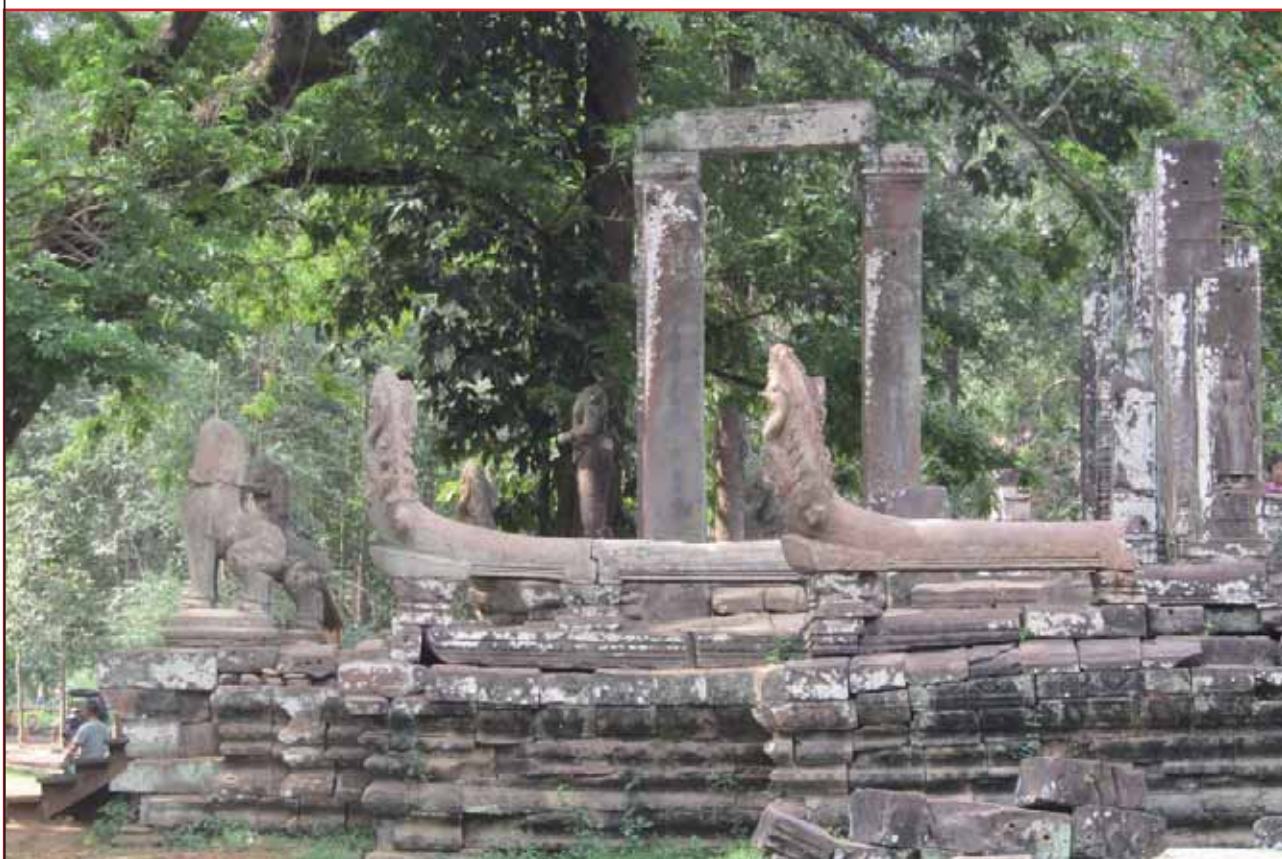
After Restoration

The Lion and Naga statues were not initially planned to be dismantled, but during the process of dismantling the balustrade elements, it was confirmed that these statues were also in a serious condition, so it was decided to carry out dismantling and repairs. The treatment of the statues is as follows.

Lion statue (No. 63.3.9.1.1): many cracks were found on all four legs, which were already nearly broken and threatened to collapse. Therefore, the statue was partially dismantled, the body and pedestal sections, which were on the verge of breaking, were separated, reinforced and then joined together.

Naga statue (No. 63.3.8.1.1): a fragment of this Naga statue could be found in the scattered stone material on the west side of T63.3, so it was joined to the Naga statue. In addition, the previous restoration work carried out on the base of the head of the statue was not in good condition, so it was removed and rejoined.

Naga statue (No. 63.3.8.1.5): the cracks were reinforced by injections.

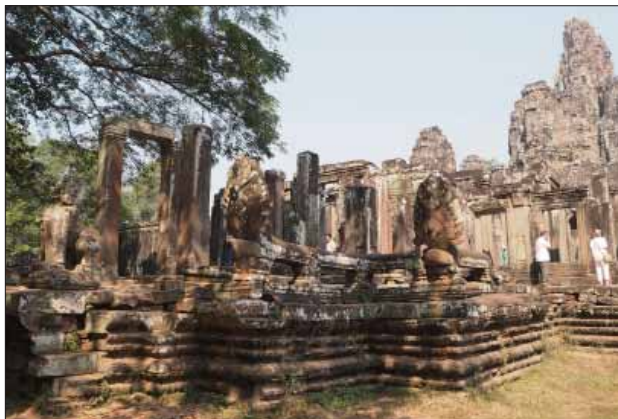
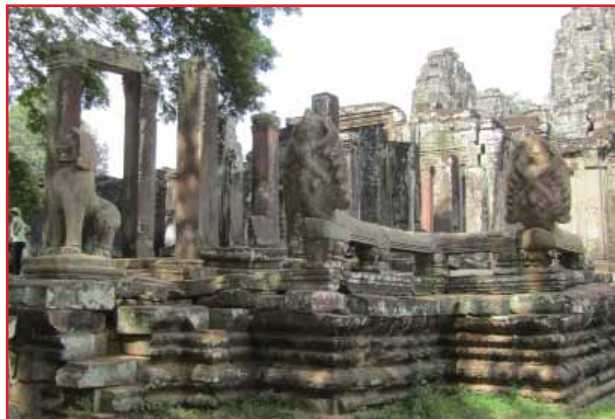
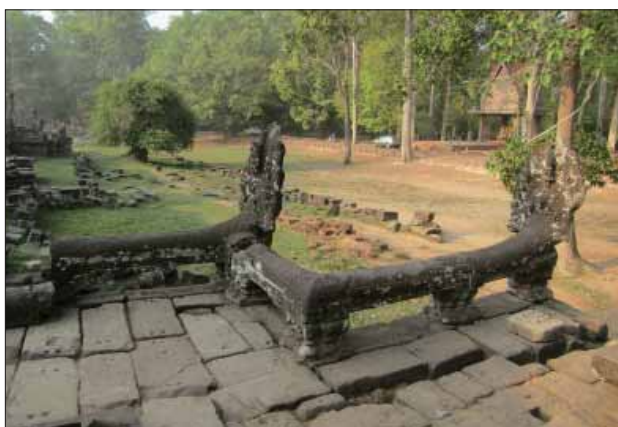
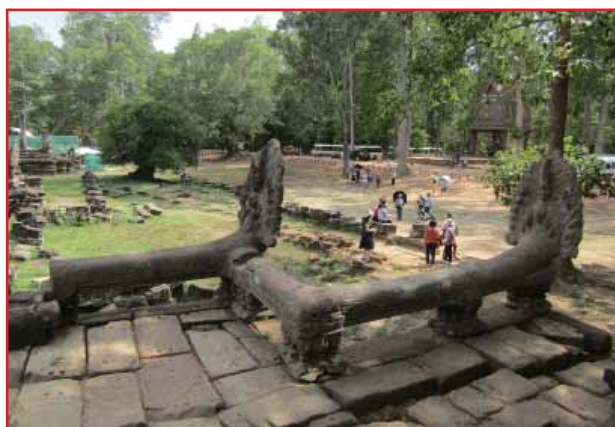
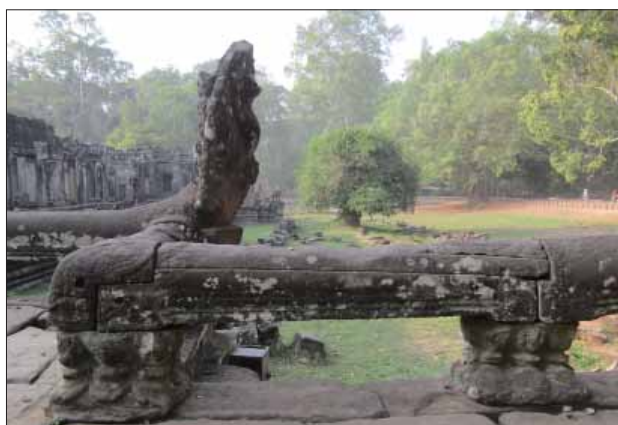
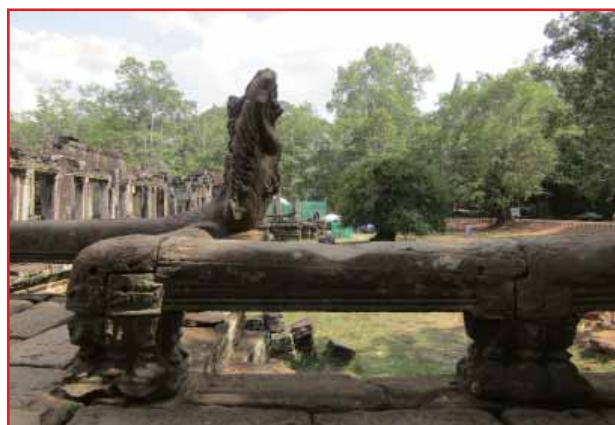
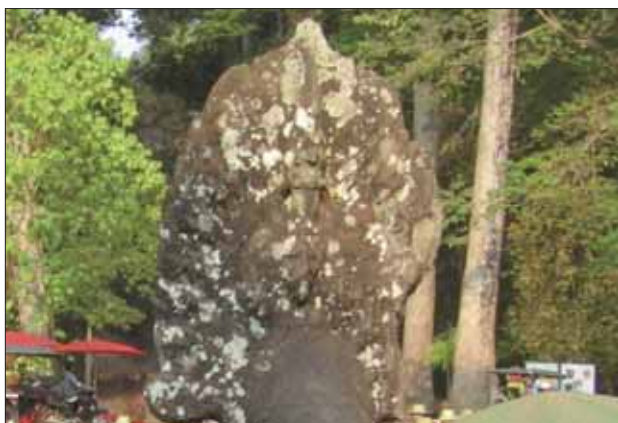
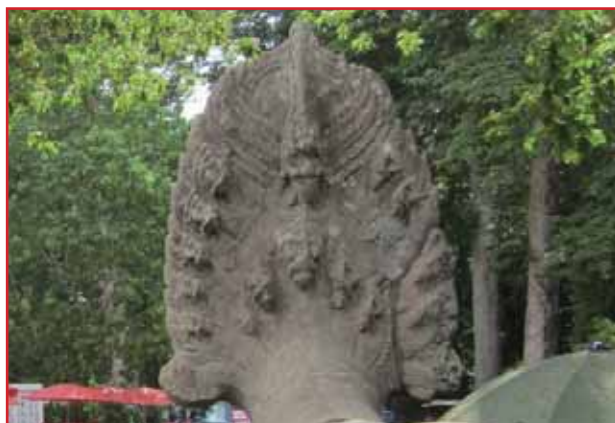
Area : T63.3 work period : 4 weeks

<Before and after restoration>

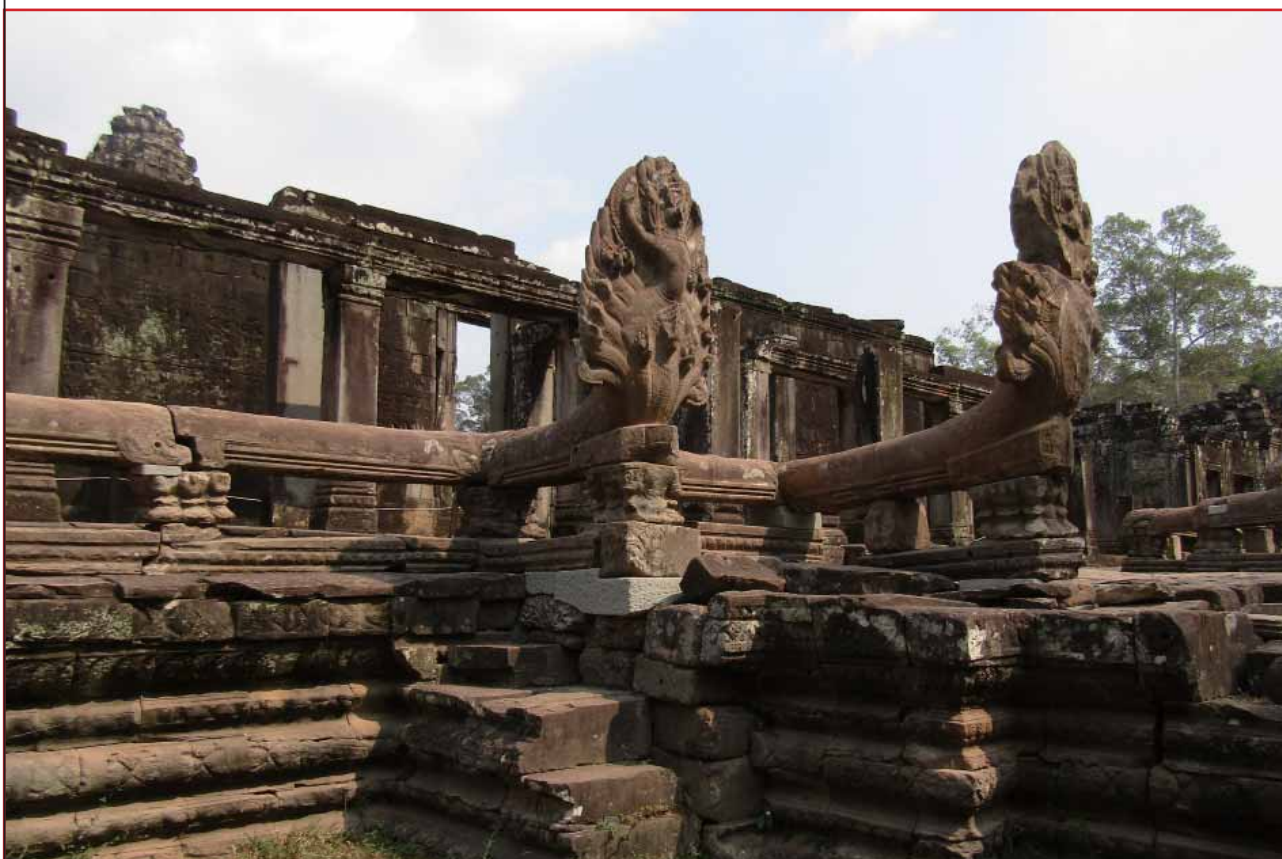
After Restoration

For the northern Naga statue, due to the improvement work in order to reduce large gap between floor of the platform under the northern balustrade of this Naga statue, we could bring these balustrades near to wall of the outer gallery. Thus Naga statue no more needs concrete support inserted at previous restoration. Also for the southern Naga statue, before restoration, upper half was broken and already lost. Though after survey by workers, they could found that one scatter stone lying in front of T63.2 would be connected with this Naga statue. Some of the elements of platform around these 2 Naga statue were already lost and distortion could be seen at this area, new sandstone plate were needed when reconstruct Naga statues.

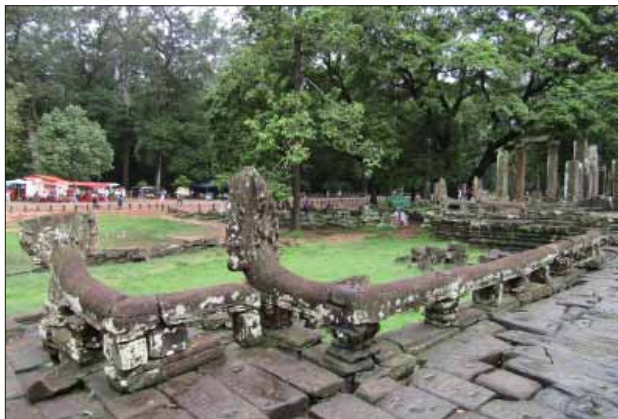
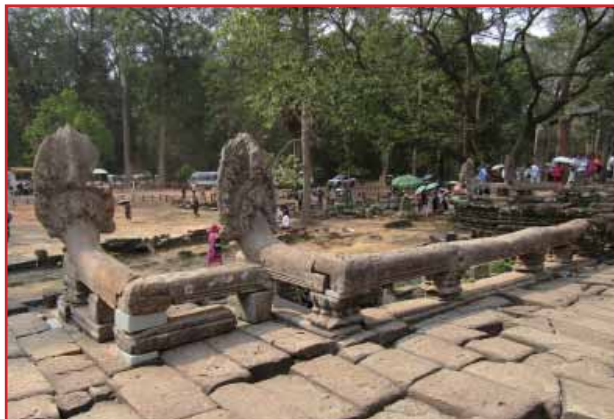
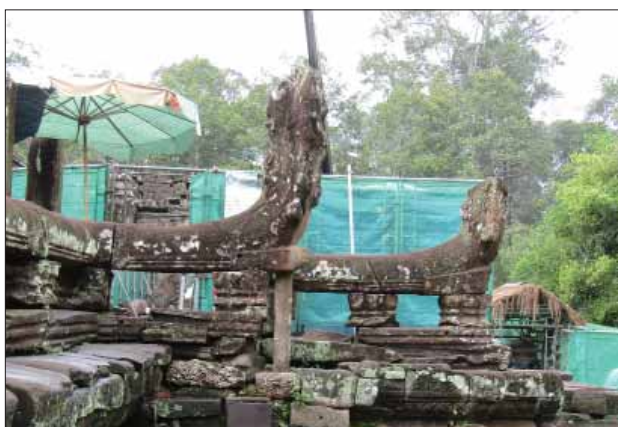
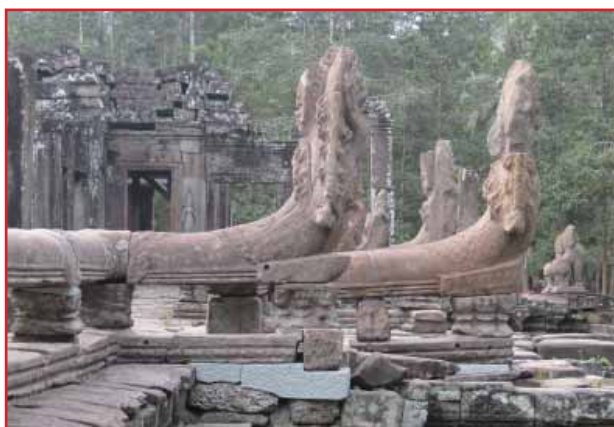
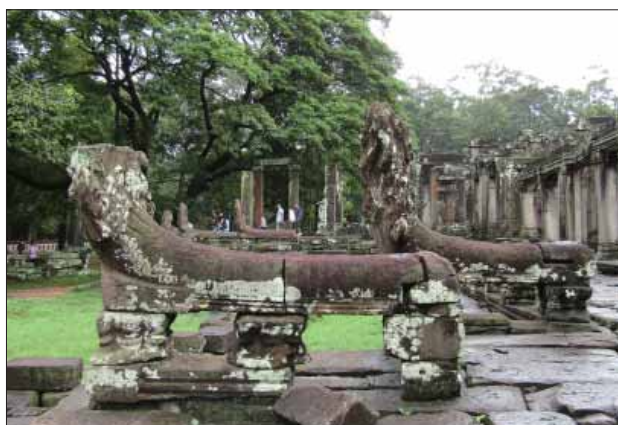
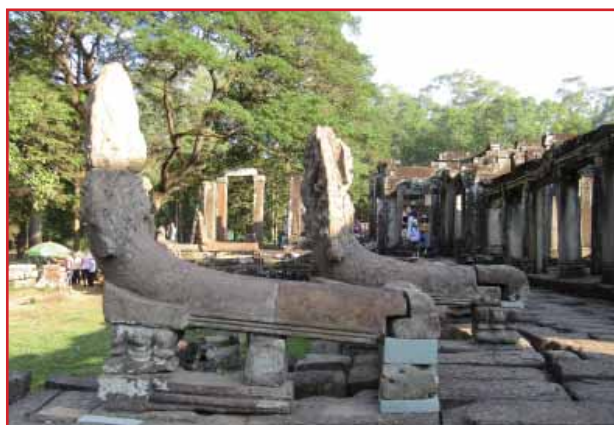
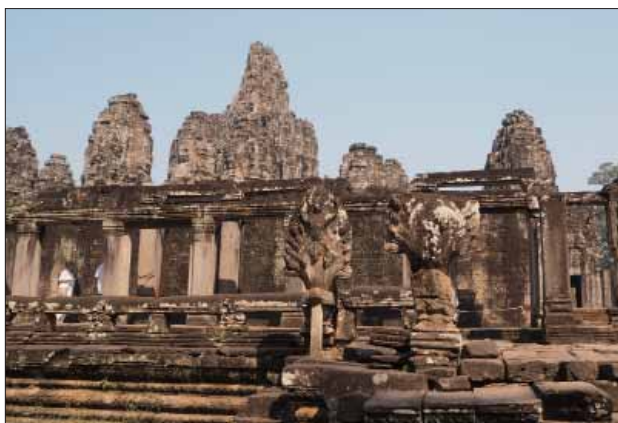
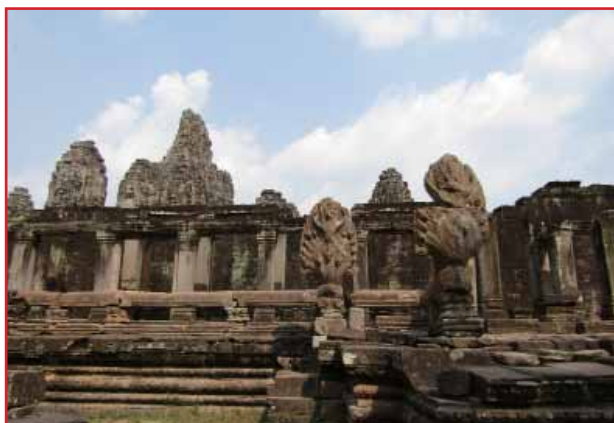
Area : T62.1 work period : 14 weeks

-The body of the Naga balustrade on the south side(C.8.4.1 and 62.1.8.1.8.2) was broken into 2 pieces. There were no connecting treatment at previous restoration, and supported by only substitute post.

<Before and after restoration>

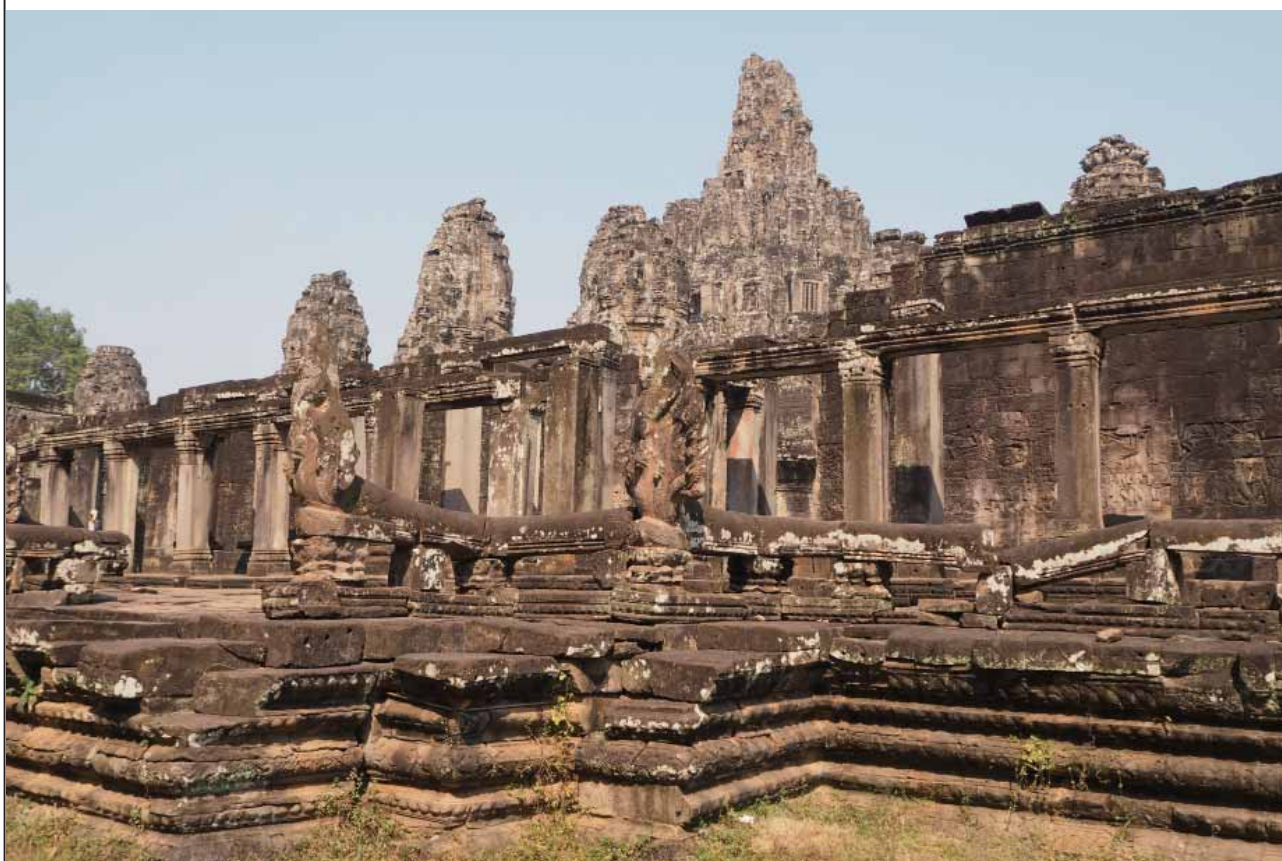
Before Restoration

There are 2 Naga statue at T62.2, though both of Naga head are not in original position. The body of northern Naga(62.2.8.1.3) was broken in 2 pieces which was not restored and only supported by substitute post. Also we confirmed heavy depression under the balustrade, thus we insert many sandstone plate under the basement for adjustment the height. Also, we changed position of basement, post and substitute post in order to make most stable situation.

For the basements, some elements that had broken into several pieces were jointed and repaired. For the Handrails, it was observed that the positions of 62.2.8.1.1 and 62.2.8.1.3 on the Naga head were interchanged, so these locations were replaced. Due to the large distortion of the platform near the commandment, it was necessary to insert many sandstone plates during the installation of the basement.

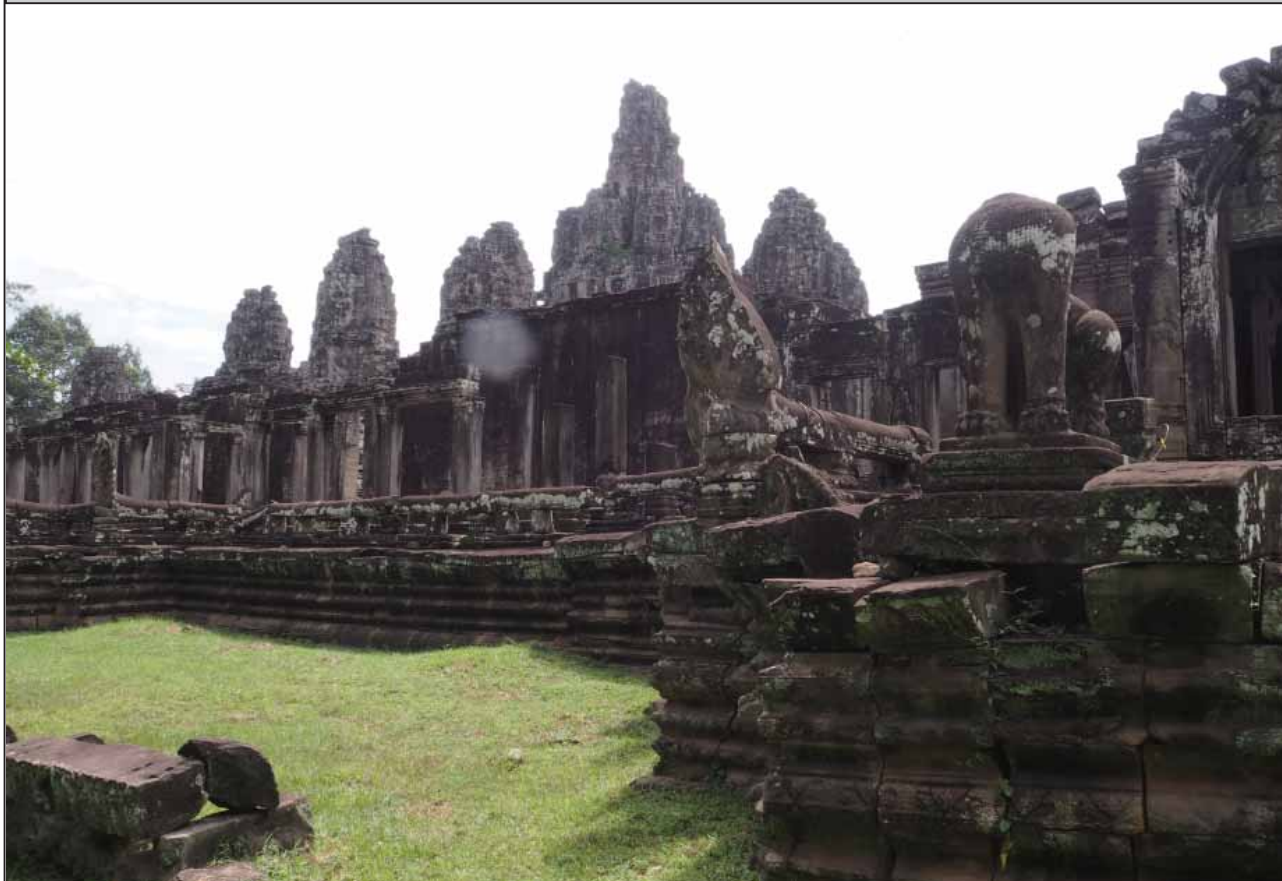
**Before Restoration**

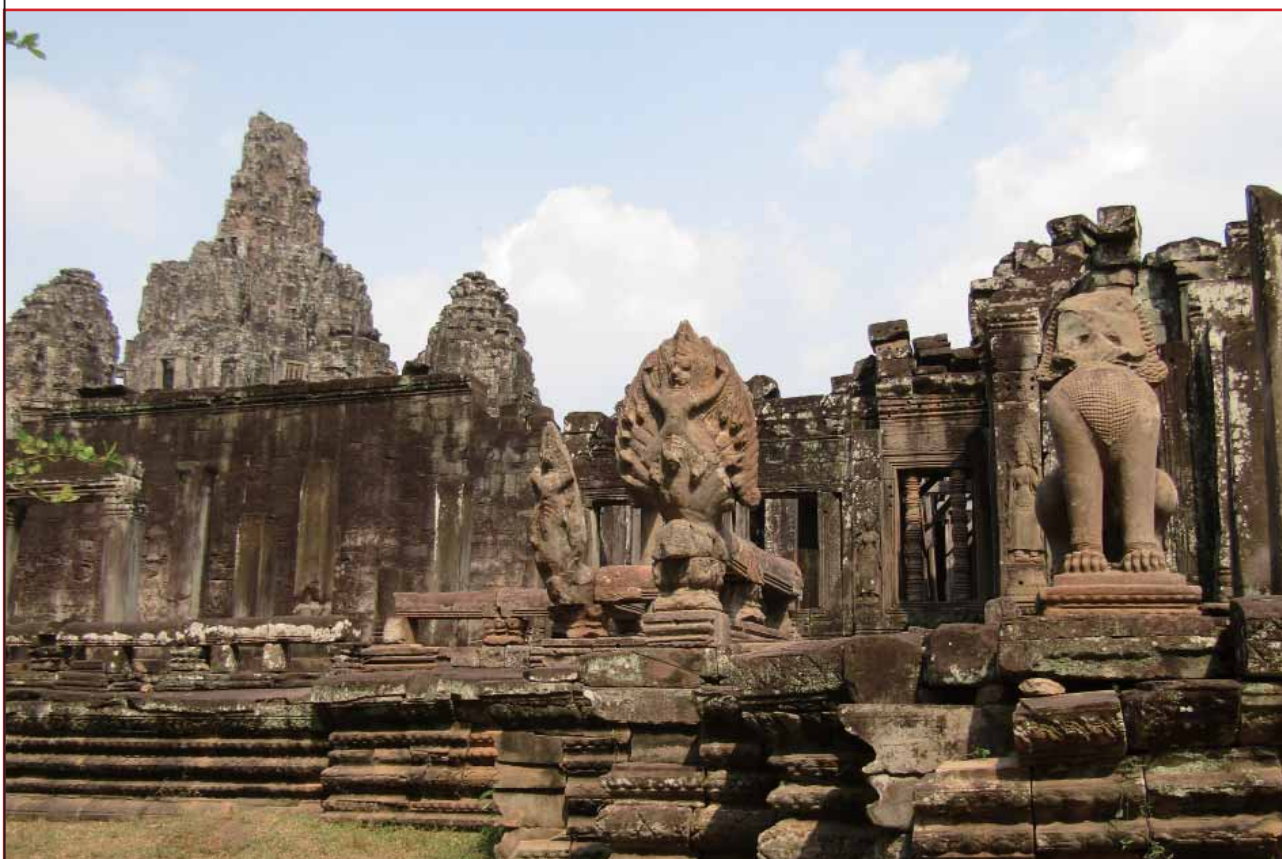
**After Restoration**

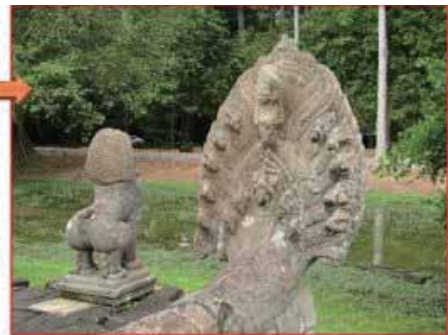
Before restoration

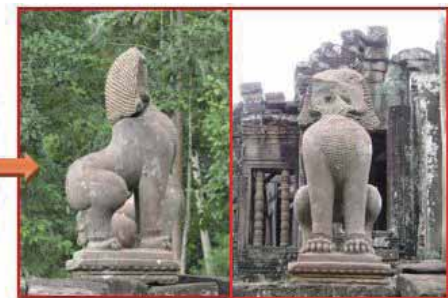
Before restoration

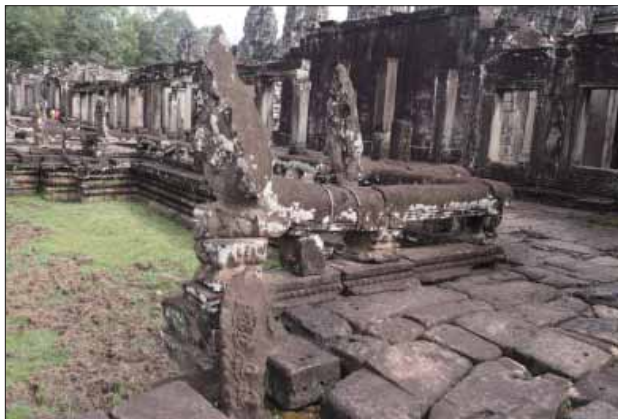
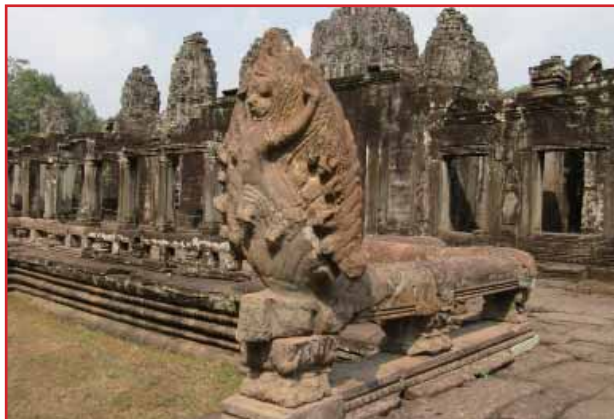
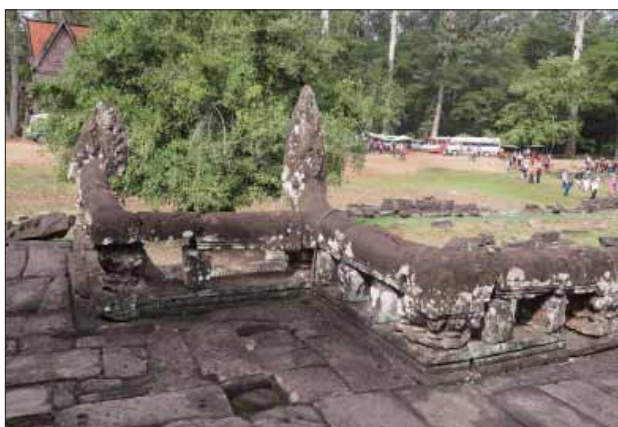
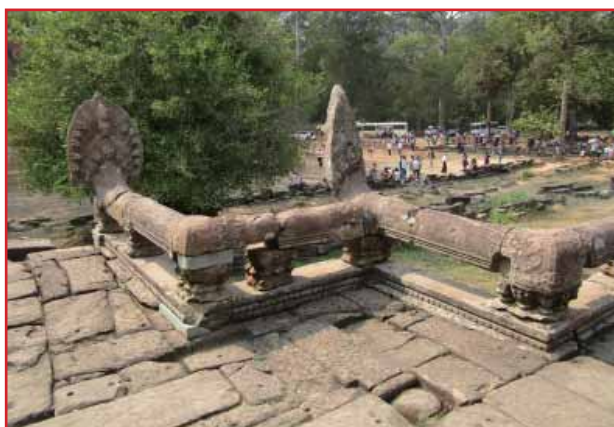
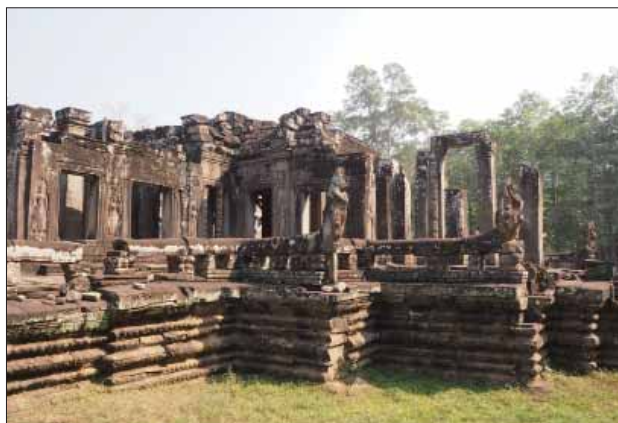
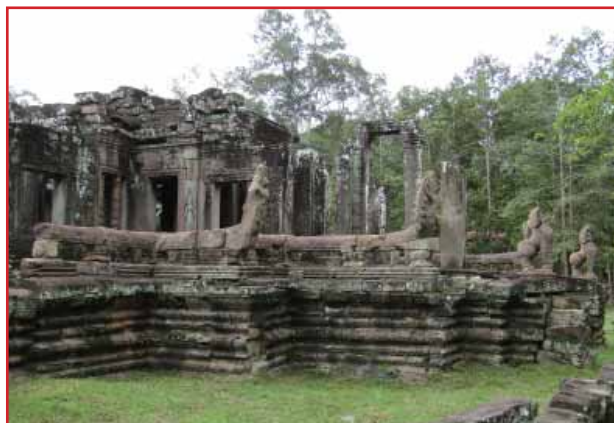
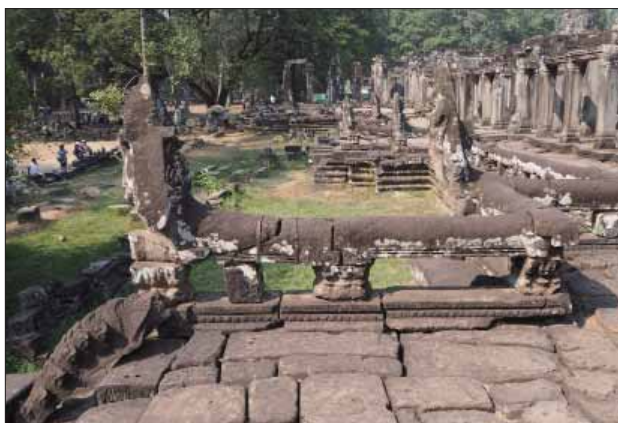
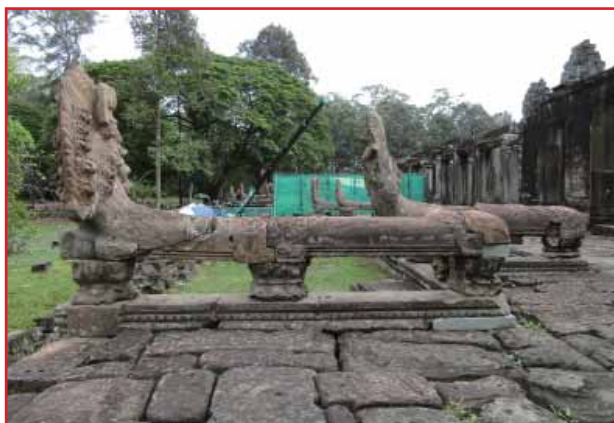
<Before and after restoration>

-Among two naga which existed in this area, the head of southwestern Naga statue(61.4.8.1.8) was broken into two parts, and broken half has fallen into the platform. In addition, the balustrade part was broken on some small pieces and tied up by restoration in the past, but this iron belts were about almost came out, and there was the risk that the whole Naga statue collapsed. After restoration, these pieces of the head and trunk was connected, and it was stable and came to be able to stand without any support.

In this area, 1 Lion statue was restored (61.4.9.1.1). The head of this Lion statue was broken and fell down on the ground near the platform. In the rain season, this head part was soaked in the water and caused further deterioration. By the restoration work, this head part could be connected to the body.

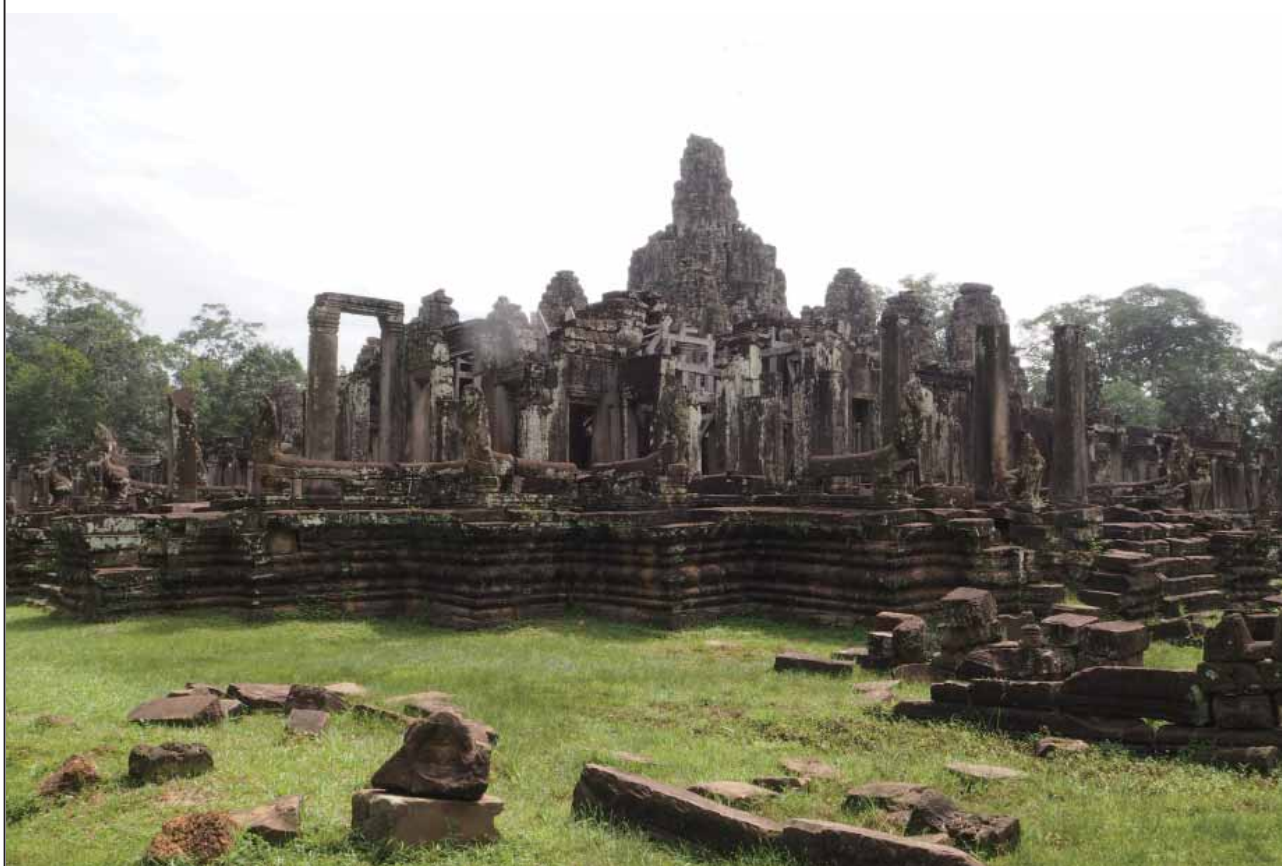
**Before Restoration**

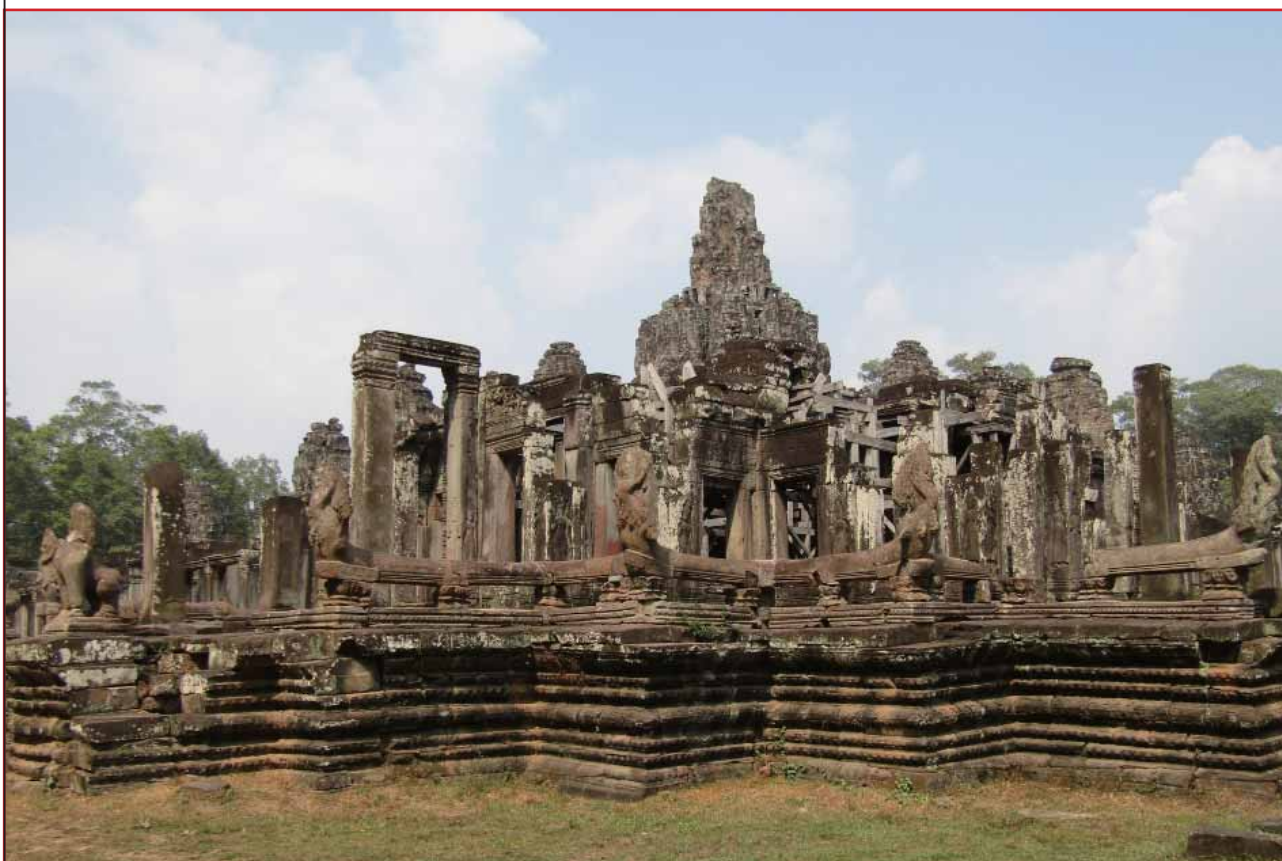
**After Restoration**

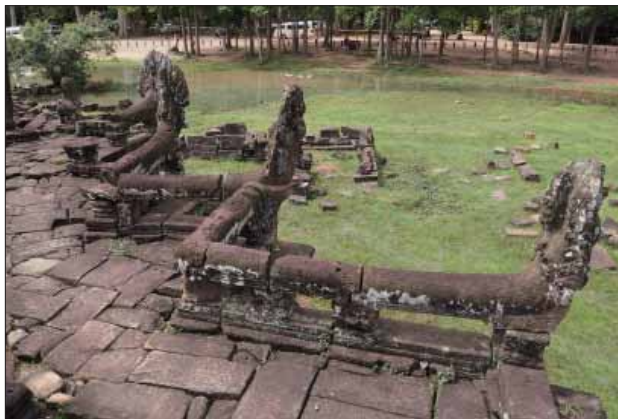
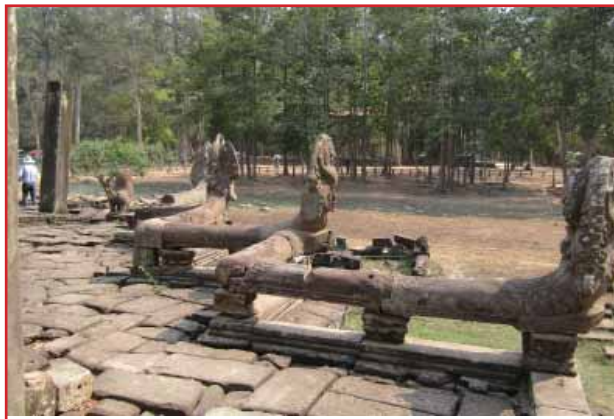
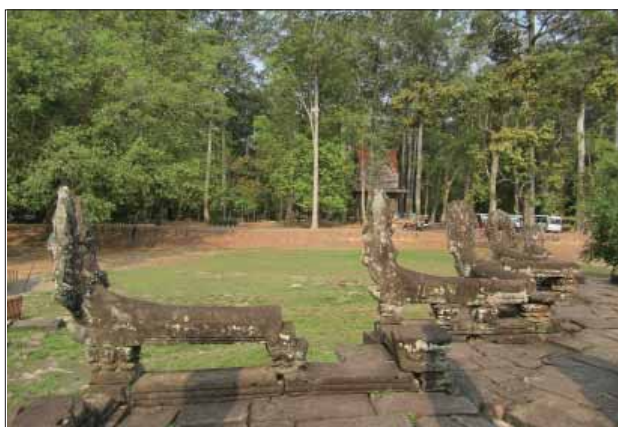
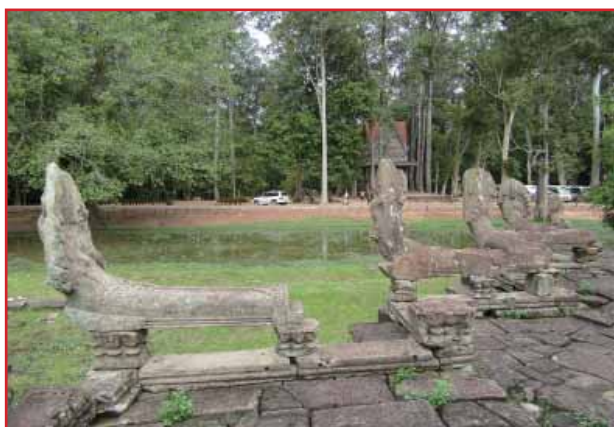
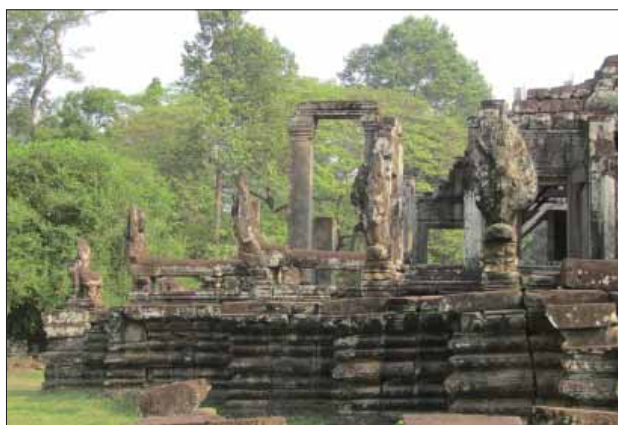
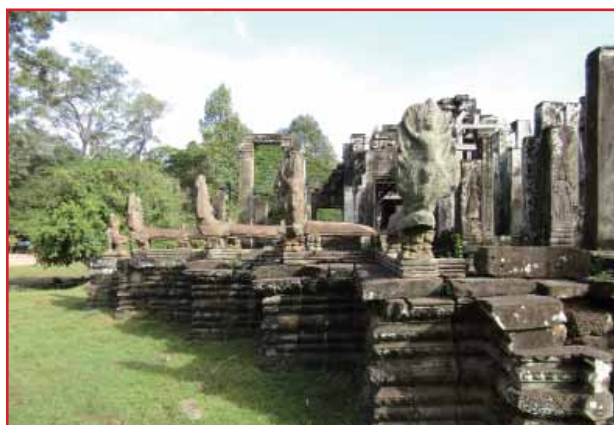
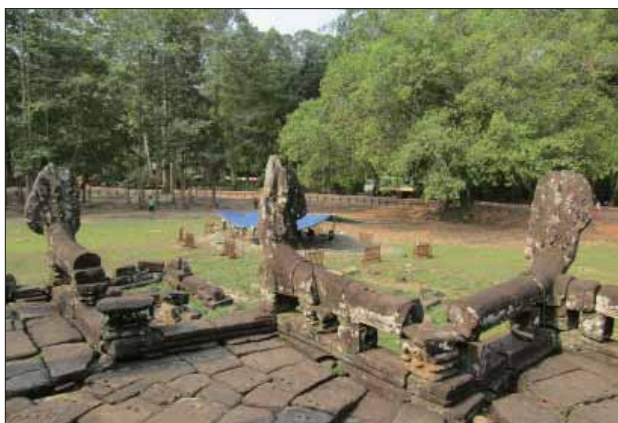
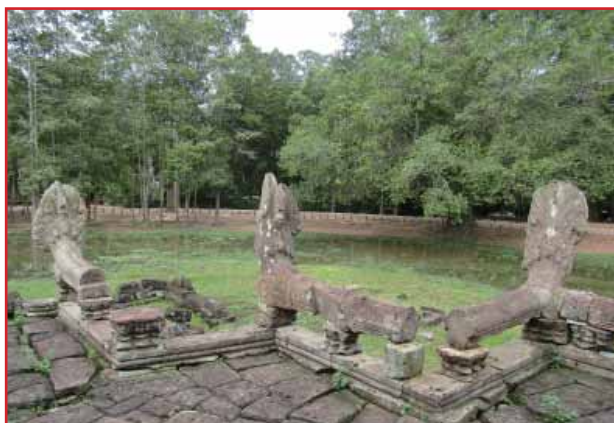
Area : T61.3 work period : 13 weeks

In this area, 2 Lion statue was restored (61.3.9.1.1 & 61.3.9.1.2). 61.3.9.1.1, the statue part and the pedestal part were completely broken at the ankle of the statue and had been joined by previous restoration, but the mortar used here had deteriorated and was in danger of breaking again, so they were rejoined using stainless steel pins. The pedestal was also ruptured and was repaired. 61.3.9.1.2 was injected for reinforcement.

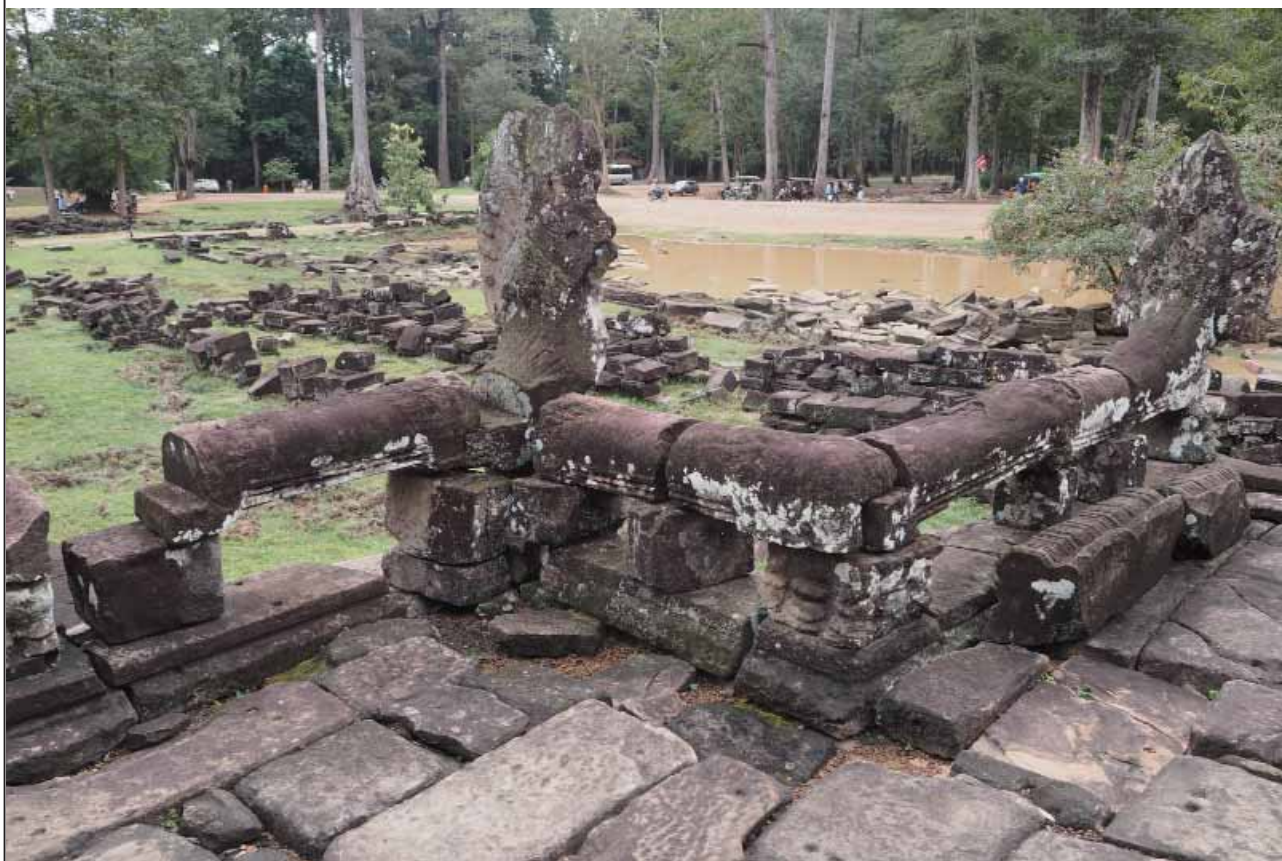
Area : T61.2 work period :9 weeks

In this area, platform situation was not so bad, though most of the balustrade elements were not in the original position, thus these could only be installed in an unstable form, and cement and iron pin were used to fix these part in the previous restoration which was already deteriorated. Thus we decide to dismantle all of the balustrade and reconstruct at same situation as before. Though when we reconstructing these balustradem we insert new sandstone plate and lead plate instead of previous cement.
