# ***APPENDIX I***

## ***Restoration activities for each area***

*Report on the Conservation and Restoration work of  
LION and NAGA Balustrades at the Causeway and Outer  
Gallery of BAYON  
Angkor, UNESCO World Heritage Site.*

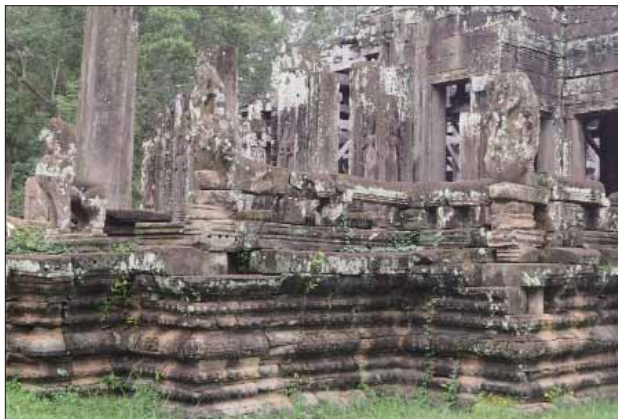
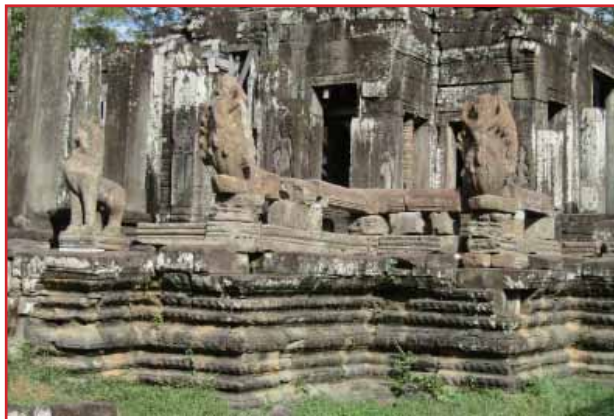
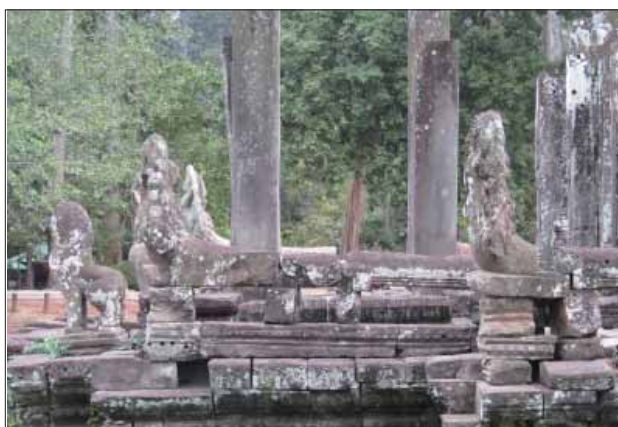
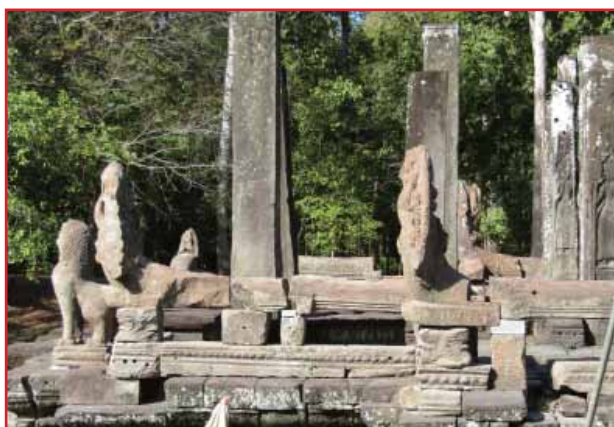
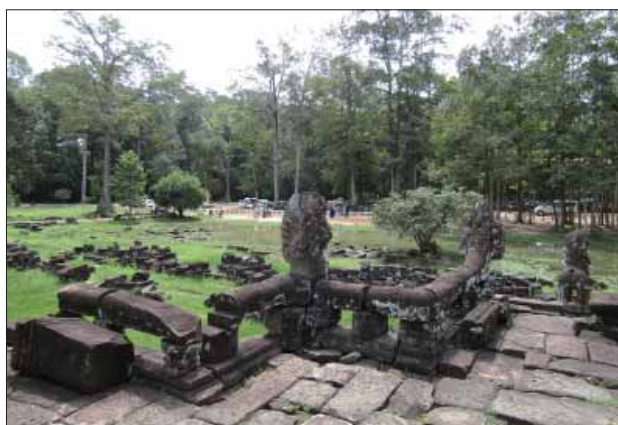
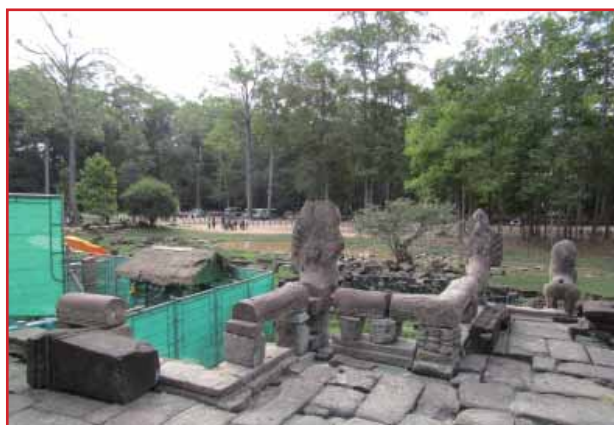
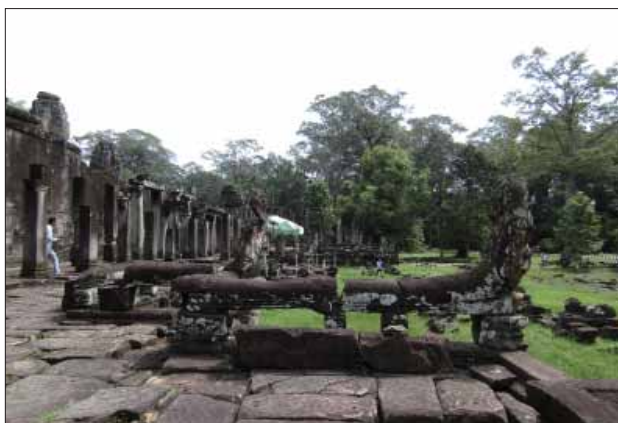
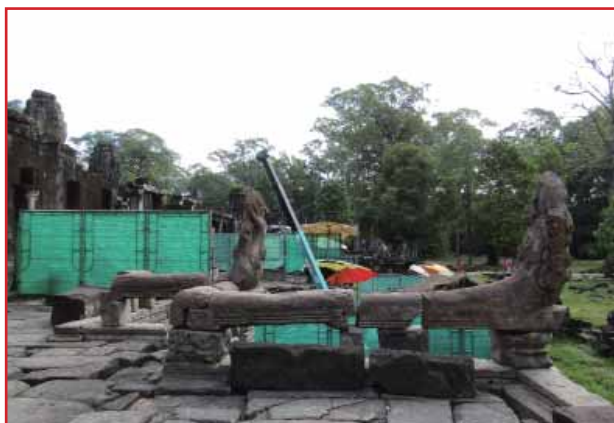
Area : T61.2 work period :9 weeks

In this area, 1 Lion statue was restored(61.2.8.1.1).The base of the pedestal was completely cracked, which could lead to further collapse of the entire statue, so it was fixed by grazing.

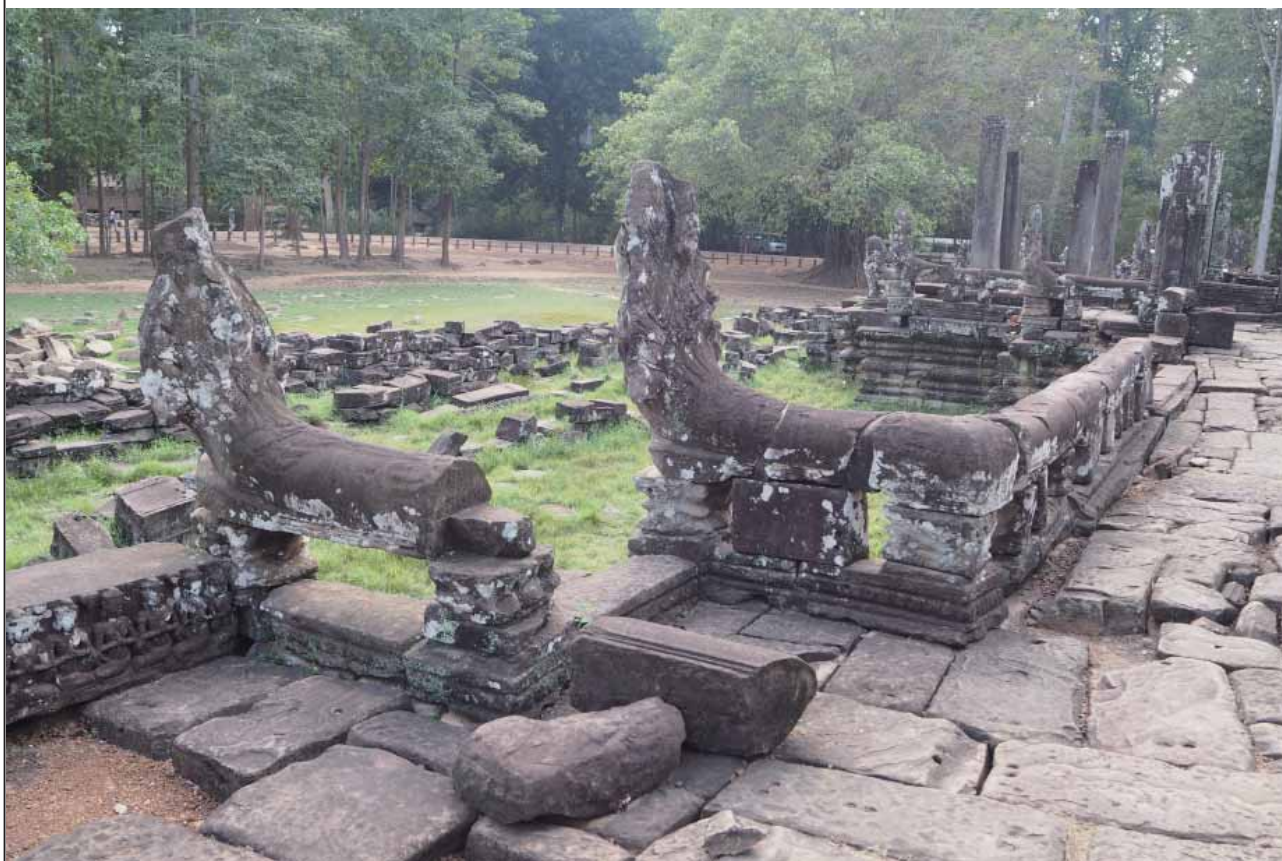
**Before Restoration**

For T60.1, the situation before restoration was very complicated, as most of the element of balustrade were moved wrong pieces were connected or lined in not original position by previous restoration. As a result of our survey, we found many pieces that can be connect as an original element, and could identify original position so that can be back to safely. Also, due to uneven subsidence, floor of the platform directly under the balustrade was subsided, thus we had to implement platform maintenance with supplying many new sandstone plate to these subsided line. The process of the work was done with supplying new sandstone plat and lead plate. One more problem at this area was some heavy rain instead of dry season. Due to rain, sometime it was difficult to set up Mini Crane.

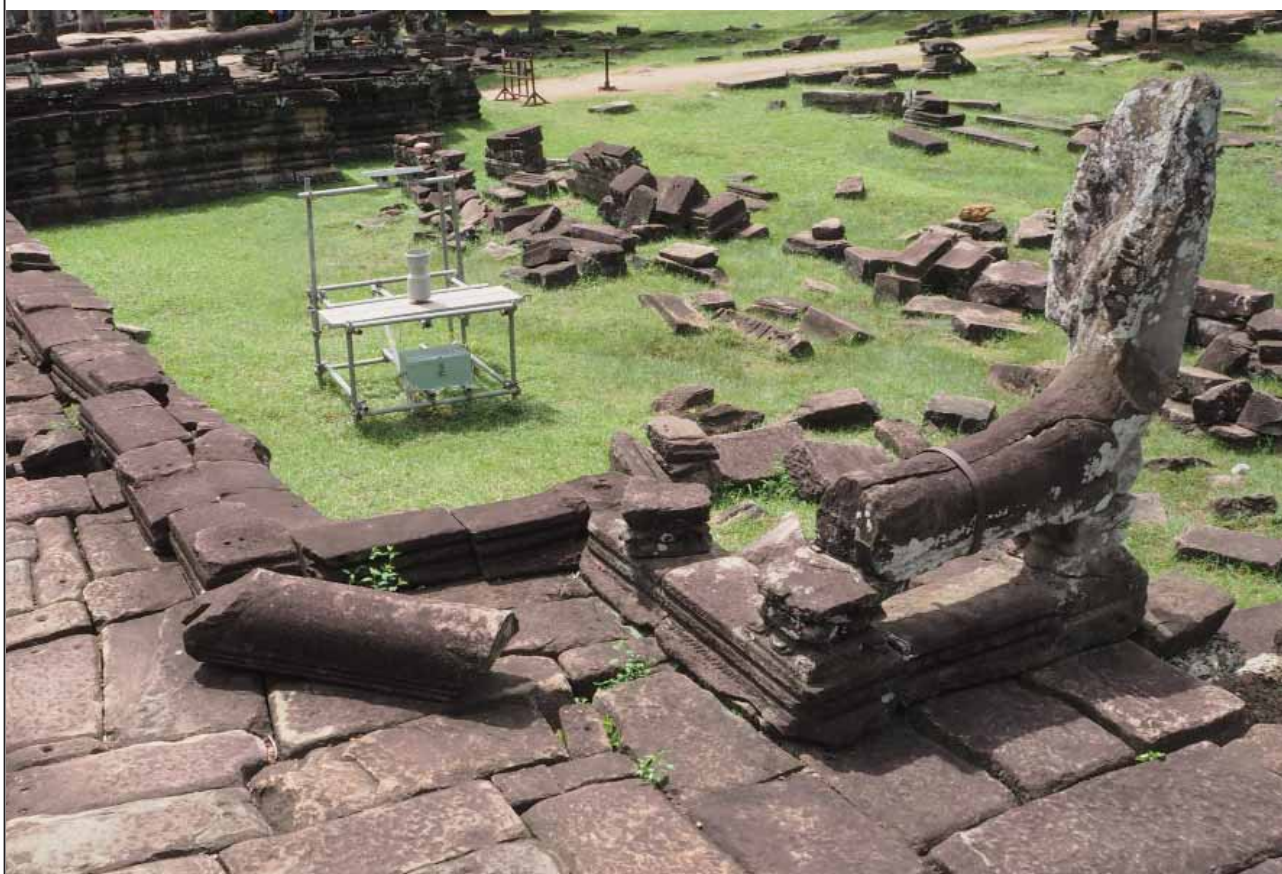
Before Restoration

Naga statue at this area was broken into some pieces and this part was combined with iron belt installed in precious restoration. Though iron belt was deteriorated and almost fell out. We dismantled and repaired elements of the balustrade including this Naga statue.

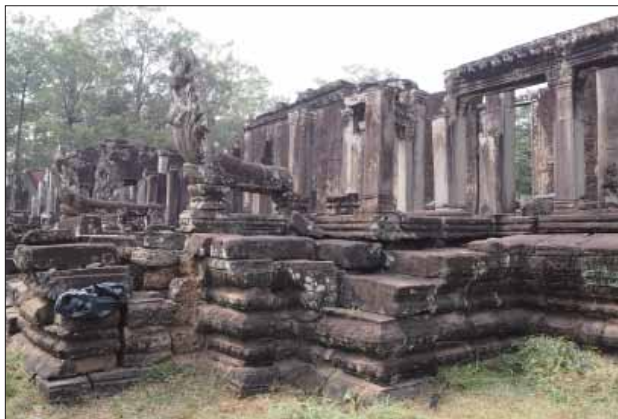
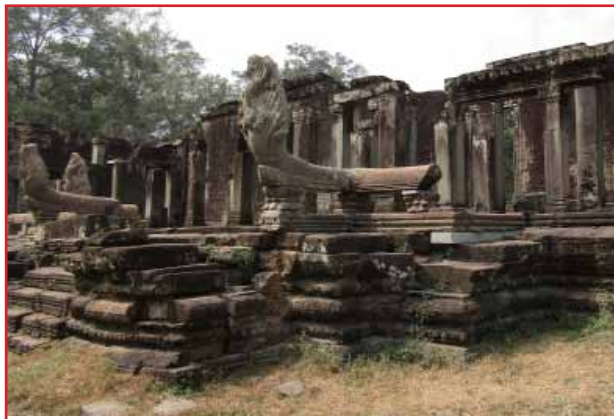
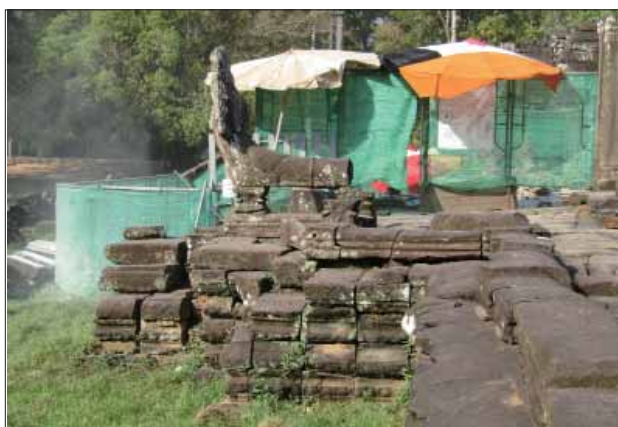
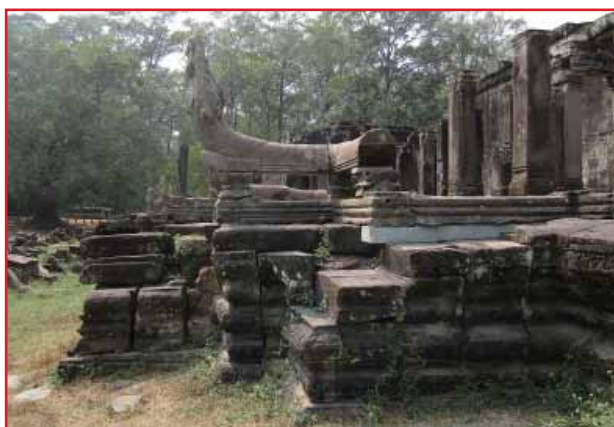
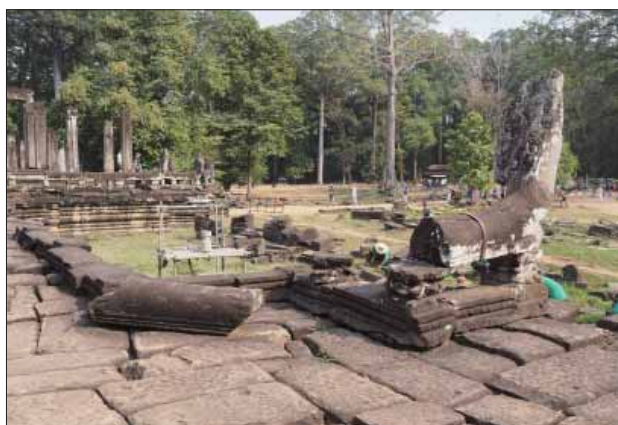
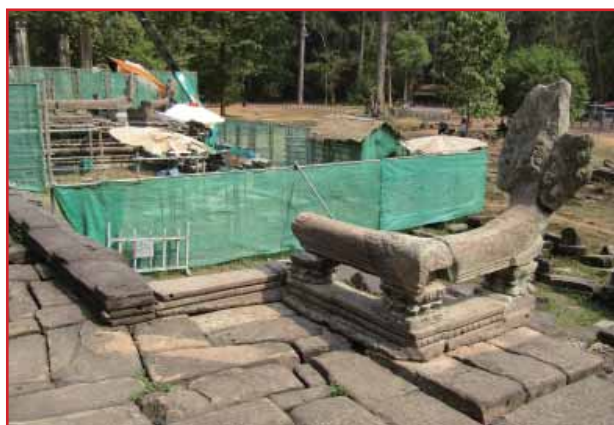
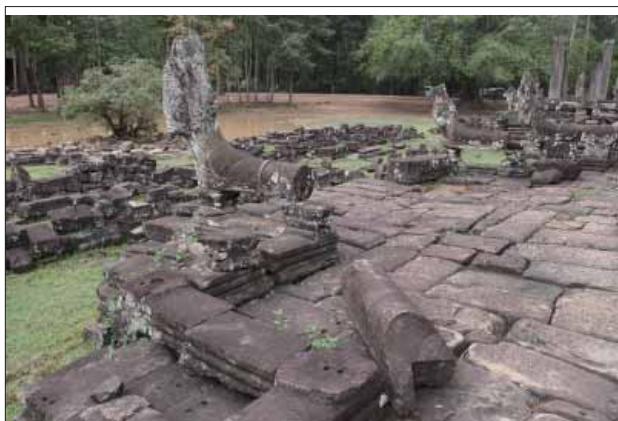
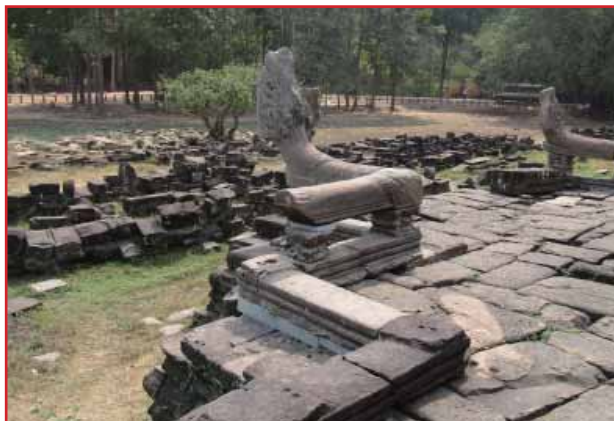
Area : T60.2 work period : 10 weeks

Although there was no change in the position of the handrails or the basements, sandstone plates were inserted to stabilize the basements. E11.2.3, a fragment of the naga head that had also fallen onto the platform, was repaired and installed after it was confirmed that it could be joined with 60.2.8.1.1.

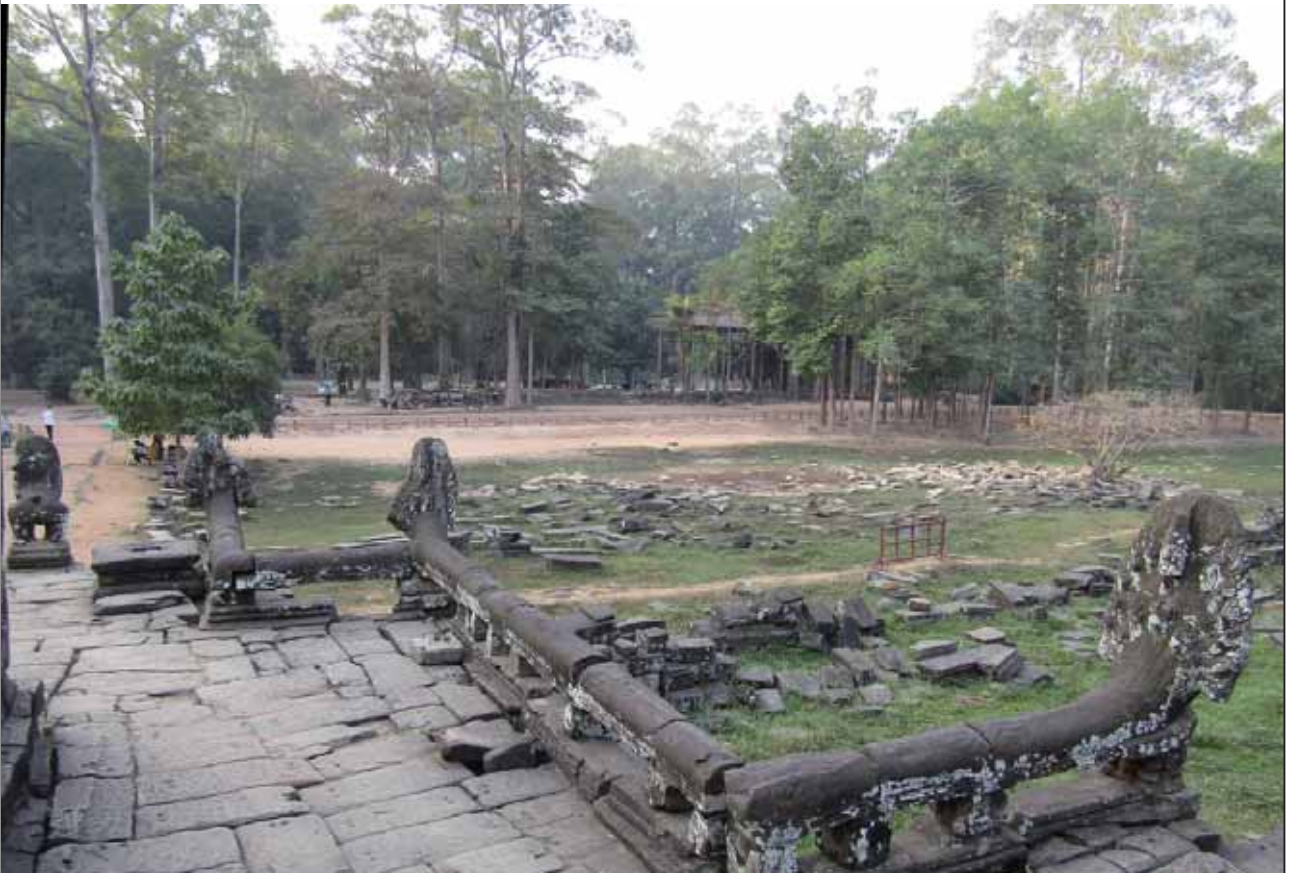
**Before Restoration**

**Balustrade:** For this area, some of the basements were missing and most elements were not situated in the original position and it changed place. Also, because of inclination of the platform to the outside, balustrade are also inclined to the outside and causing unsafety situation.

**Lion statue:** One lion statue stands on this area, though this statue had many scale and cracks, thus we decided to dismantle this statue and implement repairing.

After dismantling balustrade, One basement were broken and had scaled part. We found that this basement can be connected with other basement part in this area, also could found original position. Though before set back these repairing basement, this area need some improvement of platform.

There was only one original post in this area, and others were all substitute elements put at past restoration and is was put in unsafe balance which causing further danger of balustrade. Thus when reconstructing balustrade, we again reuse these substitute element, though carefully seek for safe and horizontal position.

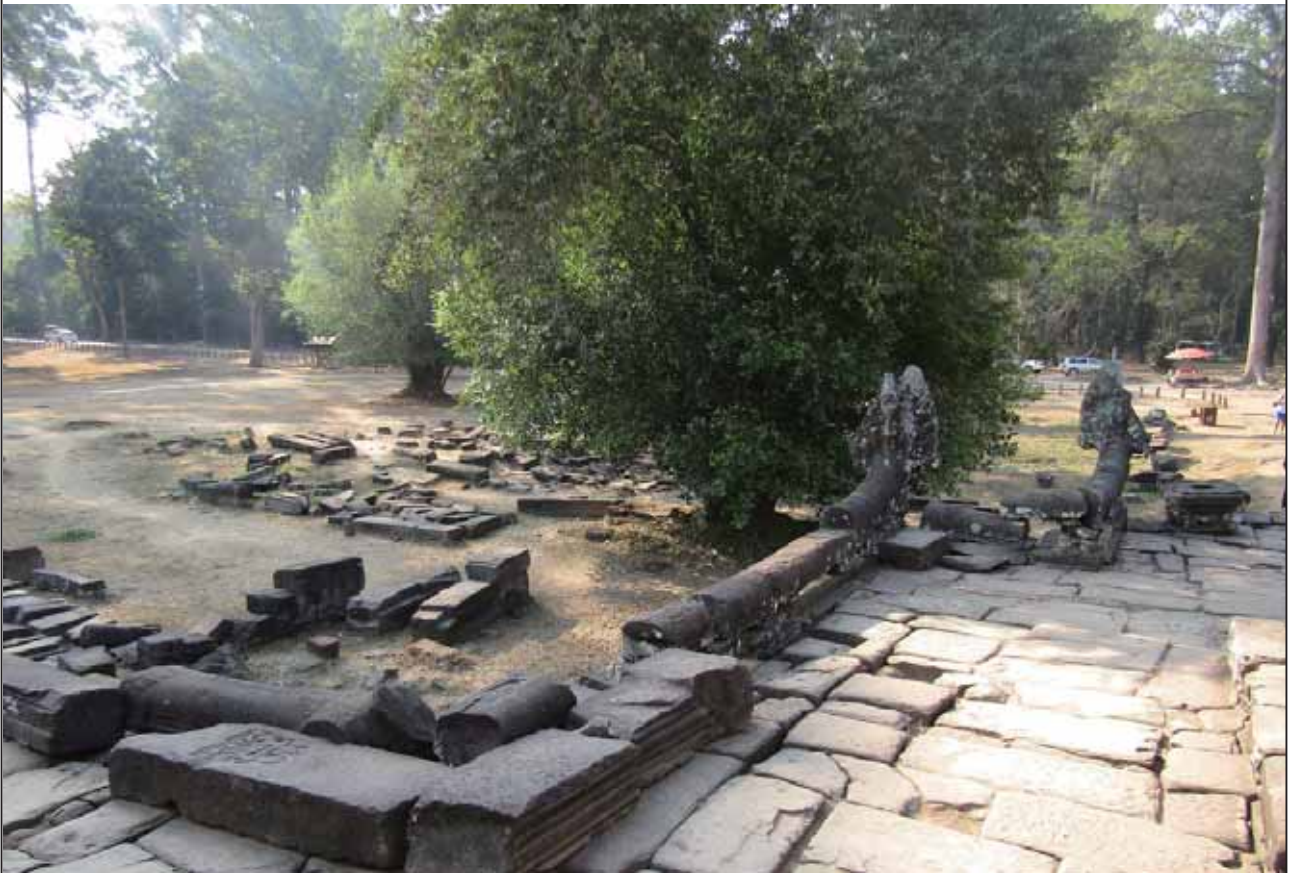
Before Restoration

Before the restoration, T59.2 had a very complicated situation because of the many changes of elements. Also, there were little different construction method for balustrade, that elements of platform were directly curved like basement, and used instead of basement. We tried to find the best position to make better platform in trial assembly work, and found some elements that can be back to original place and safe. There were two Naga statues in this area. For the southern Naga, half part of the head was broken and fall down to the ground, so we connected, also we found original connection with another element at the corner of this area, so we can make it safe situation and better landscape.

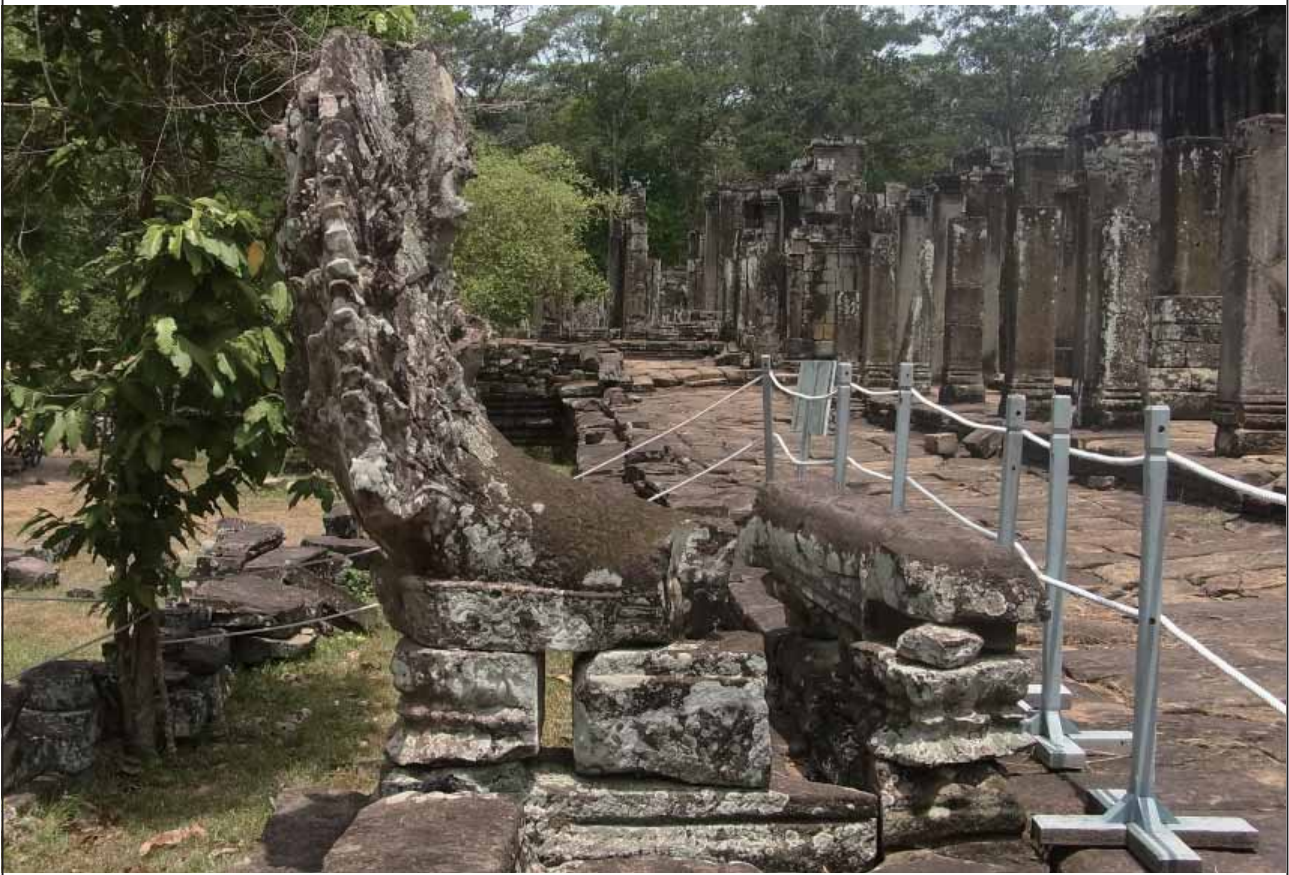
Before Restoration

When the third phase of JASA started in 2006, a ramp for bringing in and installing heavy equipment was installed on the south side of the outer gallery of the Bayon (Fig. 1). In the second half of February, the stones of these T58.1 blocks were moved to the restoration site and the stones were repaired, which took about two weeks. The balustrades were then reinstalled at the site where the base had already been maintained.

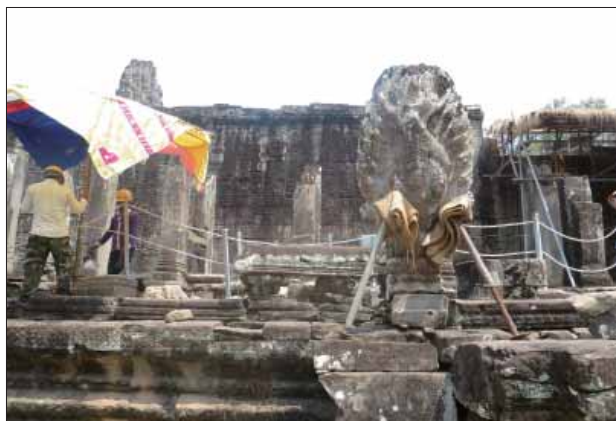
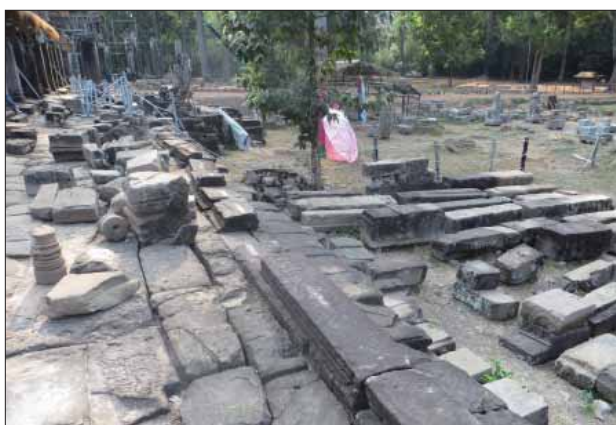
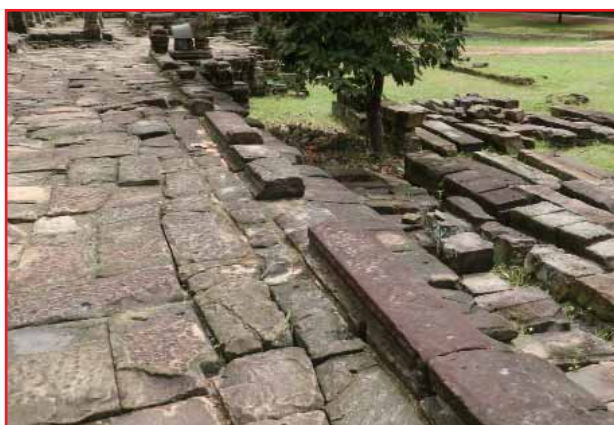
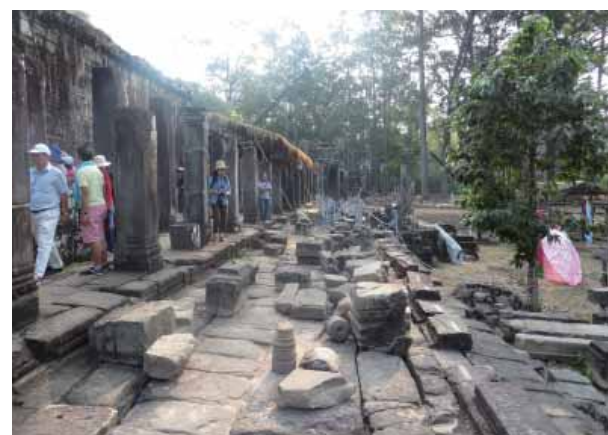
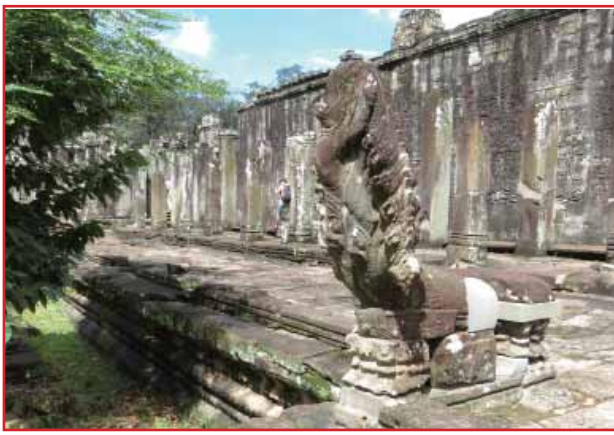
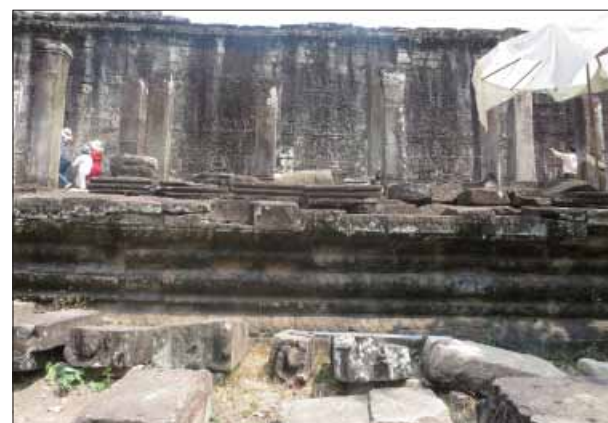
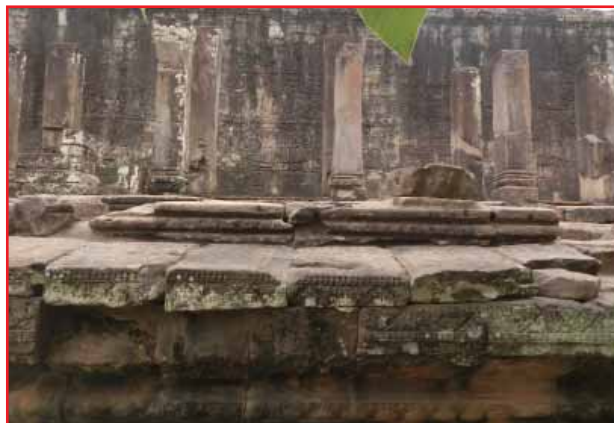
Area : T58.1 / West    Operated Term : 2 month

<Before and after restoration>

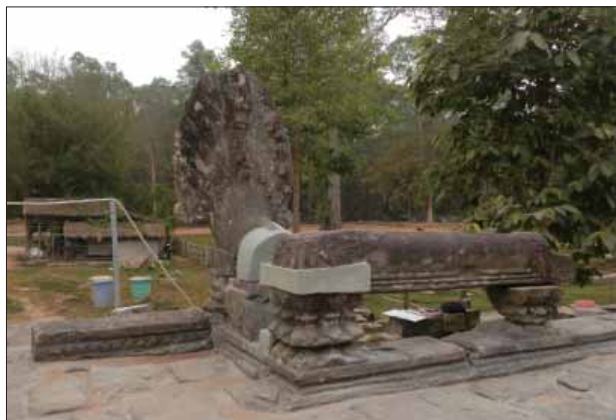
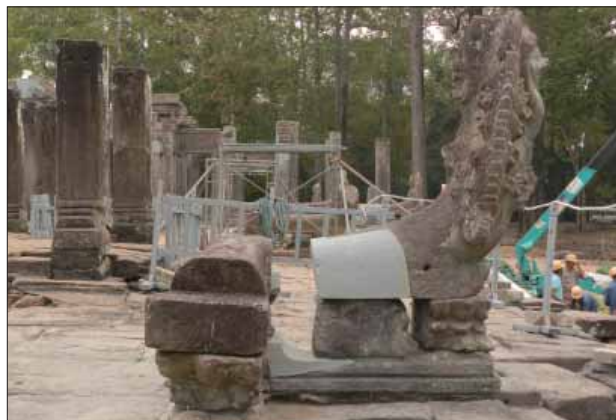
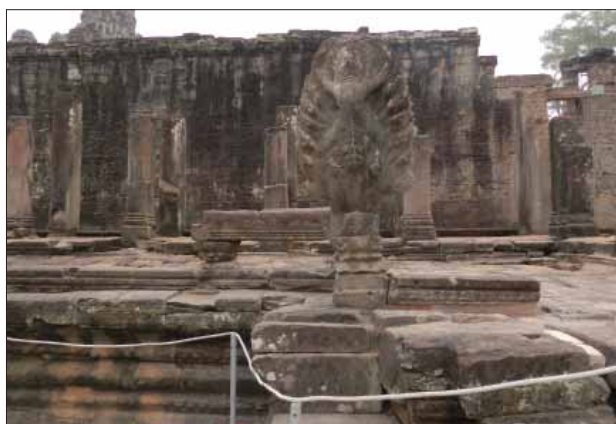
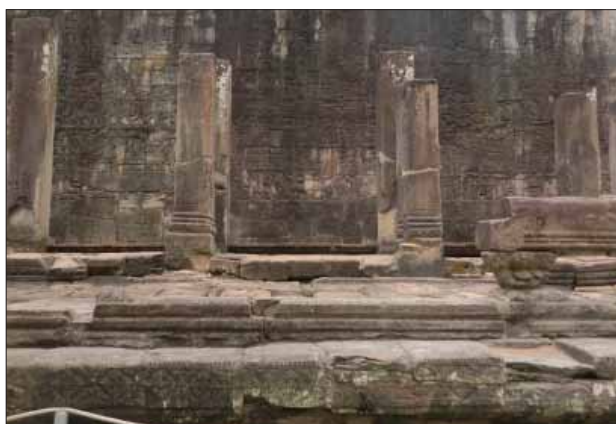
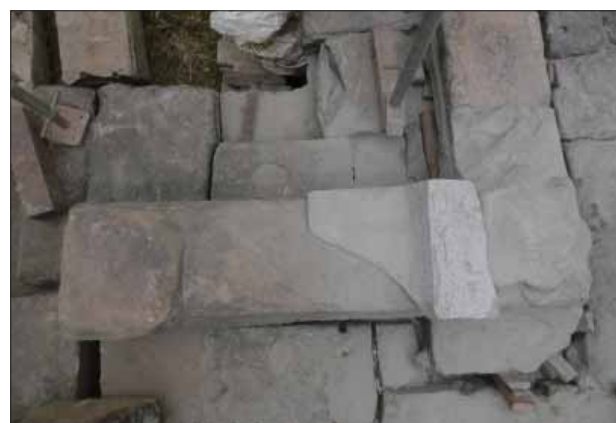
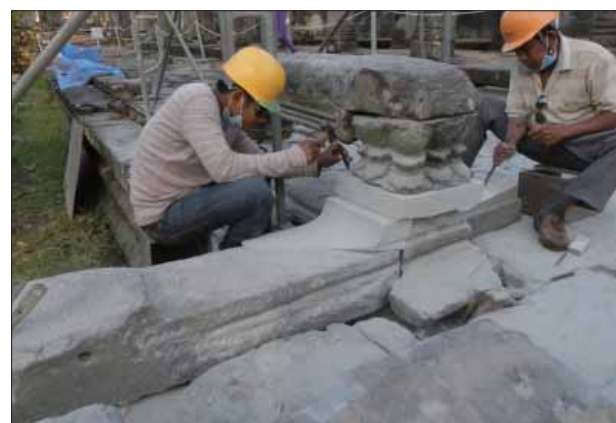
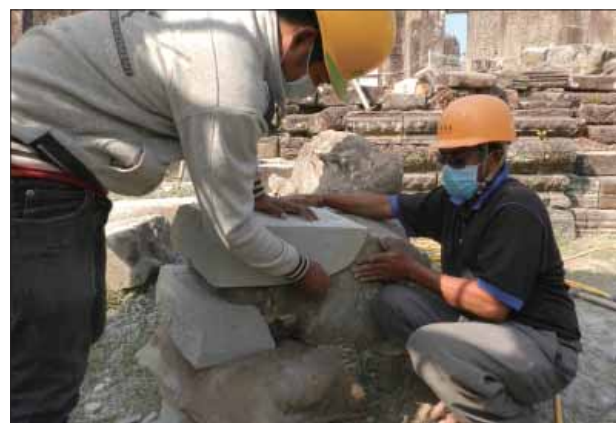
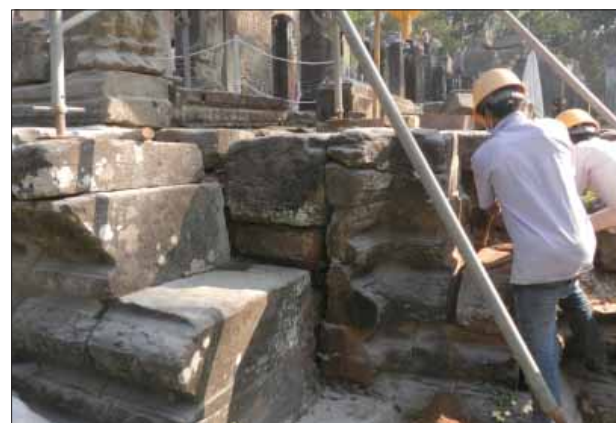
Area : T58.1 / West    Operated Term : 2 month

<After restoration>

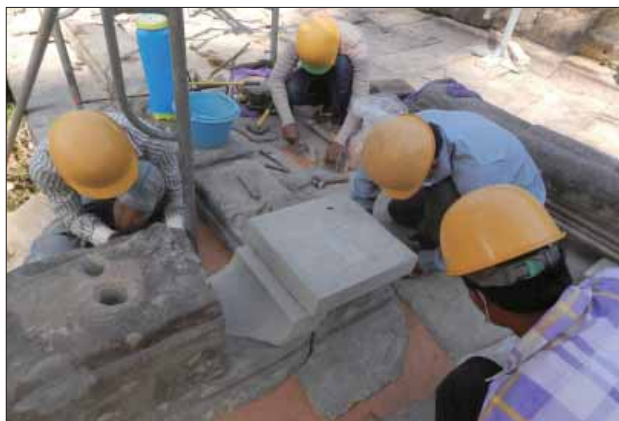
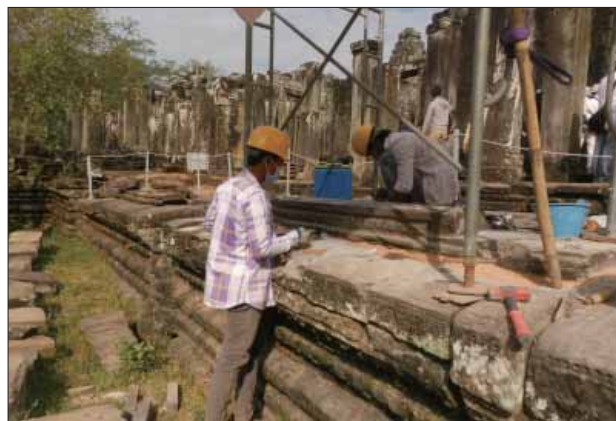
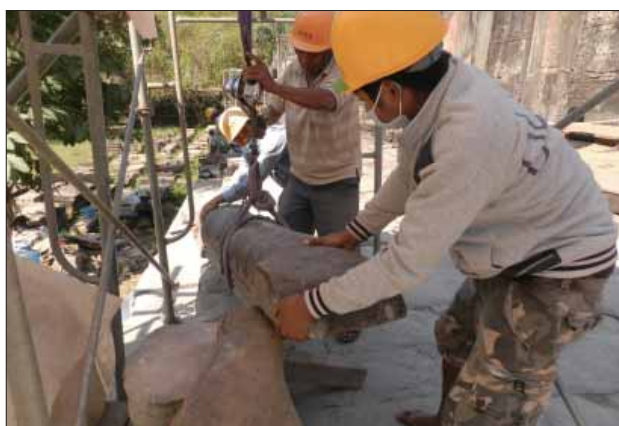
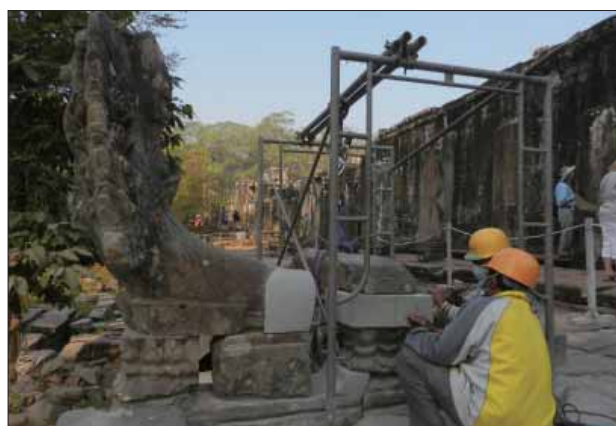
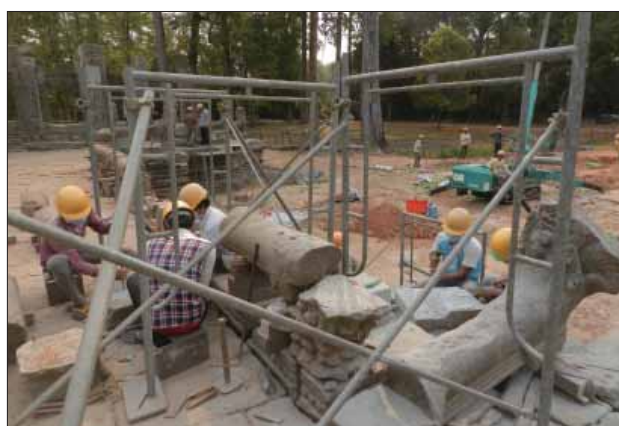
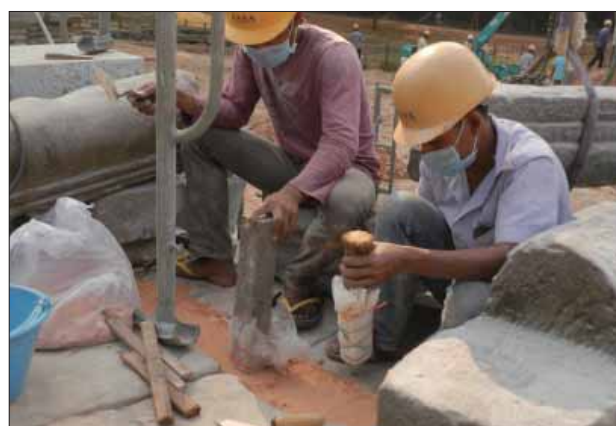
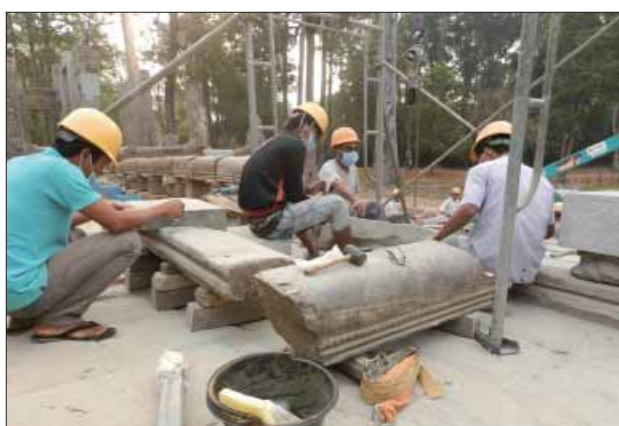
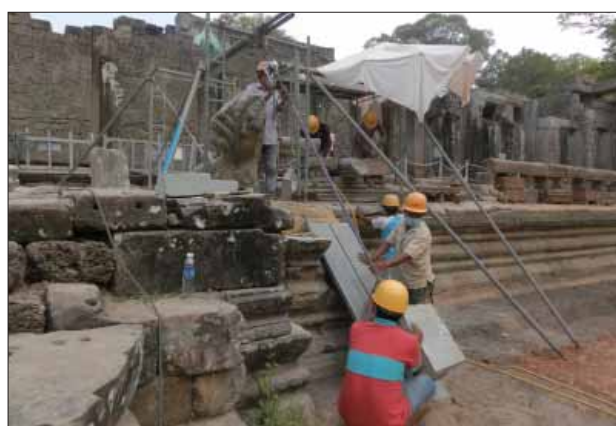
Area : T58.1 / West    Operated Term : 2 month

<Photos during restoration>

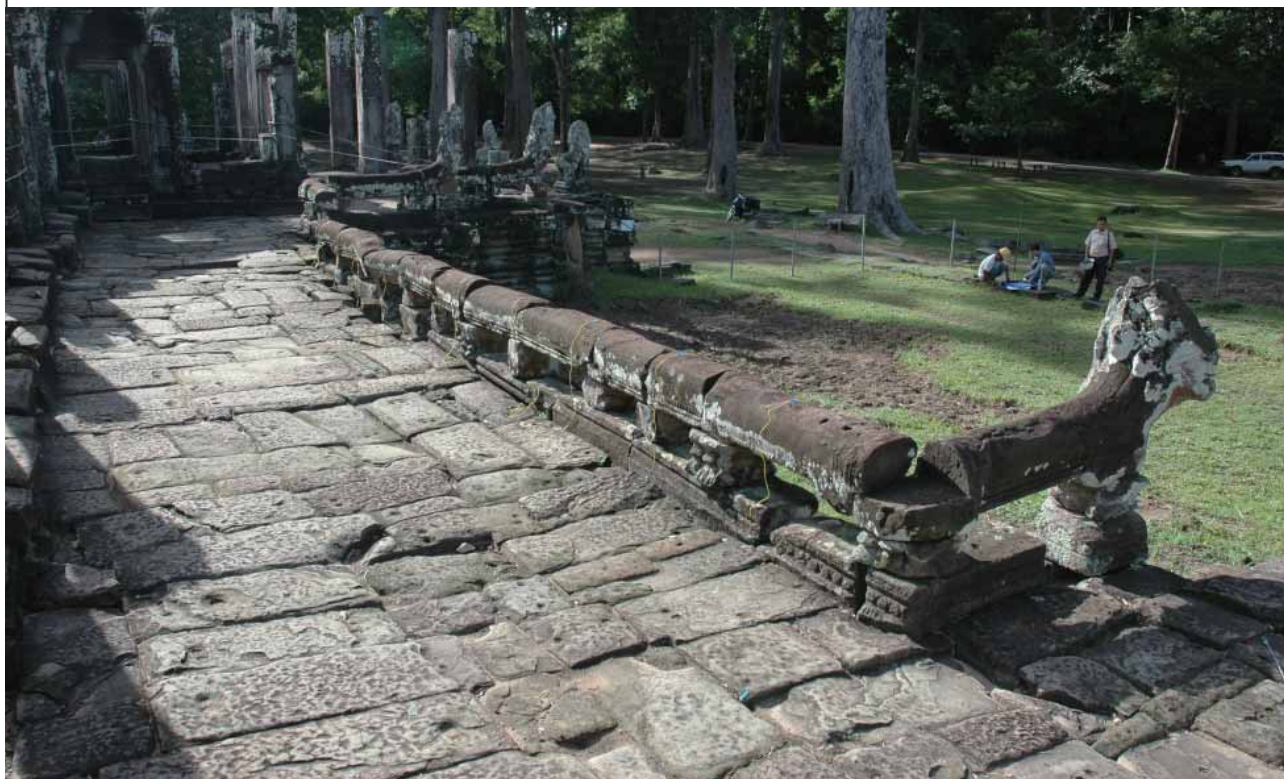
Area : T58.2 / East part Operated Term : 1 Months

**Before Restoration**

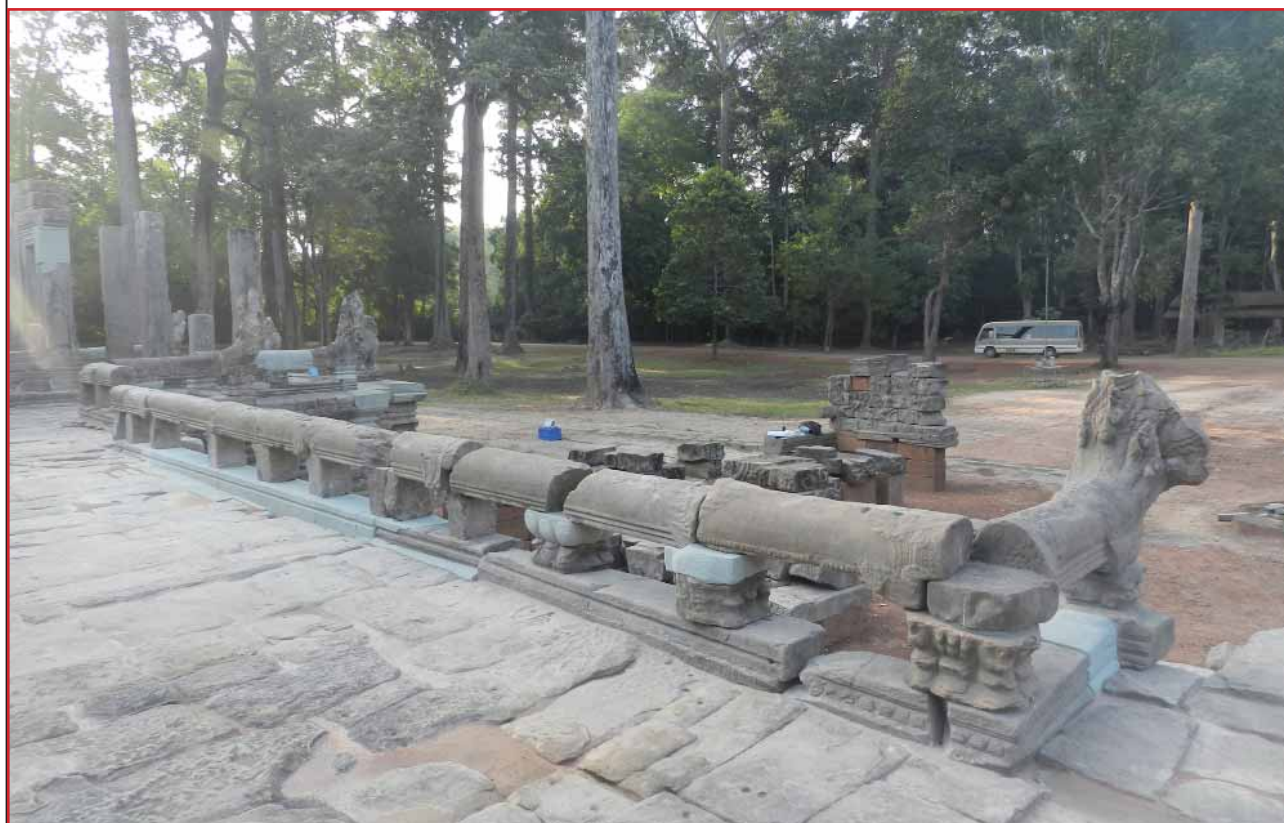
**After Restoration**

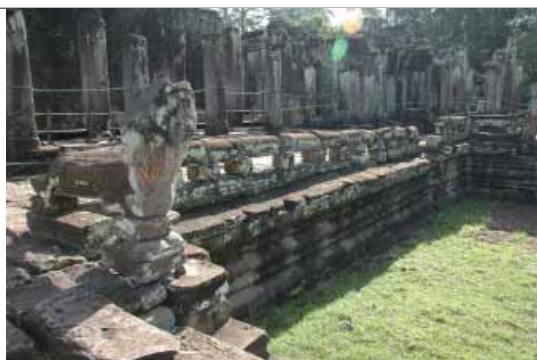
## Area : T58.2 / East part Operated Term : 1 Months

&lt;Before restoration&gt;

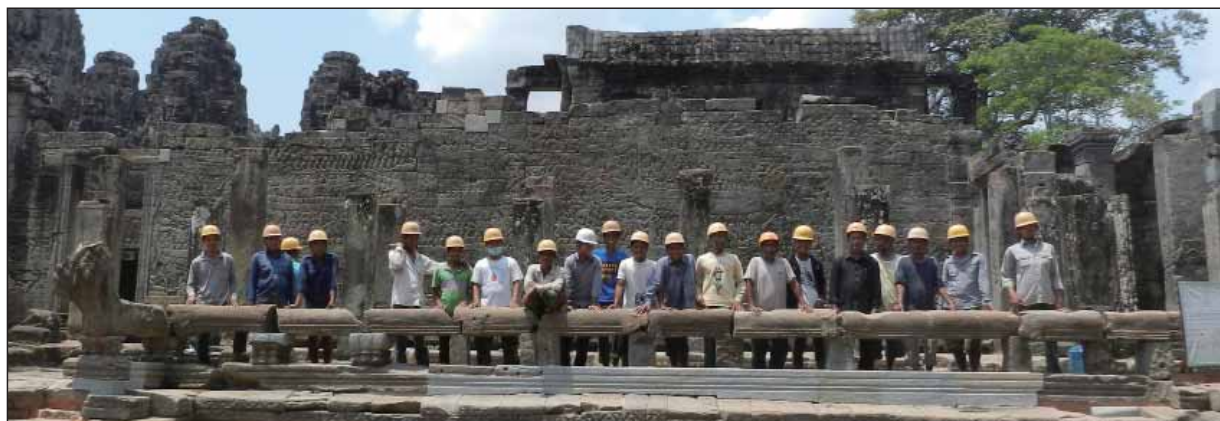
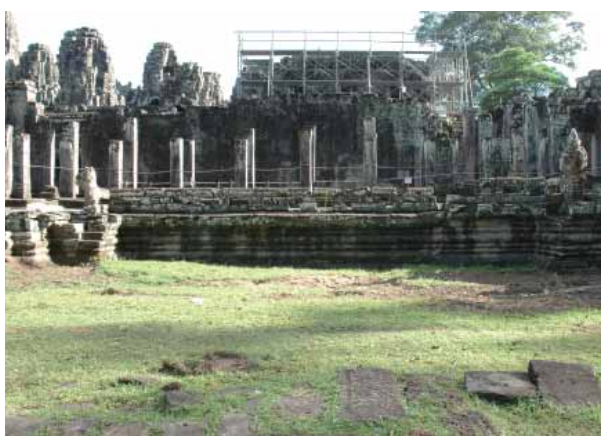
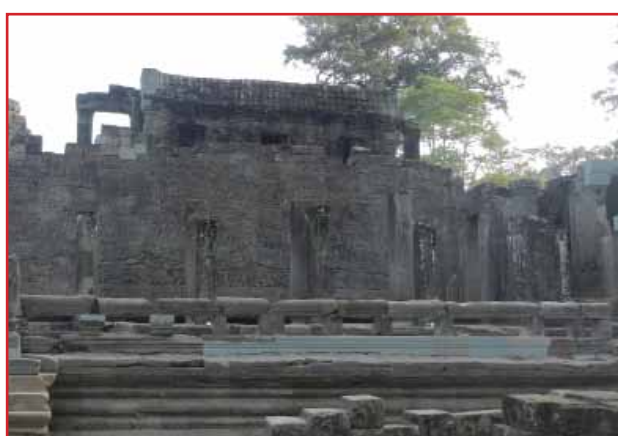
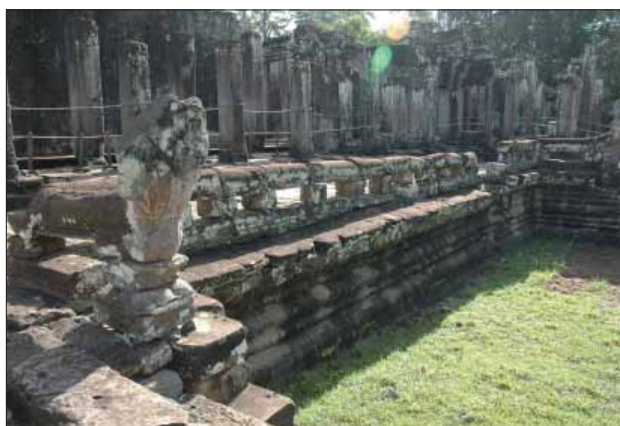
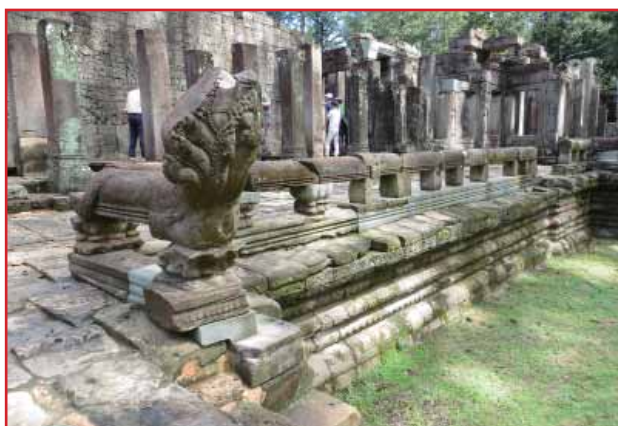
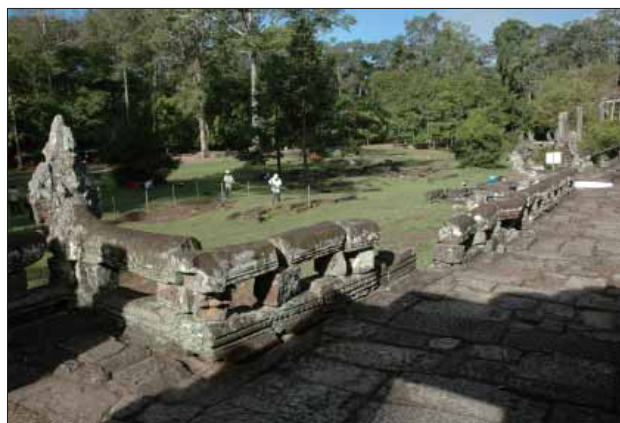
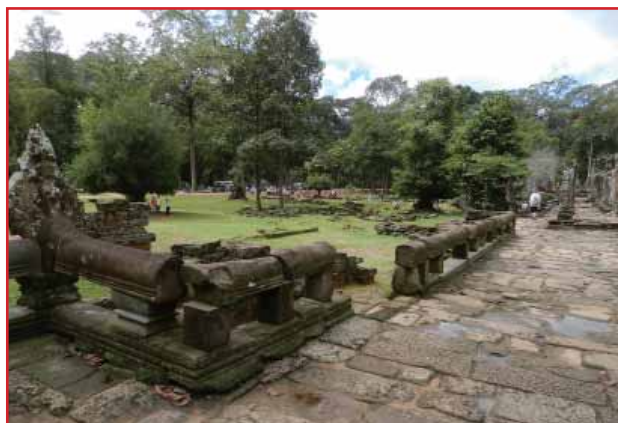
Area : T58.2 / East part Operated Term : 1 Months

<Before and after restoration>
