# ***APPENDIX I***

## ***Restoration activities for each area***

*Report on the Conservation and Restoration work of  
LION and NAGA Balustrades at the Causeway and Outer  
Gallery of BAYON  
Angkor, UNESCO World Heritage Site.*

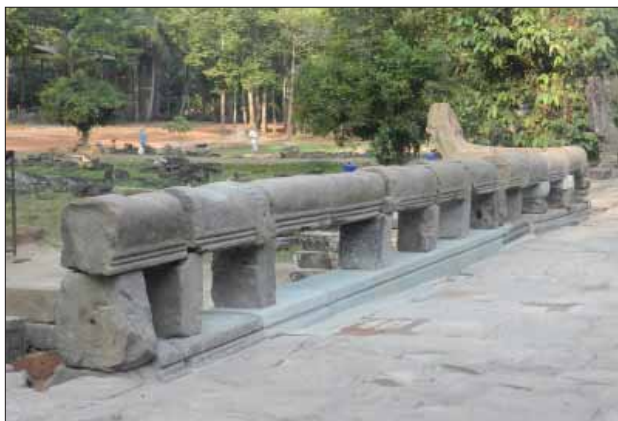
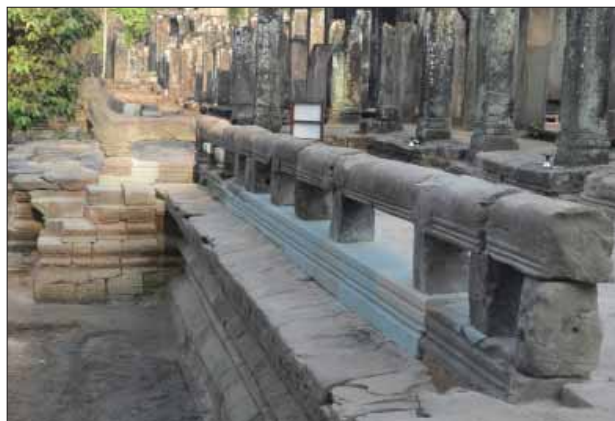
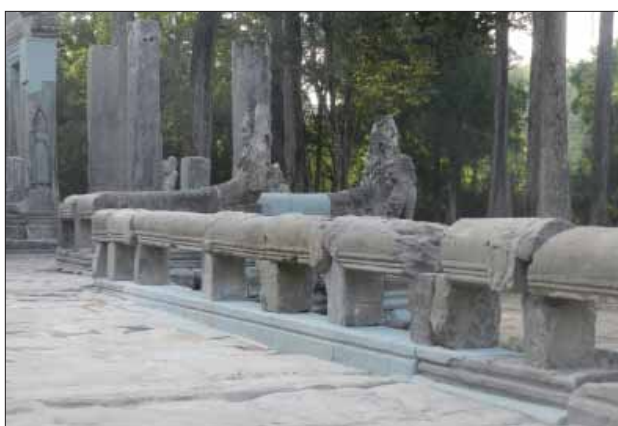
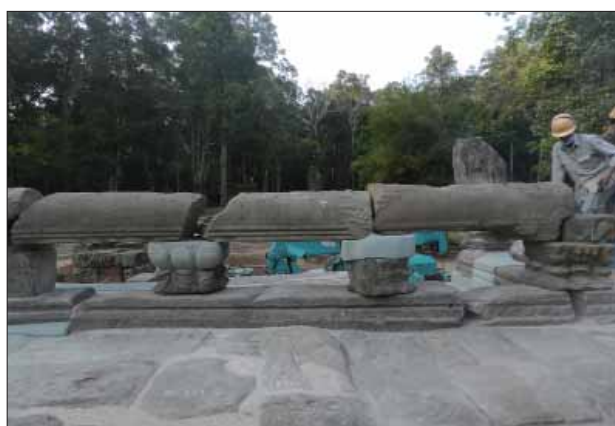
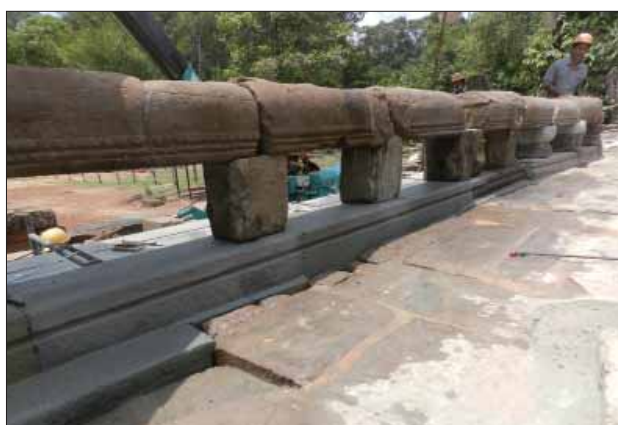
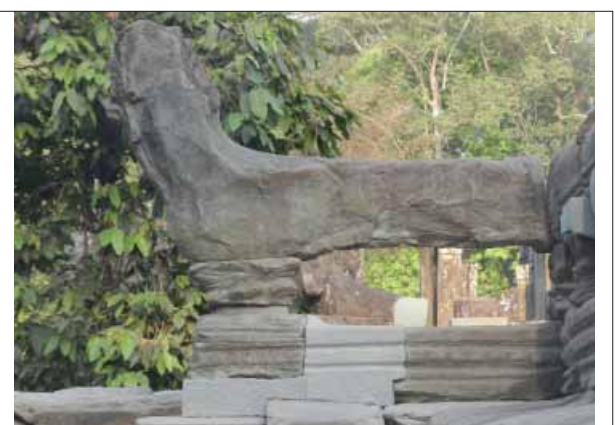
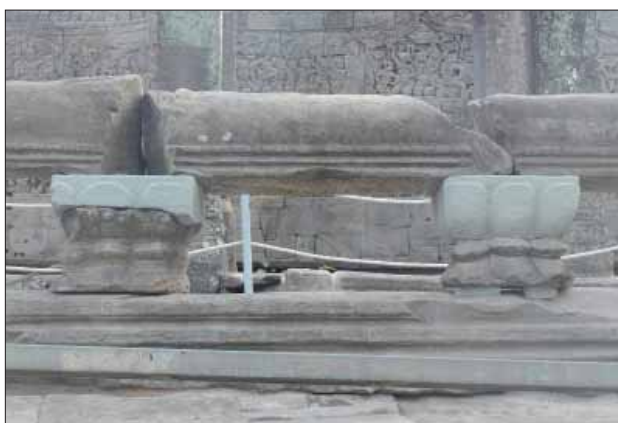
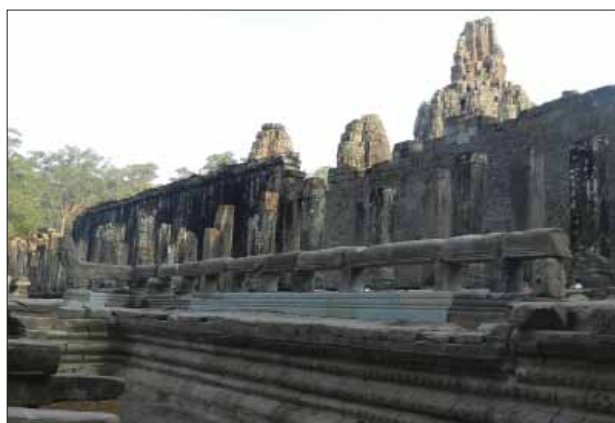
Area : T58.2 / East part Operated Term : 1 Months

<After restoration>

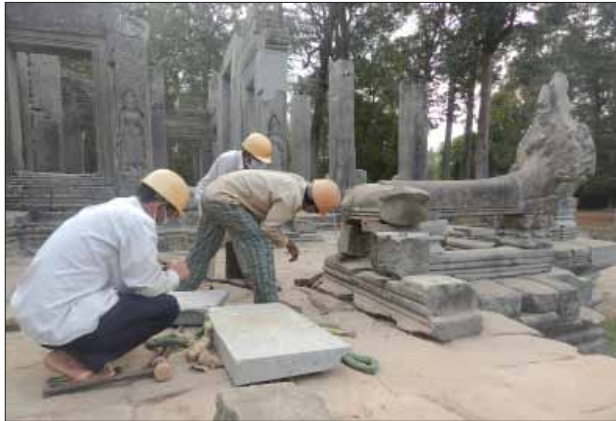
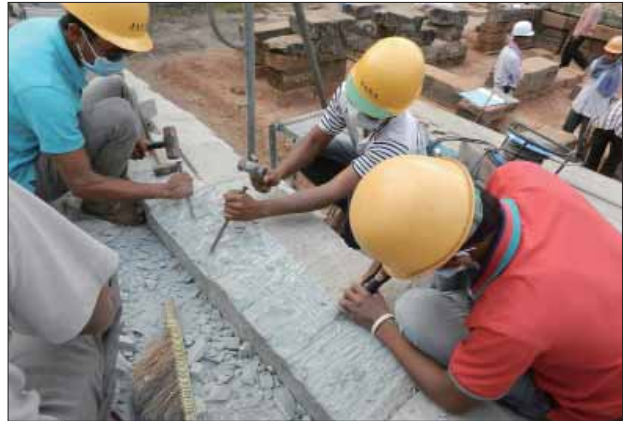
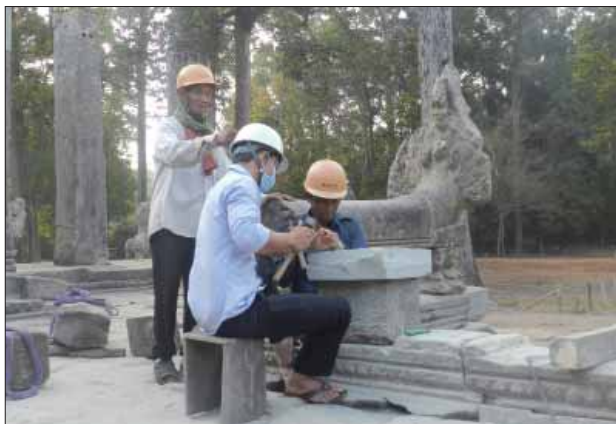
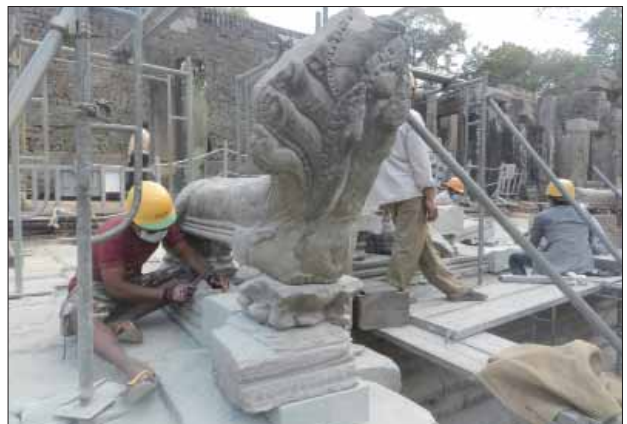
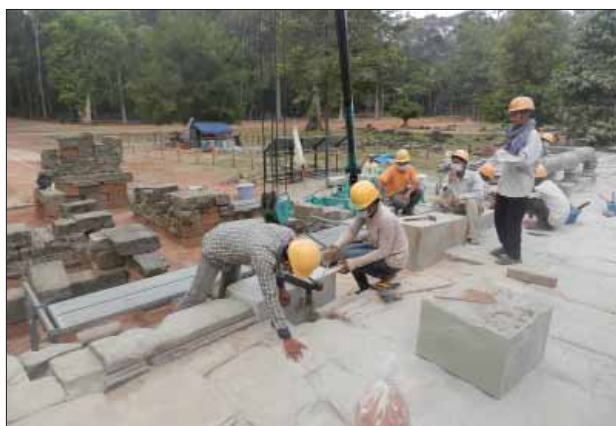
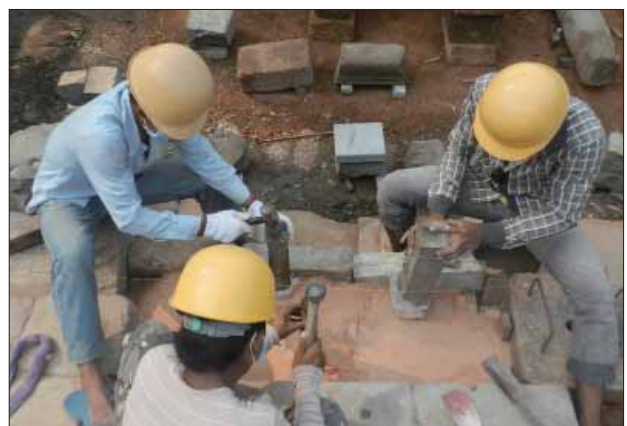
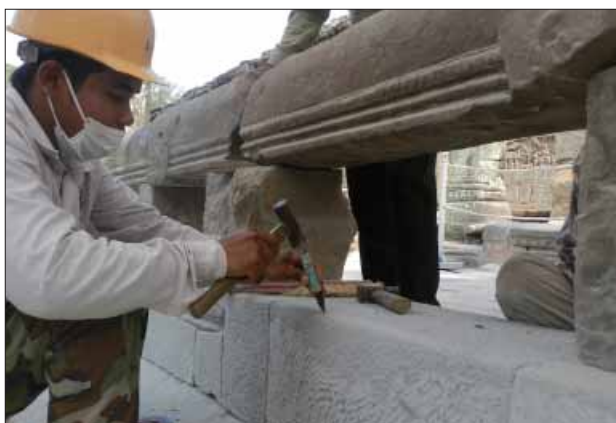
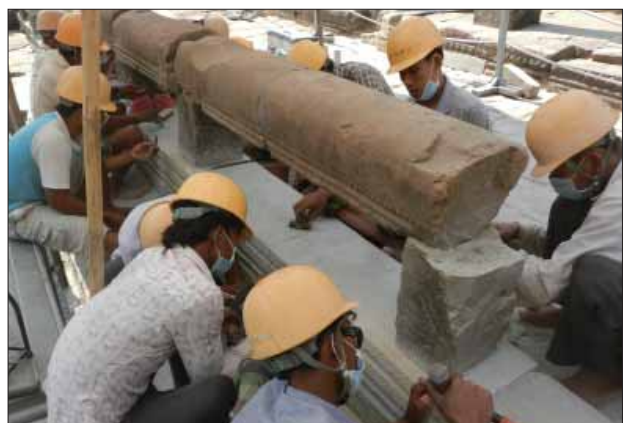
Area : T58.2 / East part Operated Term : 1 Months

<Photos during restoration>

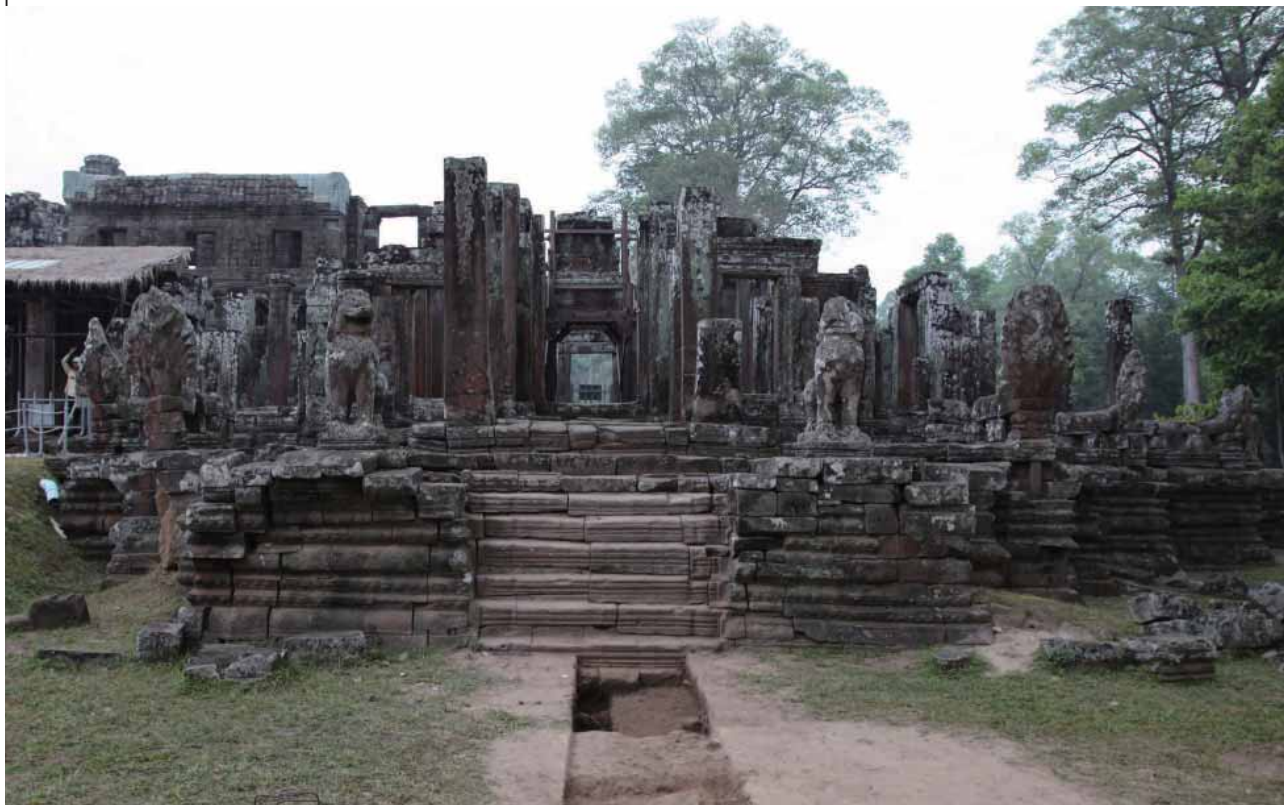
Area : 57.3 / Southwest Operated Term : 4 month

**Before Restoration**

Since this area was the first area to be restored in this project, which started in September 2012, and also the first area to be restored by JASA, the repair of the parapet components was carried out under the guidance of JASA technicians, one by one, according to the specifications of each component.

The mortar on the lion statue had deteriorated due to the previous restoration, the mortar and iron pins were removed and replaced with new stainless steel pins and new sandstone material. The new wood processing was led by JASA technicians because the skills of the project staff were not yet sufficient.

In this area, 1 Lion statue was restored (57.3.9.1.1, L-3). The ankle portion was lost due to breakage, and although it had been mortared and joined in the previous restoration, there was a risk that it would break again due to deterioration of this material. Therefore, new sandstone material was processed according to the required size, filled in, and joined. The finishing process was based on other Lion statues, but was done in a way that would make it easy possible to distinguish it from the original.

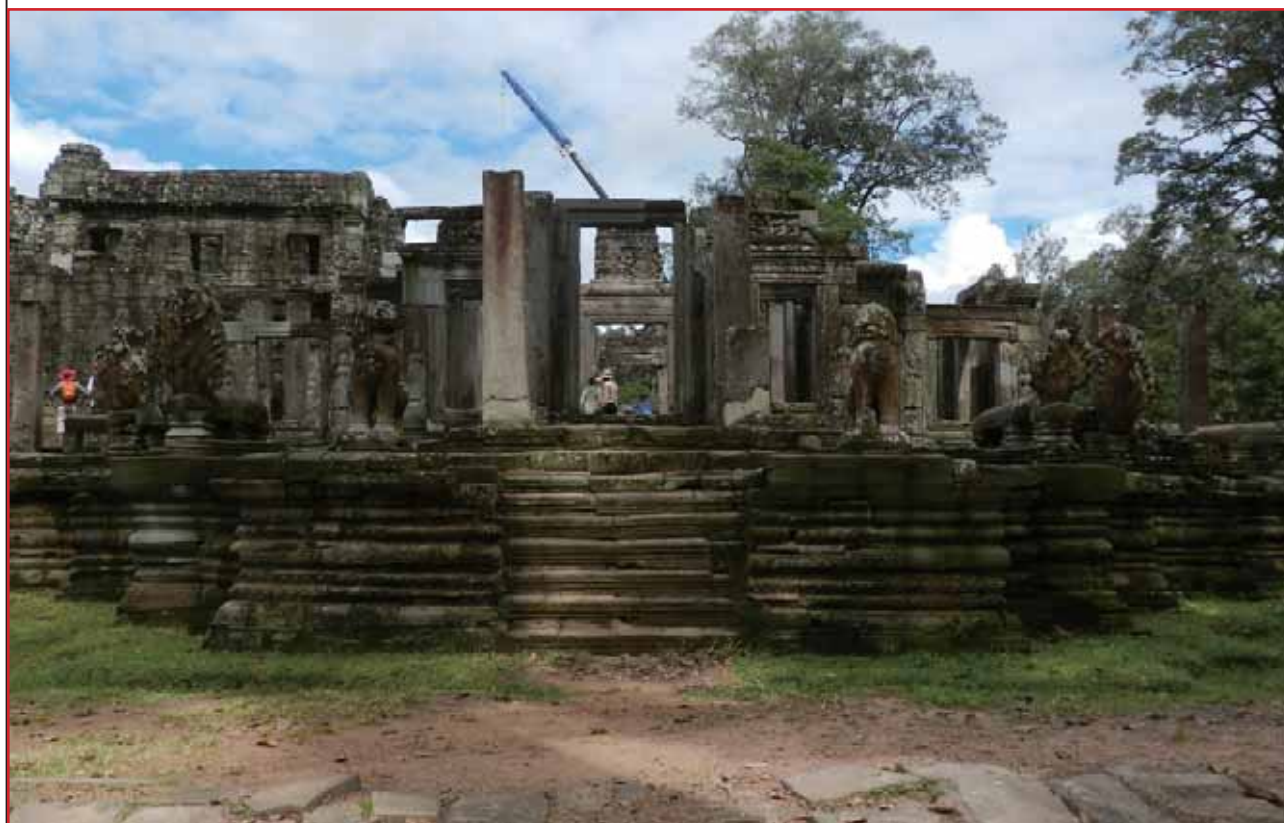
**After Restoration**

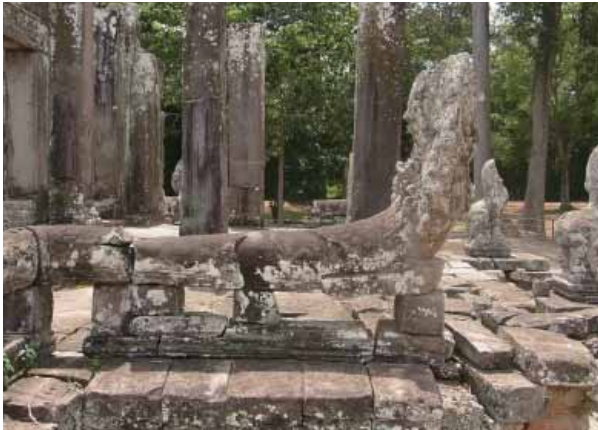
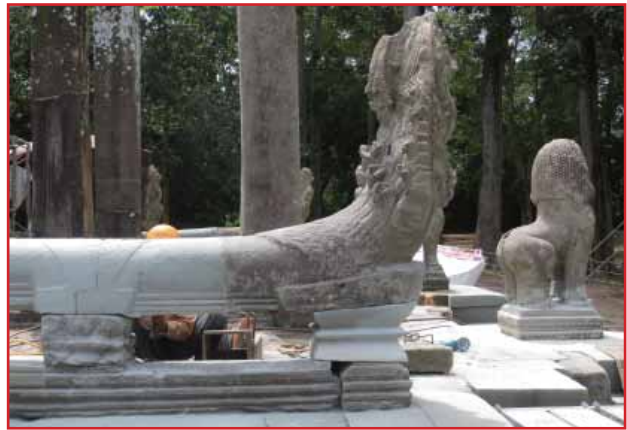
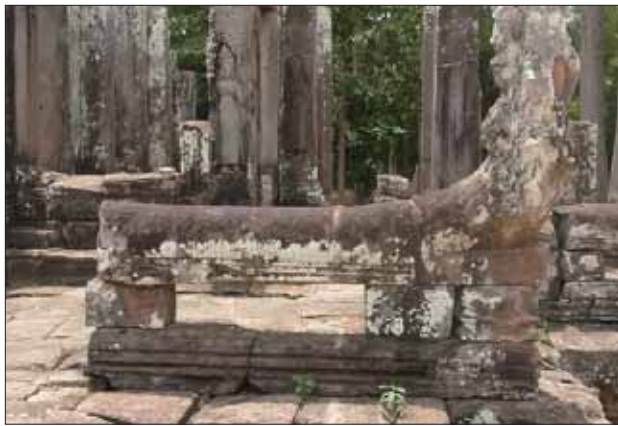
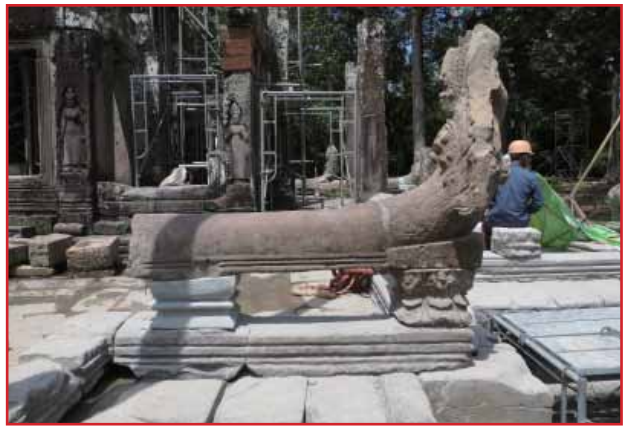
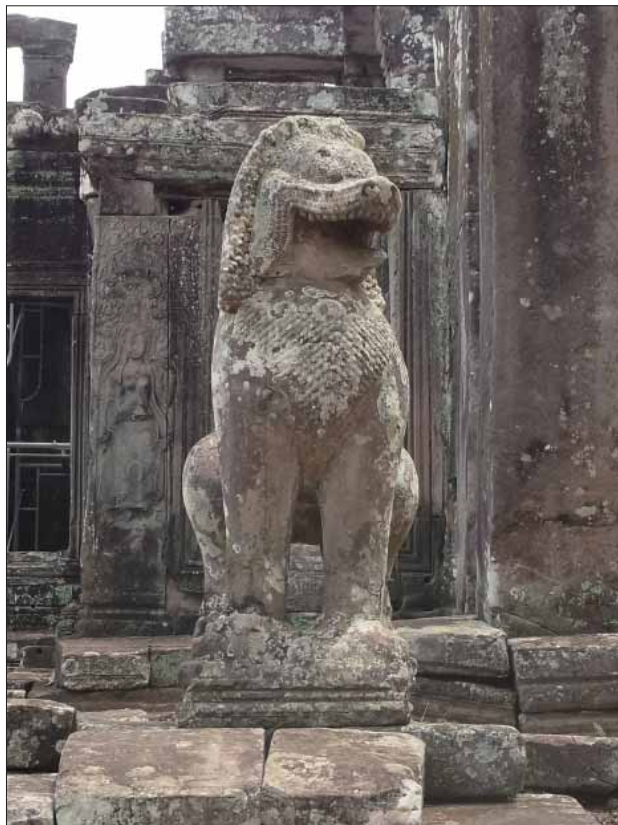
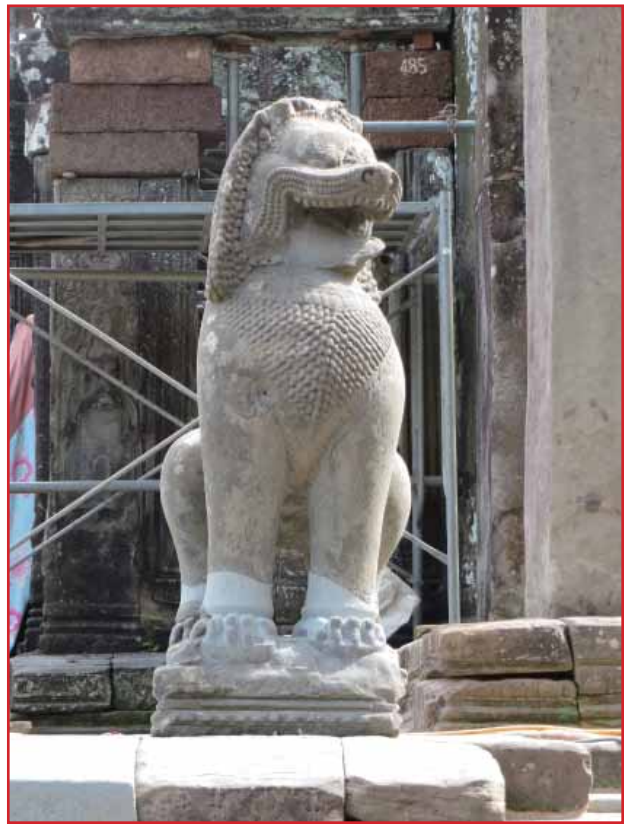
Area : 57.3 / Southwest Operated Term : 4 month

<Before and after restoration>

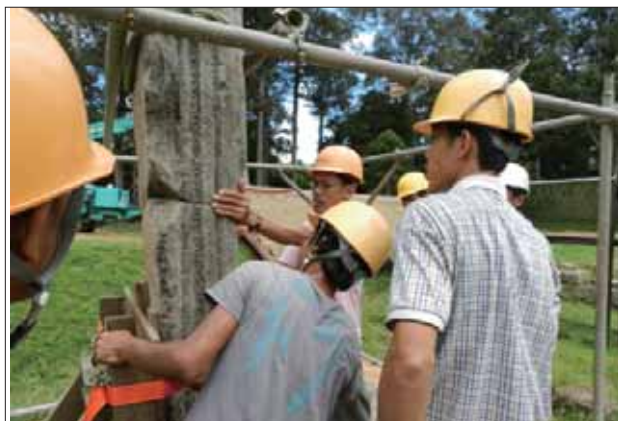
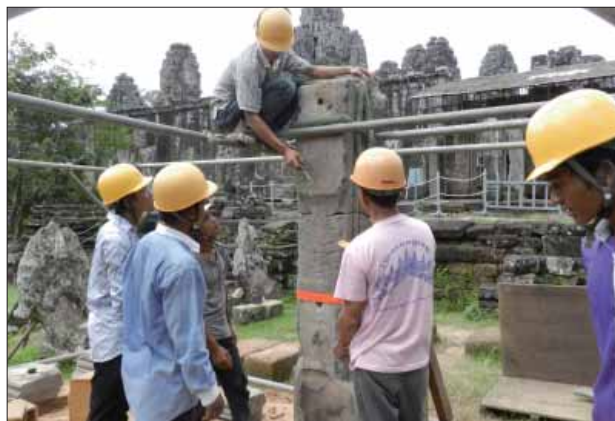
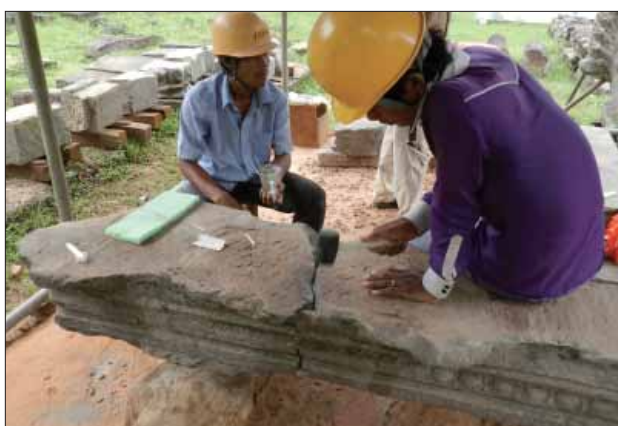
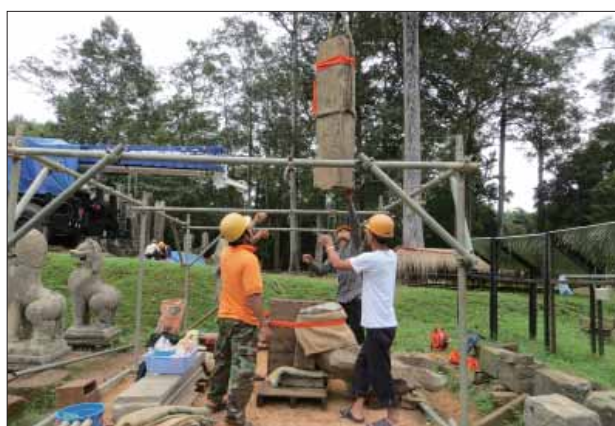
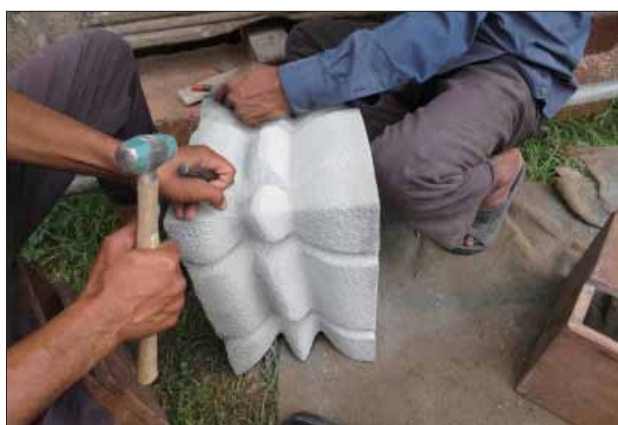
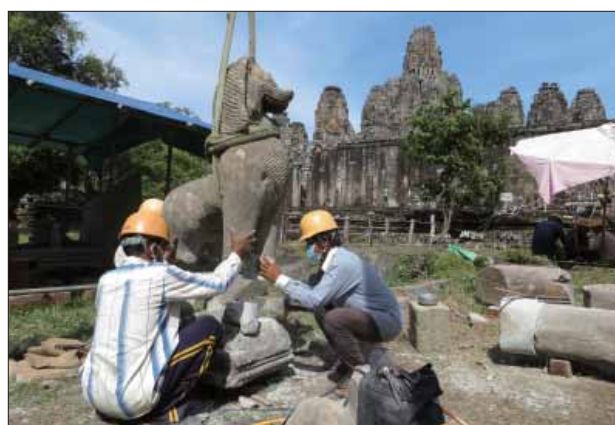
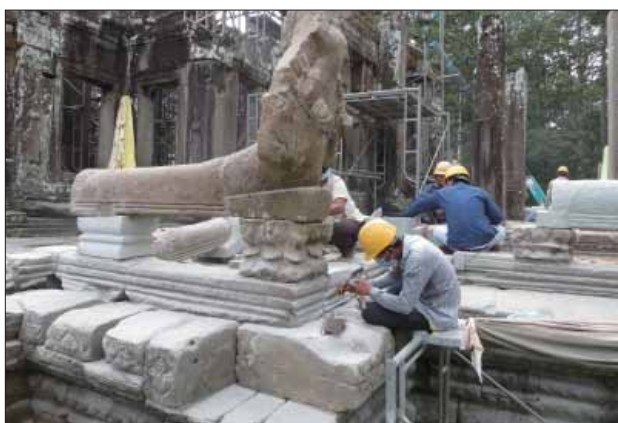
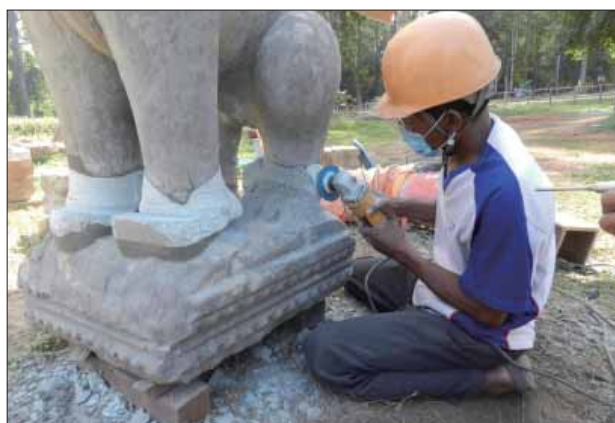
## Area : 57.3 / Southwest Operated Term : 4 month

## &lt;Photos during restoration&gt;

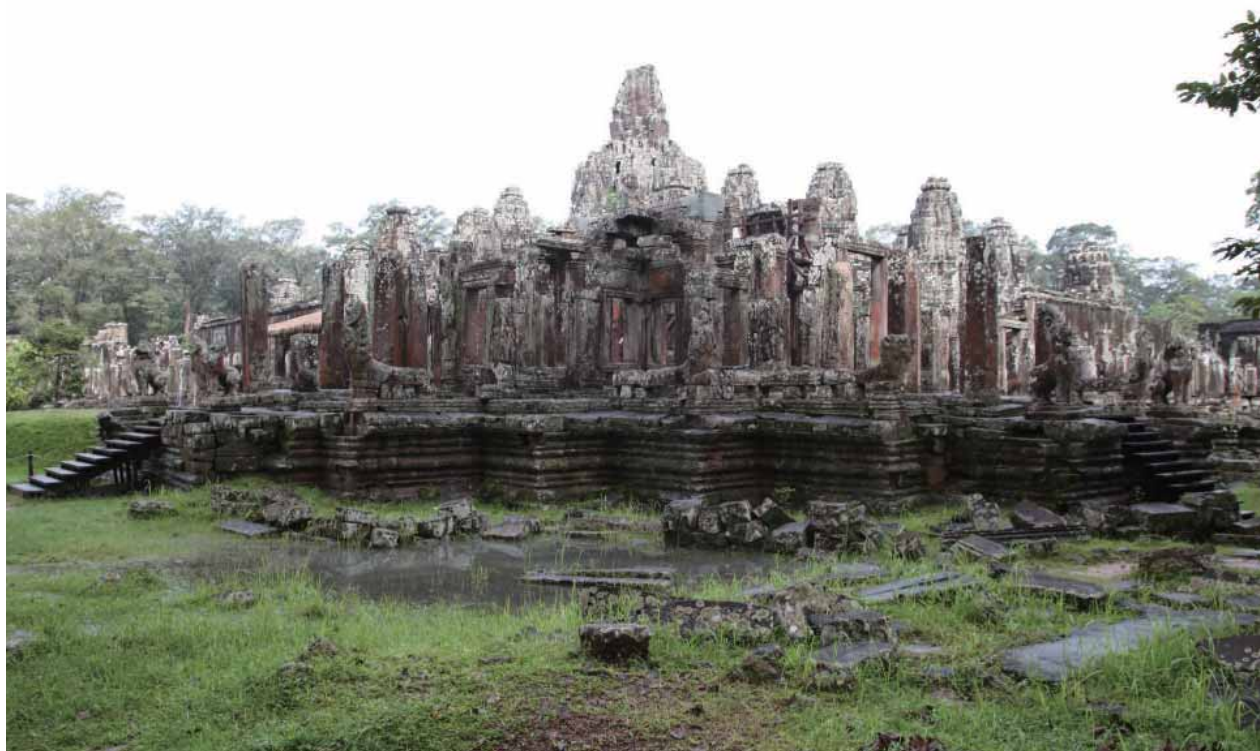
Area : 57.2 / SouthEast Operated Term : 3 month

**Before Restoration**

Since this area was subject to restoration by JASA, after repairing the parapet components and before reinstalling them, the base was prepared with guidance from JASA technicians on how to fill in the gaps and stabilize the stones.

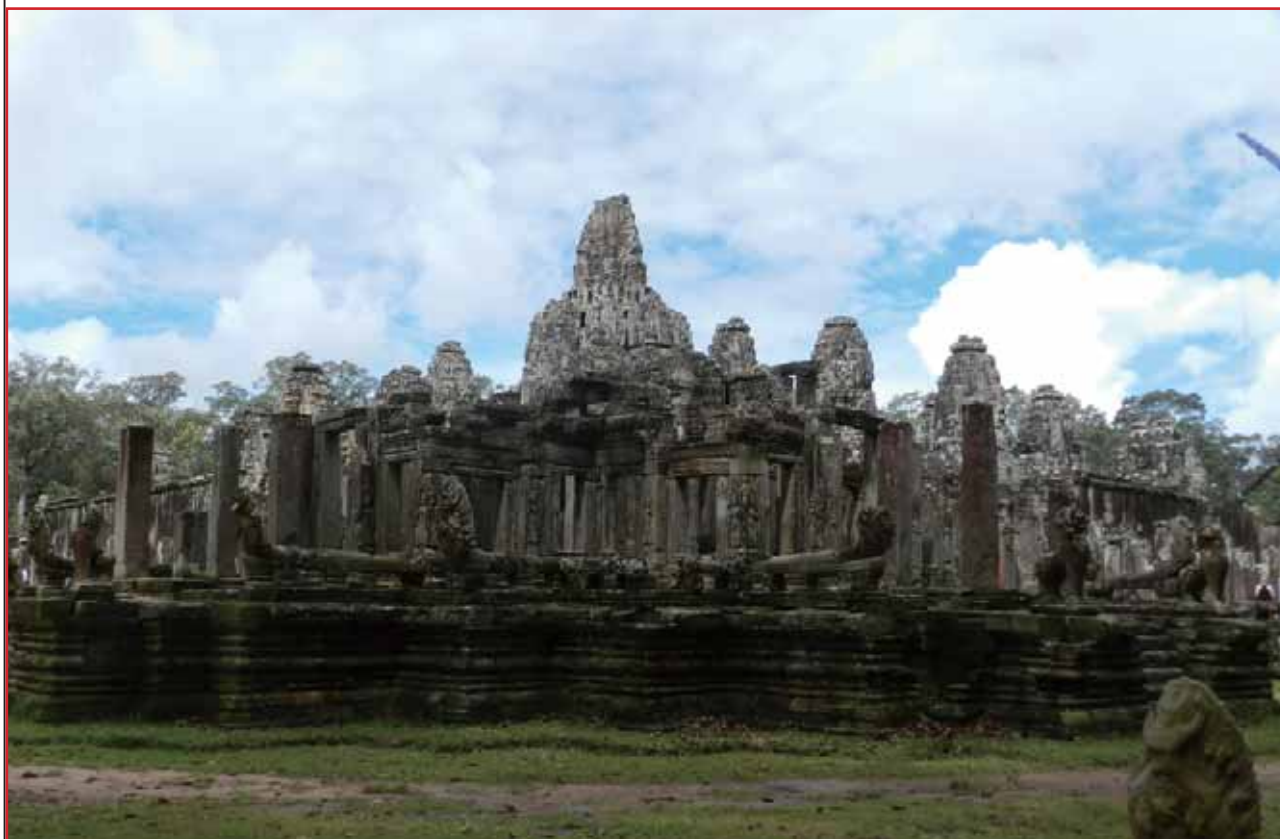
**After Restoration**

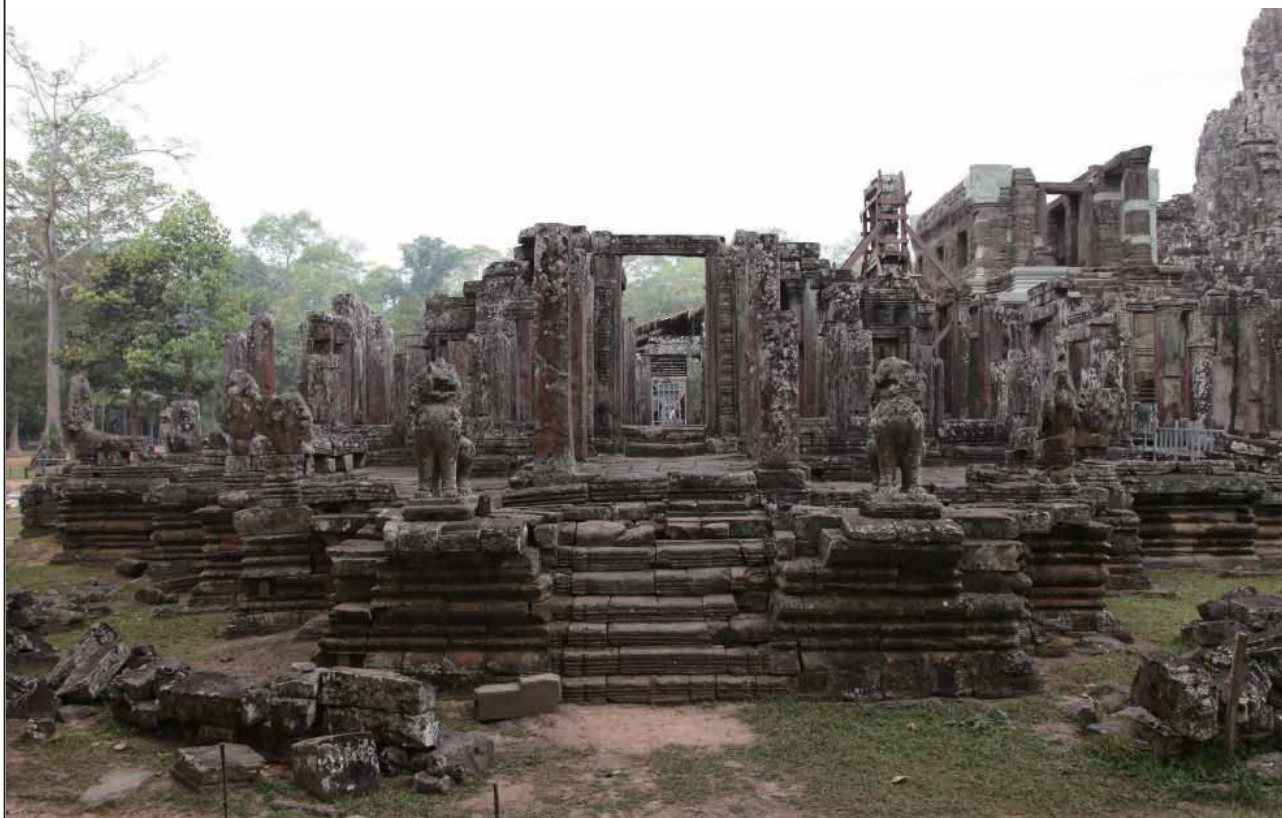
Before Restoration

The position of the basement was not changed and was partially supplemented with new material. Fragments of Naga head 57.1.8.3.3 were identified among the scattered elements and were joined together. The body elements of the other Naga head, 57.1.8.3.2, and the original post beneath it were also found among the scattered stones, so they were joined and installed.

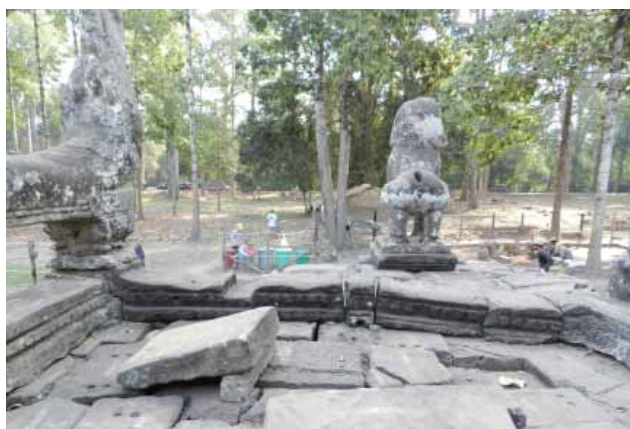
Since this area was the first area to be restored in this project, which started in September 2012, and also the first area to be restored by JASA, the repair of the parapet components was carried out under the guidance of JASA technicians, one by one, according to the specifications of each component.

The mortar on the lion statue had deteriorated due to the previous restoration, the mortar and iron pins were removed and replaced with new stainless steel pins and new sandstone material. The new wood processing was led by JASA technicians because the skills of the project staff were not yet sufficient.

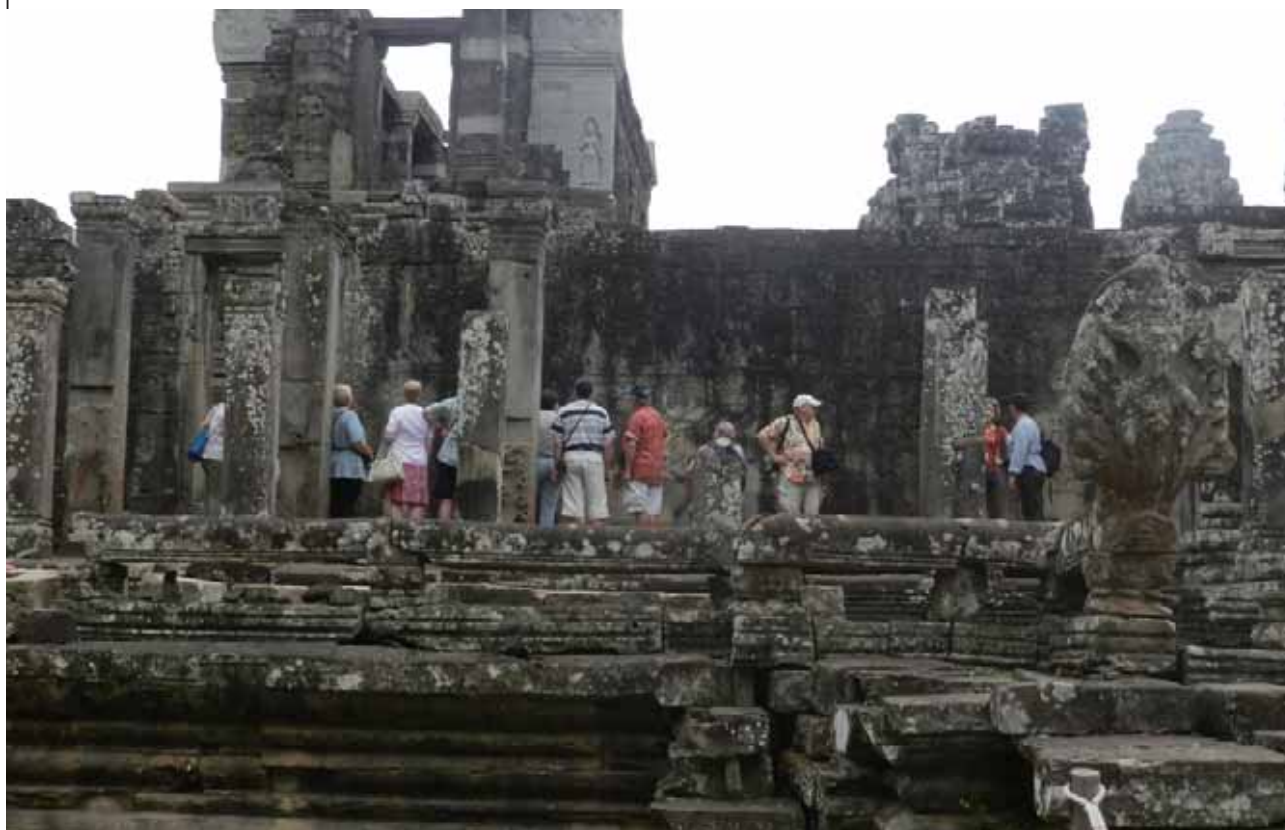
**Before Restoration**

Area : T56.2 / Working Term : 3 month

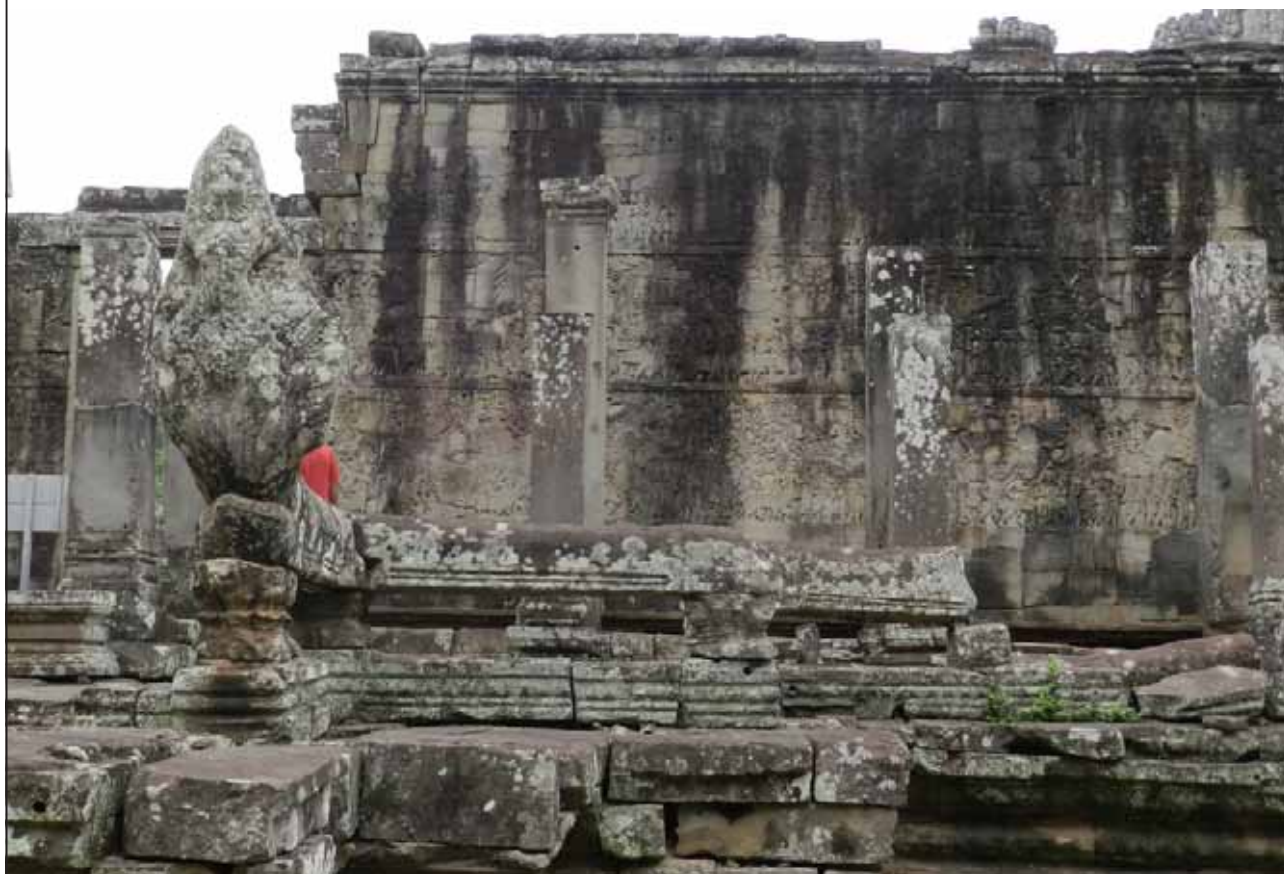
Before Restoration

It was revealed that platform under Naga head has many crack, breakage and has big gaps between elements. Also, some elements of platform are not original that was brought from other place in the past restoration. This area was too unstable to reconstruct balustrade and need some maintenance. Thus discussed with JASA experts, we made decision to do minimum maintenance for platform to make stable enough to reset balustrade. Thus, firstly we dismantled some of outer surface elements of the platform, and gave appropriate treatment to the elements which has problem and then reconstructed. However this project target is to ensure the safety of balustrade, we continue to use the same situation as before and only change position, for example elements that have curve on it (it seems belong to outer gallery relief), we put it on the surface of the platform, so that it is easy to understand in the future. After that, place that has big gaps we filled by laterite and clay powder and also soil 4 on the gaps the top layer.

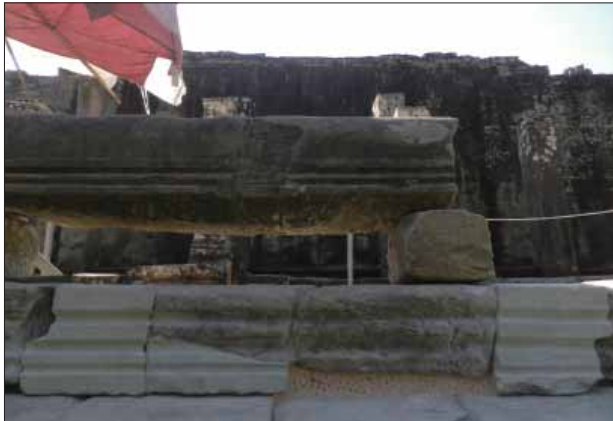
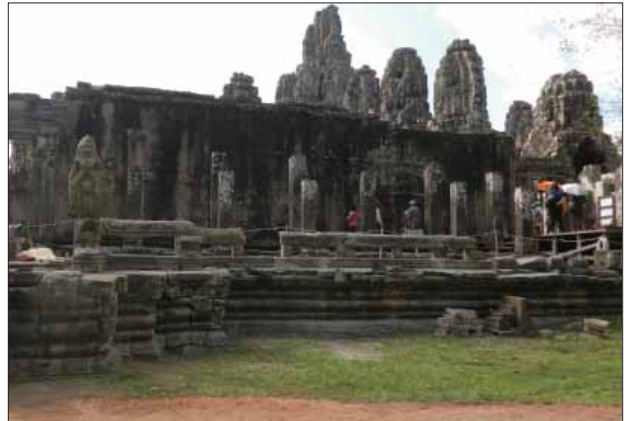
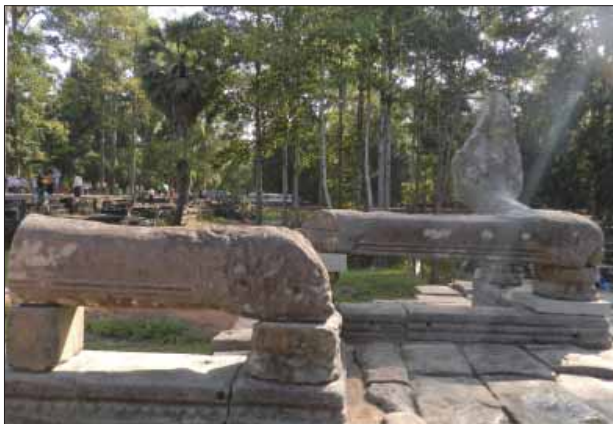
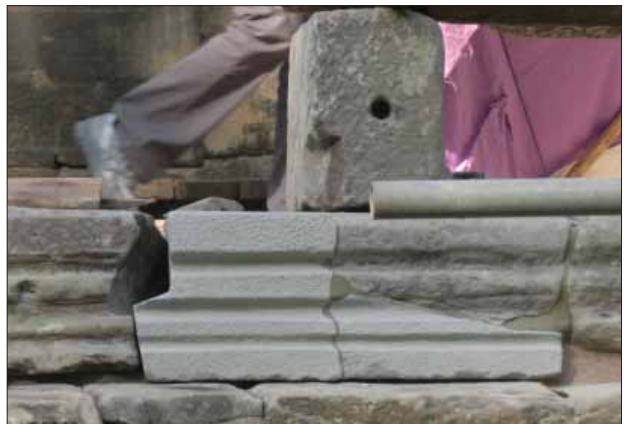
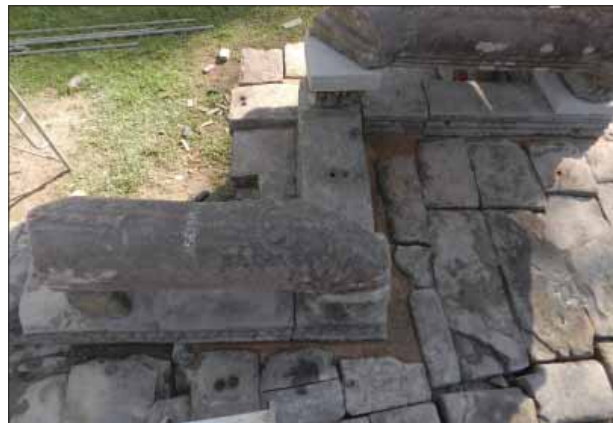
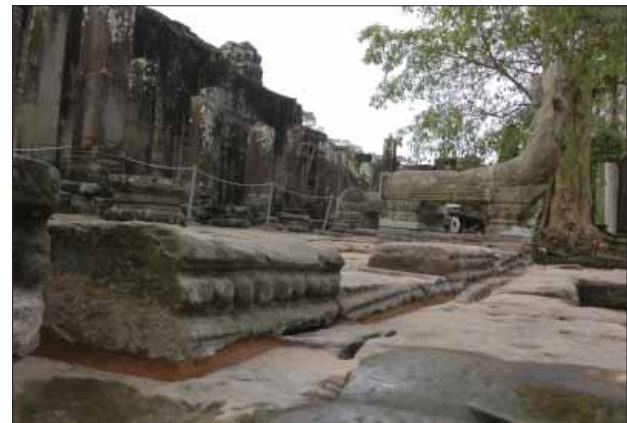
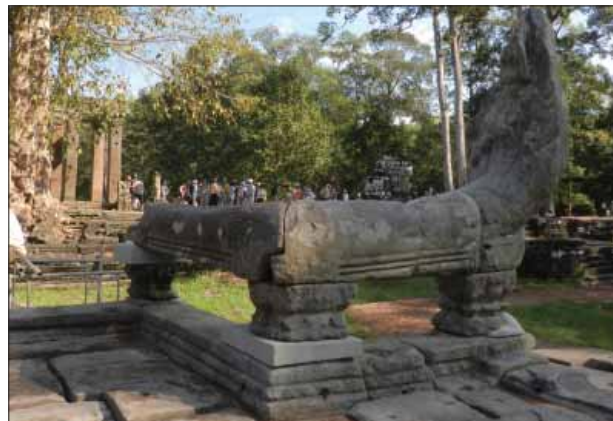
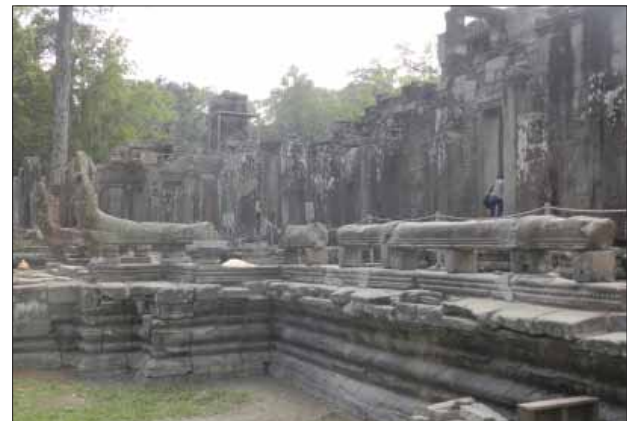
Area : T56.1 / Working Term : 3 month

<After restoration>

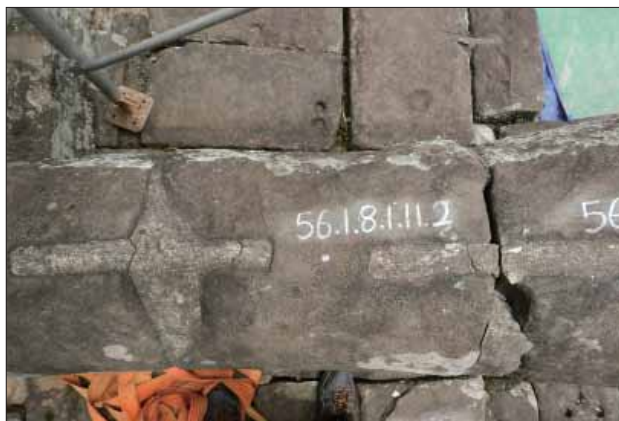
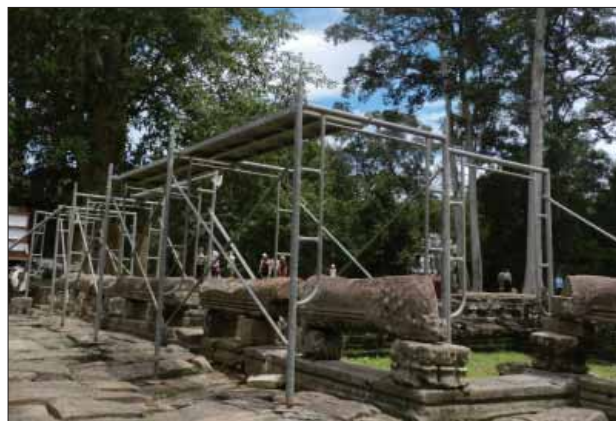
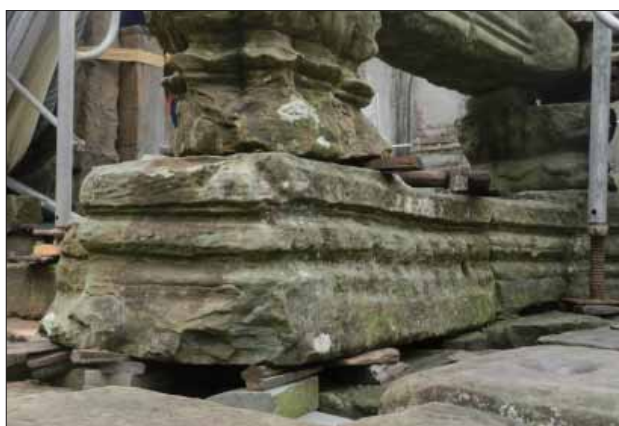
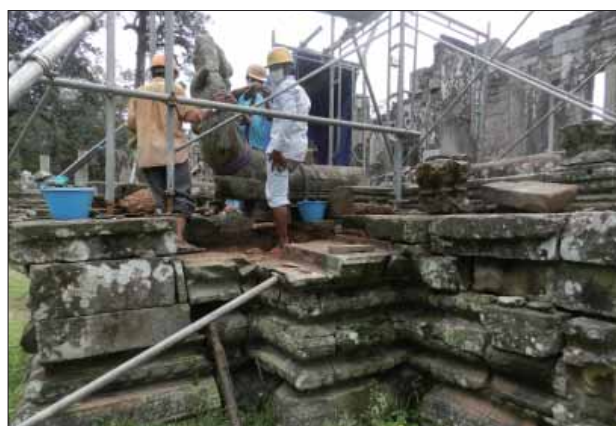
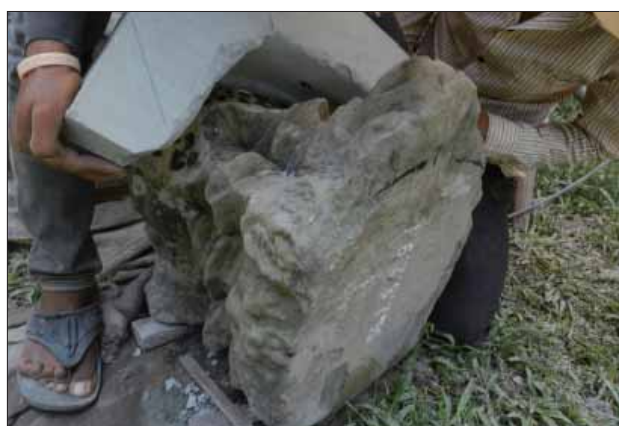
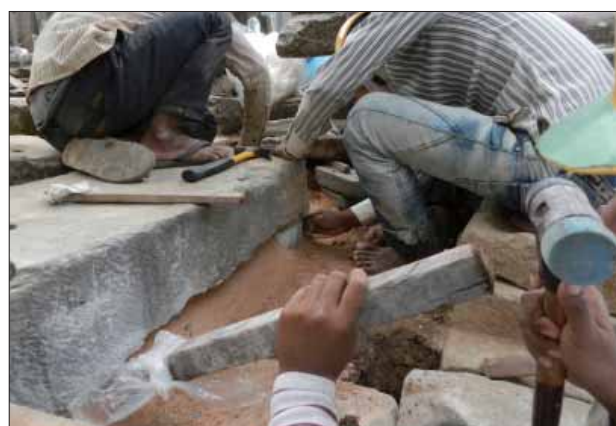
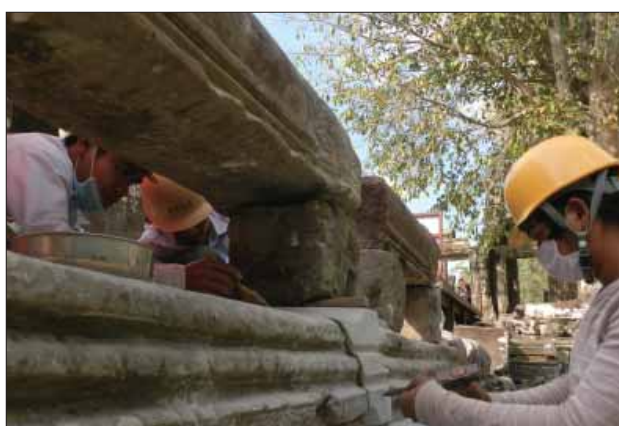
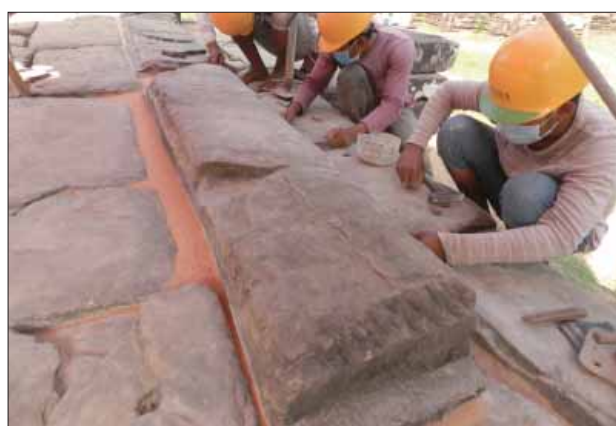
Area : T56.1 / Working Term : 3 month

<Photos during restoration>
